International Journal of Mine Water, vol. 2 (3), (1983) 25 - 38

A STUDY OF GEOHYDROLOGICAL AND ROCK ENGINEERING
ENVIRONMENT AT LAPPVATTNET EXPERIMENTAL MINE

Jan-Åke Åkesson
Senior Engineering Geologist
BERGAB - Berggeologiska Undersökningar AB
St Pauligatan 33 A
S-416 60 Gothenburg
Sweden

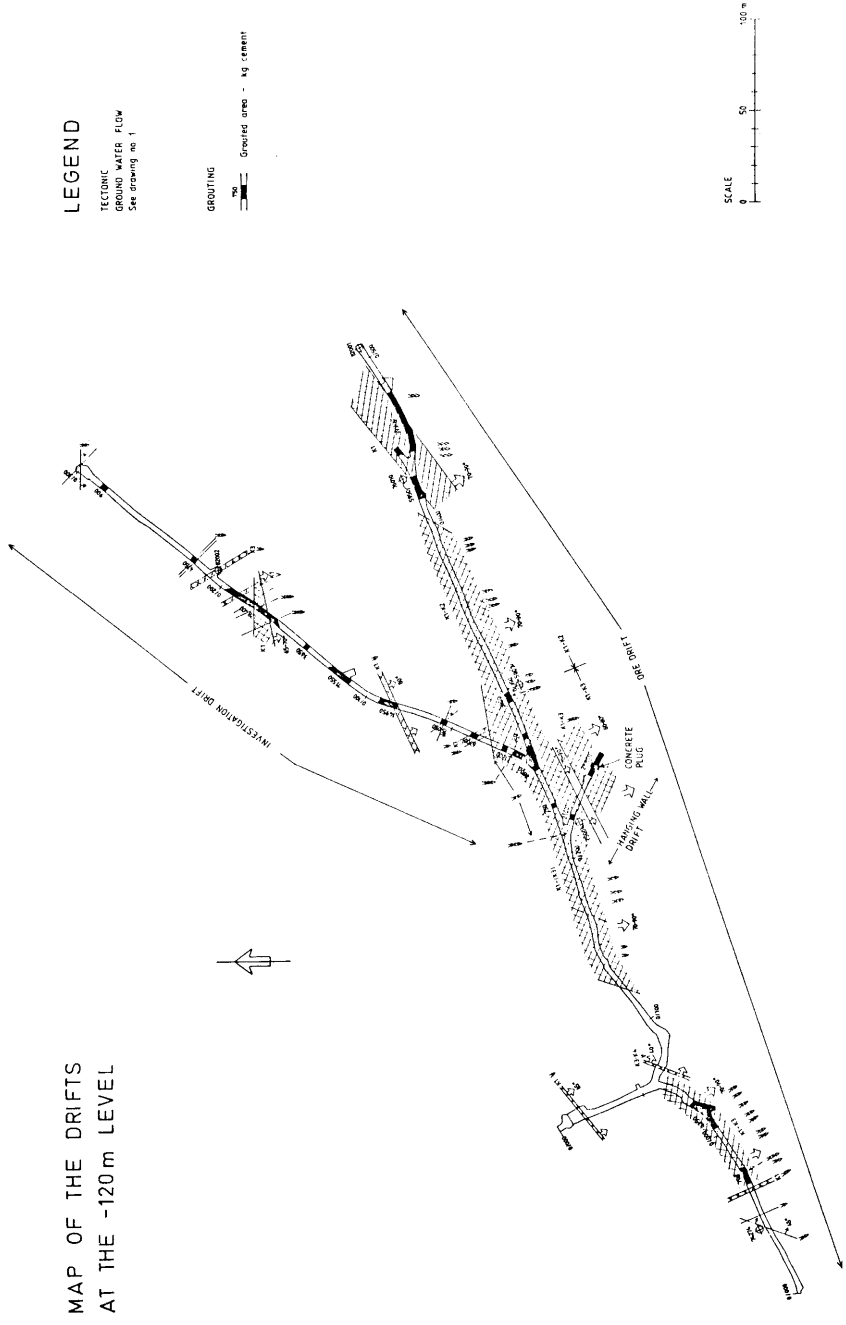
Figure 2 Layout of site of investigation

about 15 years in a large number of projects, both at the planning and development stages. The structure plan of the drifts is given in Fig. 2 which show the fissures and water bearing zones at the time of the geological mapping.

Figure 2 shows the area of drifts grouted by cement together with the information about used quantity of cement, as marked for every grouted section. The majority of the grouted sections are to be found in the parts of the drifts, where the fissure frequency is high and the ground-water flow strong. Despite occasional high quantities of cement the still leaking parts often have strong water inflows. However, there are some grouted sections in the investigation drift which do not correspond to water bearing fissures or zones (Fig. 2). Only the fissures and zones which were leaking at the time of the survey are represented in Fig. 2. If on the other hand the grouted sections were compared to a detailed drawing of the investigation drift, where all information is available, the following would appear:

- in the grouted sections there were especially vertical fissures striking about N30-35°W
- in the grouted section around O/190 there is a zone about 2 m wide, striking N35°W. In this zone the grouting cement can be seen along the previous open fissures
- the fissures still leaking within the grouted sections had small leakage (v).

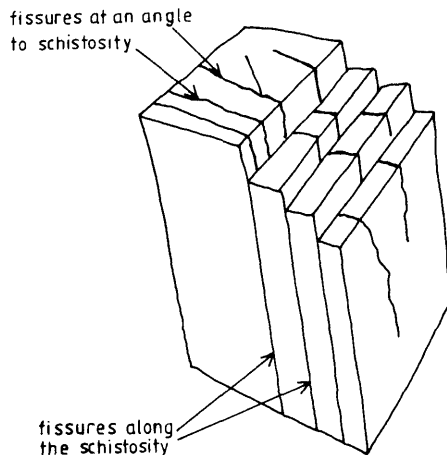
Figure 3 Principle type of fissure formation

In the ruptural deformation after consolidation of the bedrock to a rigid mass, it had been exposed again to deformation. Older schistose veins and planes formed during the plastic deformation have then controlled the new movements along the schistosity/graphite veins. Further movements had also occurred along the earlier tension cracks. The experience from areas of similar geological structure shows that fissures/schistosity zones often limit the extent of other types of fissures. Fissures at an angle to the schistosity terminate in many cases, just to fissures along the schistosity zones or continue to diffuse (see Fig. 3).

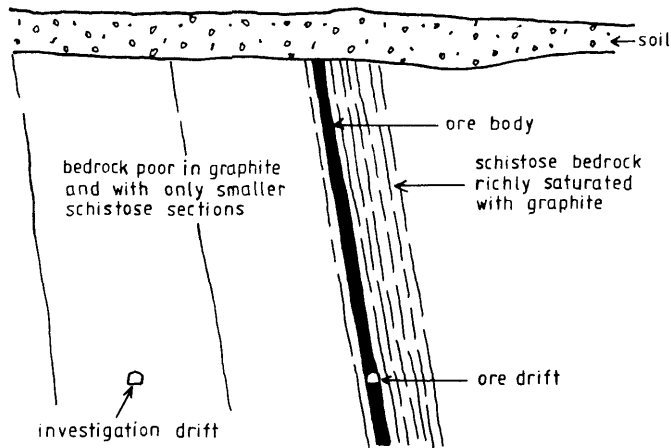
The ore drift is situated in the bedrock containing a high percentage of graphite and is characterized by the presence of slaty cleavages and minor types of fissures. The investigation drift is located in the rock mass containing a low percentage of graphite and predominantly characterized by structural features such as fissures intersecting the schistosity at an angle and to a lesser extent by the slaty cleavages. (Fig. 2 and 4).

Figure 4 Diagrammatic presentation of the bedrock around the ore drift and investigation drift

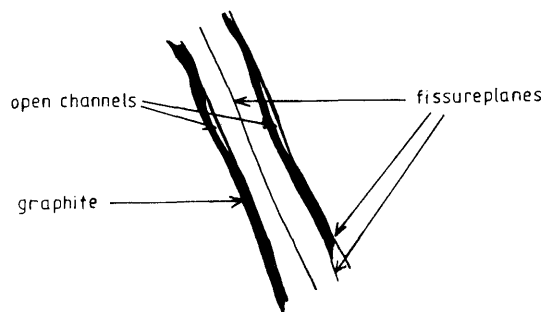
The ground-water flow was strong in both the graphite poor and graphite rich parts. In the graphite rich part the water flow is almost completely linked to the fissures flow along the schistosity and sometimes to "channels" along the graphite veins (see Fig. 5). The tension cracks formed perpendicularly to the schistosity are open and water bearing. This has been possible to verify within some grouted parts of the investigation drift where the grout was seen to have filled open fissures of this type.

In the structure mapping by borehole cores, the water bearing open fissures are normally identified by the presence of a layer of rust on the fissure surfaces. However, in the present study these direct indications of the presence of water were very rare. The absence of rust in itself is natural in the parts where the graphite veins in contact with the water bearing fissures along the whole surface or in open channels. No natural rust occurs in such an environment. (Fig. 5).

Figure 5 Diagrammatic presentation of open "channels" along graphite veins

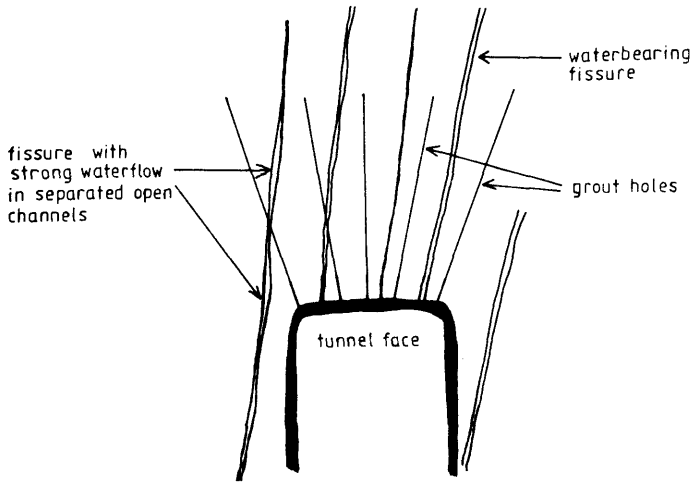
Figure 6a Conventional grouting with fissures parallel to the drift. When the grout holes are conventionally placed and directed the chances to obtain a good sealing of the fissures are small

When the drifts were mapped some substantial leakages were also observed in sections where extensive groutings had been done. An explanation could be, that the drifts, especially the ore drifts, were driven parallel to a large number of fissures which had a bad communication with each other, due to lack of transverse fissures. The forward drilling, which is almost parallel to the drift in this type of pre-grouting, could not intersect all the fissures. Many of these are therefore left ungrouted because of the lack of transverse fissures. An aggravating circumstance for the grouting can also be the water bearing channels along the fissure planes which were observed during the survey (see Fig. 6). It is difficult to achieve good grouting results under the circumstances where bad communication prevailed between the fissures together with a relatively high ground-water pressure (about 1,2 MPa). Good sealing calls for good knowledge, technical imagination and good equipment.

- when the fissures are parallel to the drift the grouting results are often poor (Fig. 6a)
- when the fissures are perpendicular to the drift the grouting results are often good (Fig. 6b).

This clearly stresses the need for a grouting method which is adjusted to the rock condition, if the ground-water inflow is to be reduced.

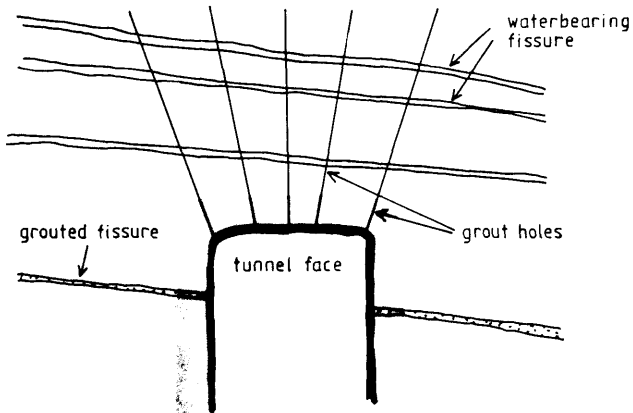
Figure 6b Conventional grouting with fissures perpendicular to the drift. Good conditions to attain a good sealing result. Each grout hole intersects several fissures and the same fissures are intersected in several places

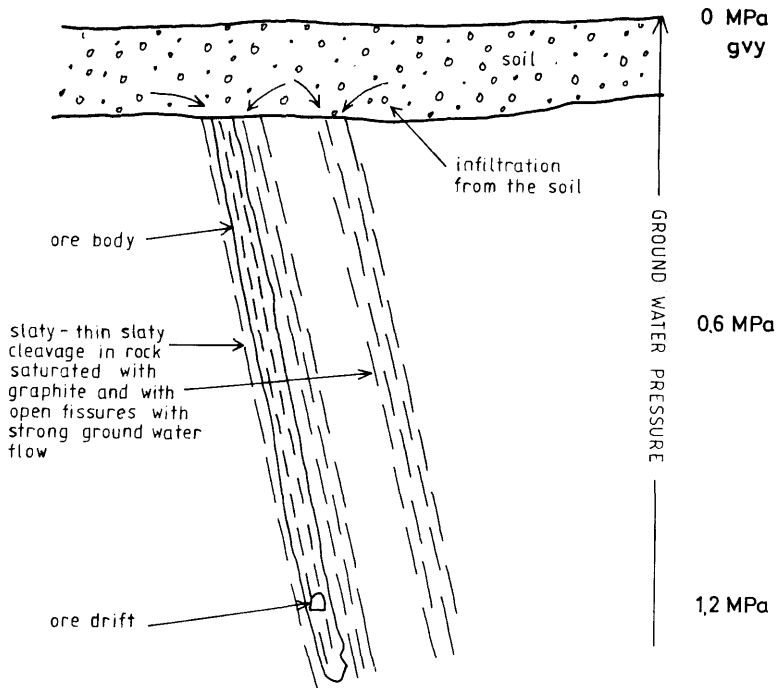
The bedrock and ground-water situation around the ore mineralisation is shown in Fig. 7.

Figure 7 Bedrock and ground water condition around the ore mineralisation

been obtained prior to opening an exploratory mine. The existing technique of rock mass characterization and the study of glaci-fluvial deposit was inadequate. It is suggested that for a successful site investigation and evaluation the following approach should have been adopted:

a large number of exploratory boreholes should have been drilled from the surface prior to the time of invitation of tenders

better borehole logging and analyses techniques should have been used in relation to soil penetration tests, core examinations and hydrogeological studies.

In order to assess the ground-water problems a series of hydro-geological tests should have been carried out in the exploratory boreholes to evaluate aquifer characteristics and to identify a range of water problems.
