Drainage Control for Surface Mines

Drainage Control and Mine Dewatering at Faro Open Pit Mine

by Randy S. Lopaschuk,
Geological/Geotechnical Engineer,
Cyprus Anvil Mining Corporation,
Faro, Yukon Territory, Canada

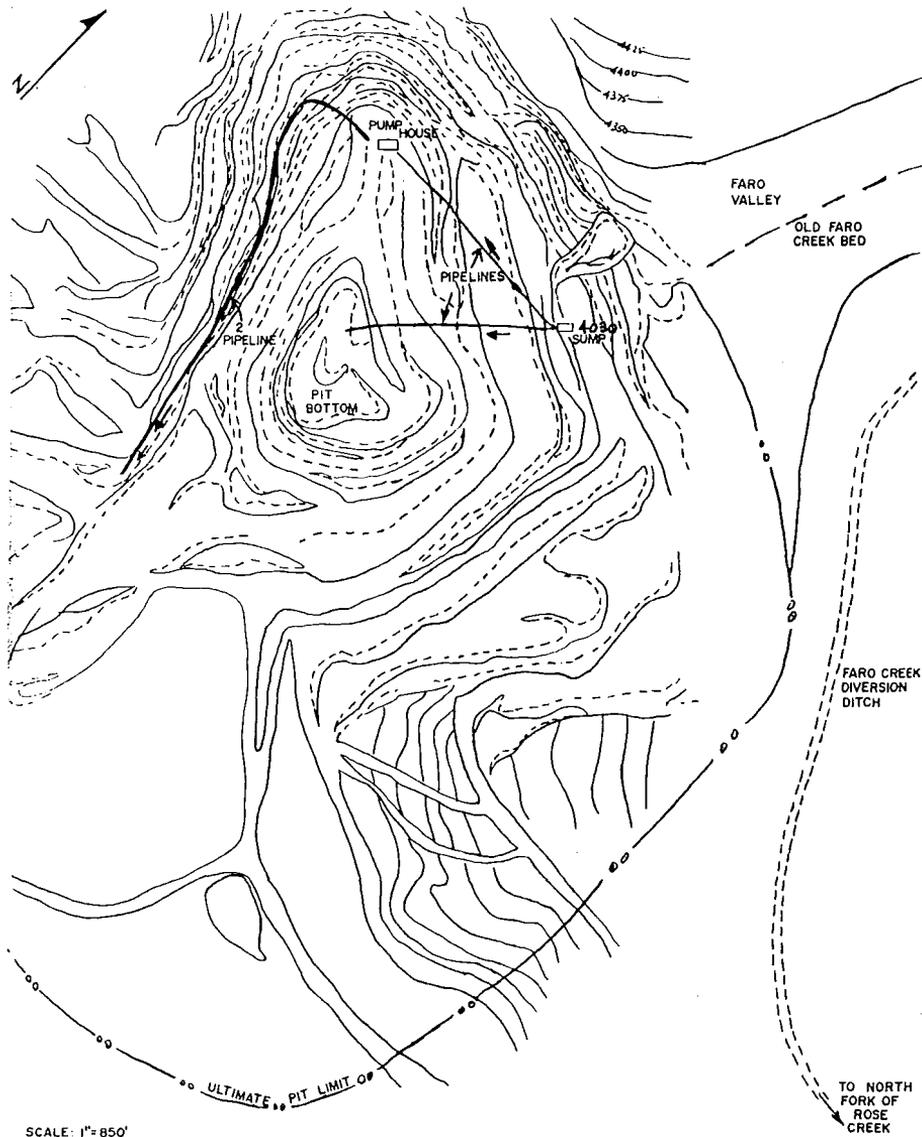
Figure No. 2 - Open pit plan showing components of mine dewatering system

As mining approached the Faro Creek, it became necessary to divert the water flow. A route was chosen to carry the flow to the east, outside of the proposed final pit limits, and discharge it into the north fork of Rose Creek. To attain sufficient elevation for the ditch to maintain grade above the pit limits, the point of diversion had to be made nearly a mile upstream from the edge of the pit. The initial ditch, while not completely water tight, diverted most of the surface flow away from the mine. Construction of this Faro Creek diversion ditch was the first major drainage control measure implemented at the mine (see Figure No. 2).

The alternative to draining the Faro Valley water around the east side of the pit, as it was done, was to drain it to the west. This could be achieved either at a constant bench elevation until the water was out of the pit, or else drained into the existing sump in the northwest corner by the pit pumphouse (see Figure No. 2).

The two pipelines were constructed of six inch Series 160 polyethylene pipe and were both 2,900 feet long. The pipelines run from the pumphouse at the 3790 pit elevation up the pit wall to a wide bench at the 4030 elevation and along this bench until out of the pit area where the water is discharged (see Figure No. 2).

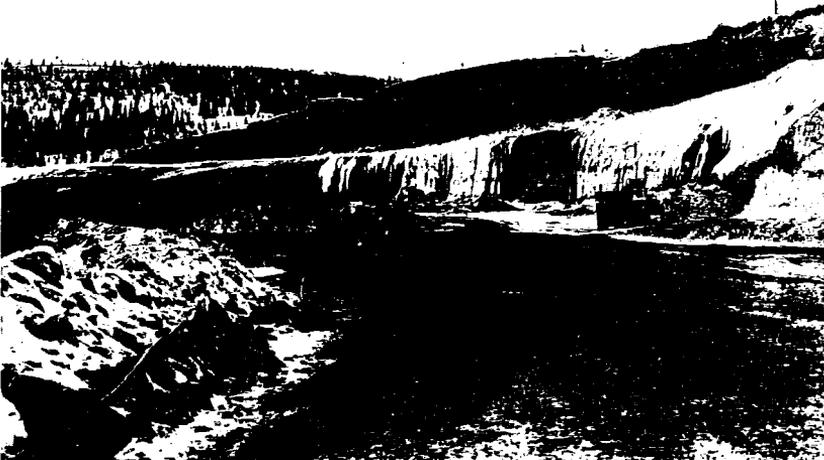
Figure No. 2B - Water entering the pit along the overburden/bedrock contact.

At the pit face, the main groundwater flow is between the bedrock/overburden contact and the 4110 elevation with smaller flows stratified above impermeable silt and clay layers upwards to the 4170 elevation in the west channel and the 4115 elevation in the east channel. Accumulated subsurface flows in excess of 350 U.S. GPM have been measured in weirs in the 4030 ditch.

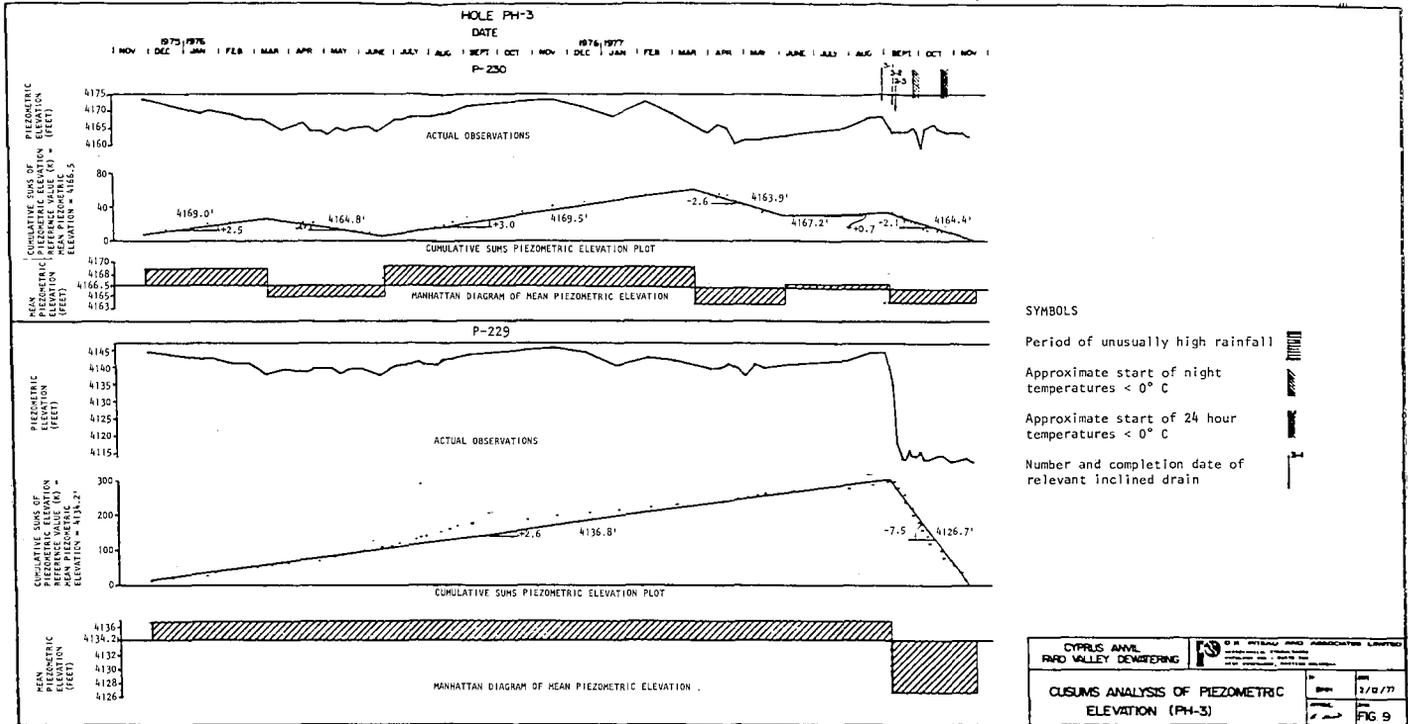
Since installing the inclined drains, the typical fall increase has been curtailed. A piezometric level drawdown occurred almost immediately, within 1 to 2 weeks after installation of the drains. This drawdown ranged from 2.2 to 31.2 feet. Most piezometers averaged 7 to 14 feet of drawdown. (3)

Figure 3 - Cusums Analysis of Piezometric Elevation. Note large decrease in piezometric elevation after drainholes were installed in September, 1977.

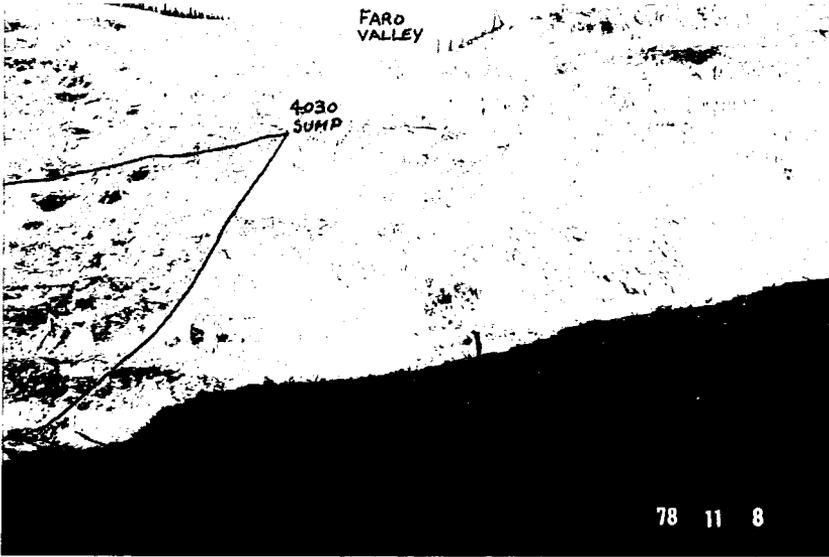
Figure No. 4 - Location of pipelines carrying water from the Faro Valley area to the pit bottom pumphouse.

A pipeline was constructed using 8 inch Series 40 polyethylene pipe from the 4030 bench below Faro Valley to the pit pumphouse sump in the northwest corner of the pit. It was decided to use a pipeline for diverting the water rather than a ditch and metal flume because it would provide much more flexibility in the course chosen for diversion and it would be easier to maintain (there would be no overflows or ice buildups as with the flume). (See Figure No. 4)

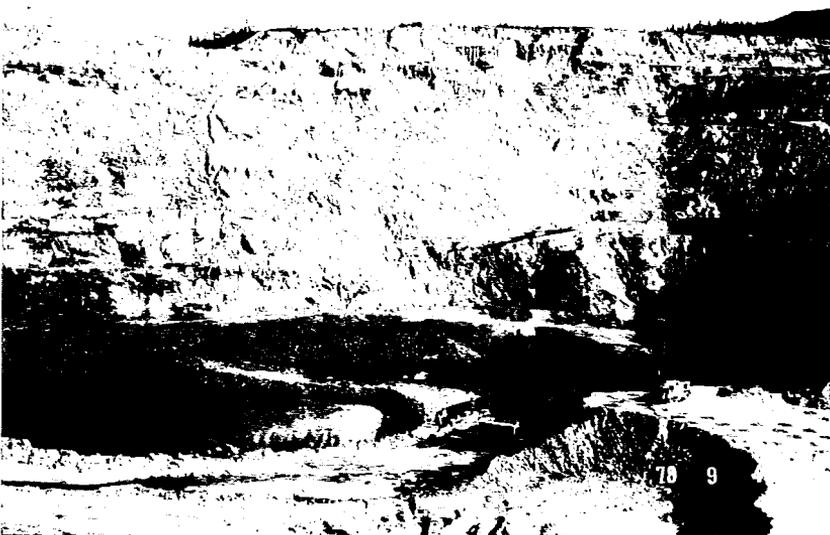
Figure No. 5 - Water collected in the pit bottom (25 million U.S. gallons, Sept./78). All this water has since been pumped out of the pit using the new pumping system

In 1975, plans for a final drainage system for the Faro open pit were proposed because the mining phase had reached the stage where the pit bottom was encountering the regional water table. Up until this time, approximately 400 U.S. GPM were being pumped from the bottom of the pit through an old exploration adit. This old pumping system did not have the capability of lifting the water over the existing pit wall and it was only because of the existence of the adit that dewatering was possible. Recirculation of water between the adit and the pit was thought to have existed, contributing to the water control problems in the pit bottom. These problems combined with the fact that the adit was scheduled to be mined out in early 1977, necessitated installation of an alternate dewatering system to prevent flooding of the pit bottom. If flooding had occurred, the ore supply would have been cut off (see Figure No. 5)
