PROTECTION AGAINST INRUSHES IN THE UNITED KINGDOM

DAVIES, A W

H.M. SENIOR DISTRICT INSPECTOR OF MINES AND QUARRIES
HEALTH AND SAFETY EXECUTIVE
SOUTH WALES DISTRICT U.K.

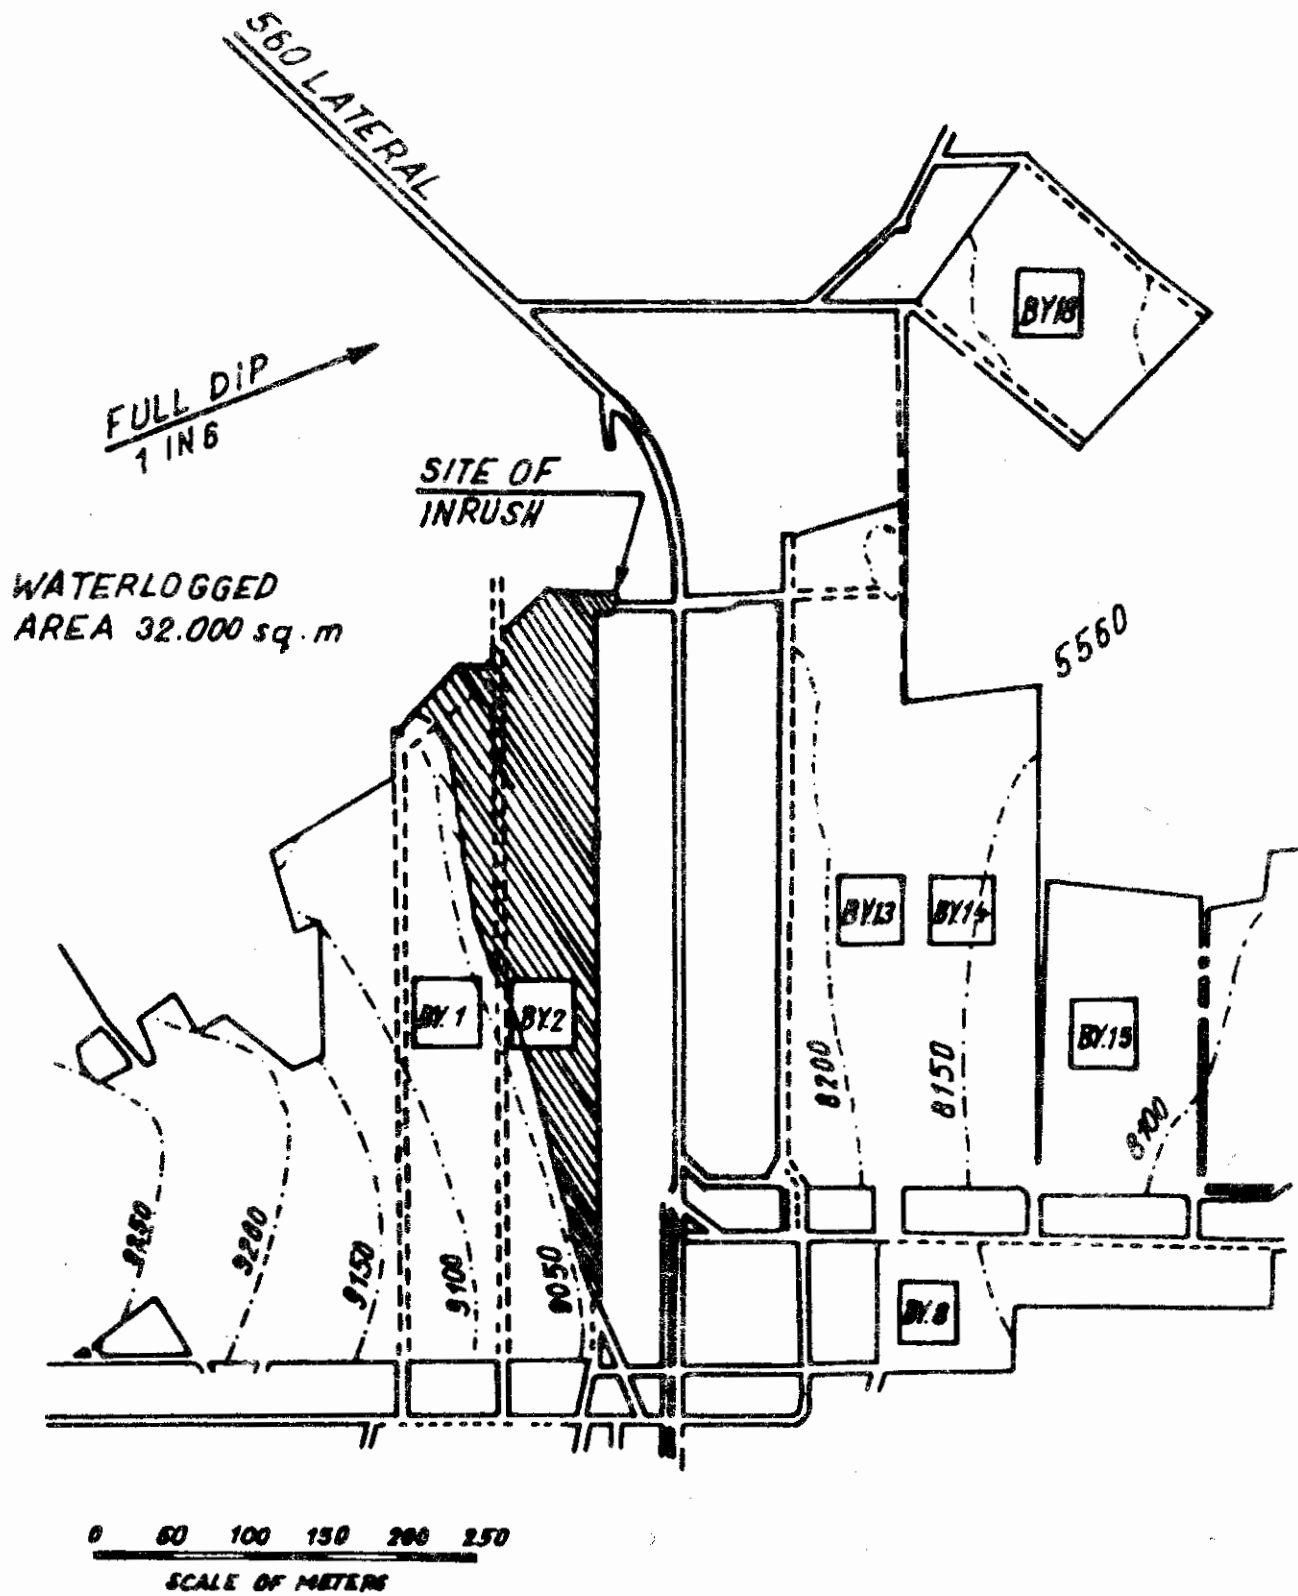
Fig. 1

Figure 1 shows the workings in the Big Vein seam which were involved in the inrush. This part of the mine was served by two level

roadways known as the 660 Horizon, which served principally as an intake airway (not shown in Figure 1 or Figure 2) and the 560 Horizon which served as a return and was some 100 m above the 660 Horizon. The BV1 and BV2 faces had been worked from the adjacent Pentremawr Colliery and were abandoned in 1966 and were allowed to fill up with water that was later to cause the inrush. The BV13 face was later worked from Cynheidre leaving a pillar to protect the 560 Horizon which was 12 m below the seam. When the BV13 finished at a fault a connection was made for ventilation purposes to the 560 Horizon. This connection, shown more clearly in Figure 2, was known as the 1 in 1, from the gradient at which it was driven. Later still this connection was extended back, first in the seam, and then across the BV13 goaf to the other gate which was then advanced through the fault at a dipping gradient of 1 in 5 to serve the BV18 face. As the 1 in 1 was then no longer required for ventilation, two separation doors were erected in that part of the roadway which was in the seam.

16. When the stopping erected at the outbye end of the middle road between the old BV1 and BV2 districts was broken down (Figure 1) the roadway was found to be readily travelling as far as the top of the BV2 face. A travelling track was restored along the face as far as was practicable to a point where survey work showed to be close to the BV2 lower roadway into which the BV12 heading had bored. The workings were now dry and an air current of about 5 m³/s was passing down into the development heading. On the basis of this information the recovery of the development heading started.

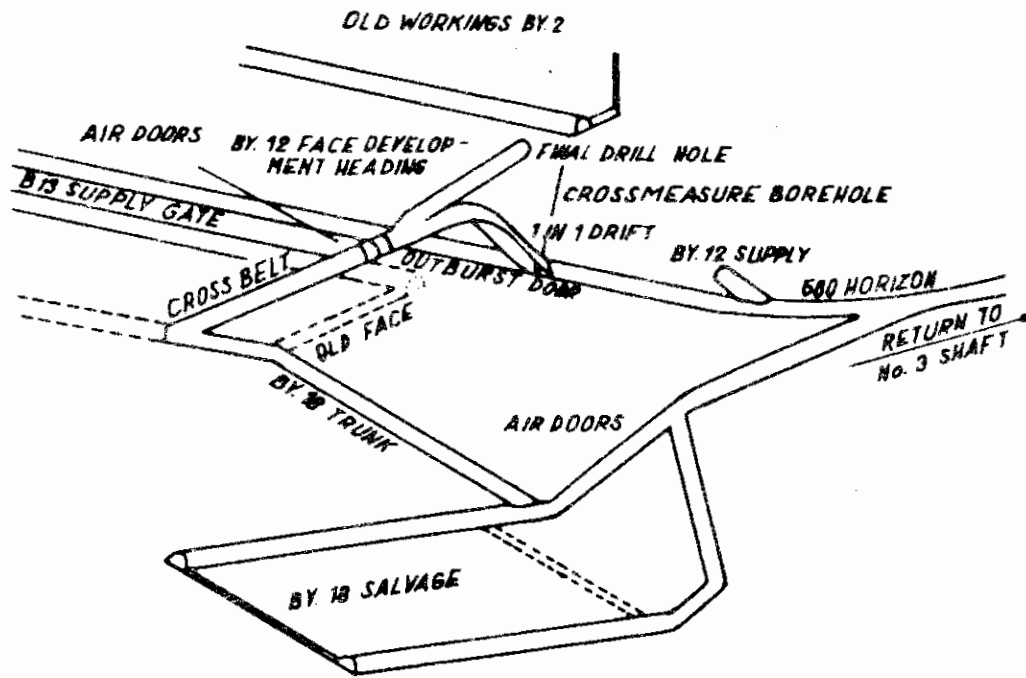
Fig. 2

7. In 1973 it was decided to develop a longwall face to be known as the BV12 to work the 120 m pillar protecting the 560 Horizon by driving a heading in coal from the left hand gate of the BV13, near the top of the 1 in 1 drift, to the flooded main gate of the BV2. In addition to the usual planning requirements two extra matters had to be taken into account when starting the BV12 face development heading. Firstly the drivage had to conform with the Outburst Code [4], a consequence of which was that the heading had to start between the top of the 1 in 1 separation doors so that the products of any outburst would pass directly down the 1 in 1 into the return which was the 560 Horizon. To cater for the possibility of gas from an outburst backing against the ventilation into the BV13 roadway an 'outburst' door was erected inbye of the two separation doors. This was similar to these doors but opened in the opposite way (Figure 2). The heading was ventilated by intake air via ventilation tubes passing through the doors.

roadway from the 560 Horizon (Figure 2) and this was successful. The initial flow from this hole was estimated visually to be 550 litres per minute and visual estimates continued to be recorded for 12 days by which time the make had reduced to 20 litres per minute. From these estimates the total make of water which came from the bore hole was calculated to be 2.6 million litres. The advance of the BV12 development heading had been stopped while this dewatering operation was being done from the 560 Horizon.

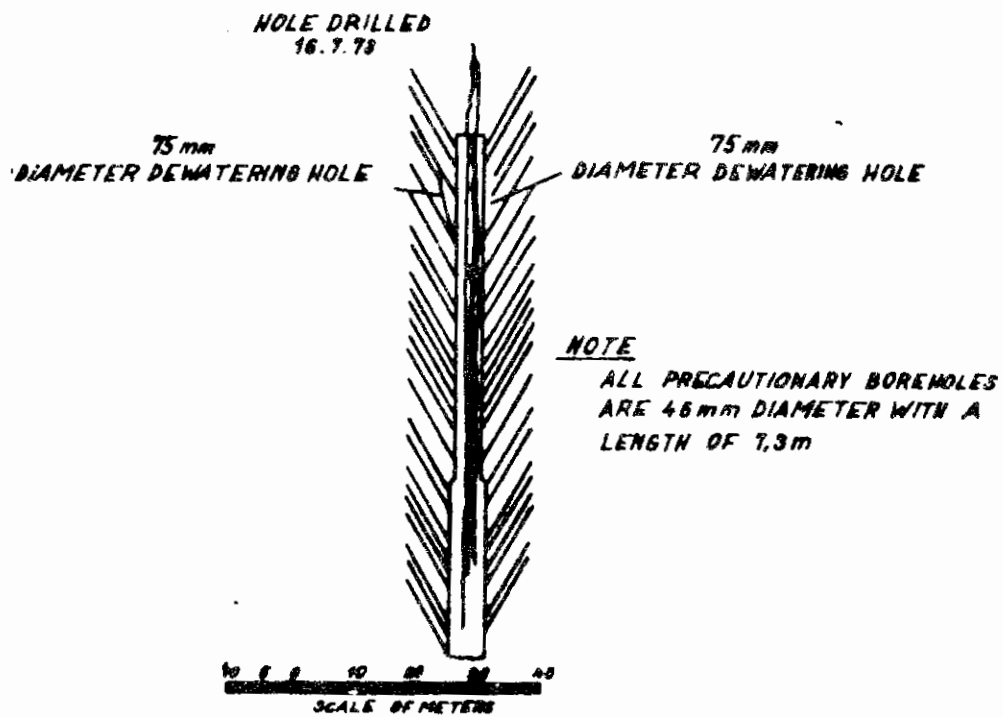
Fig. 3

8. The second matter was the dewatering of the BV2. It was decided by the management to do this from the BV12 development heading and a detailed scheme of both precautionary and dewatering holes was drawn up. Figure 4 shows the log of these holes that were drilled in accordance with that scheme, and it illustrates how thoroughly this aspect was dealt with. When the heading had advanced to a position 17 m from the old workings a dewatering hole, complete with stuffing box and stand pipe, would be established. When the time came for the hole to be drilled however, it proved impossible to keep it open in the soft outburst type coal that was encountered. A feature of the outburst phenomenon which has always been present at this mine is that bore holes, especially those of large diameter, are often very difficult to drill due to cavitation at the drill bit and drill holes often produce very large amounts of coal cuttings. A second dewatering hole was tried from the heading with a similar result.

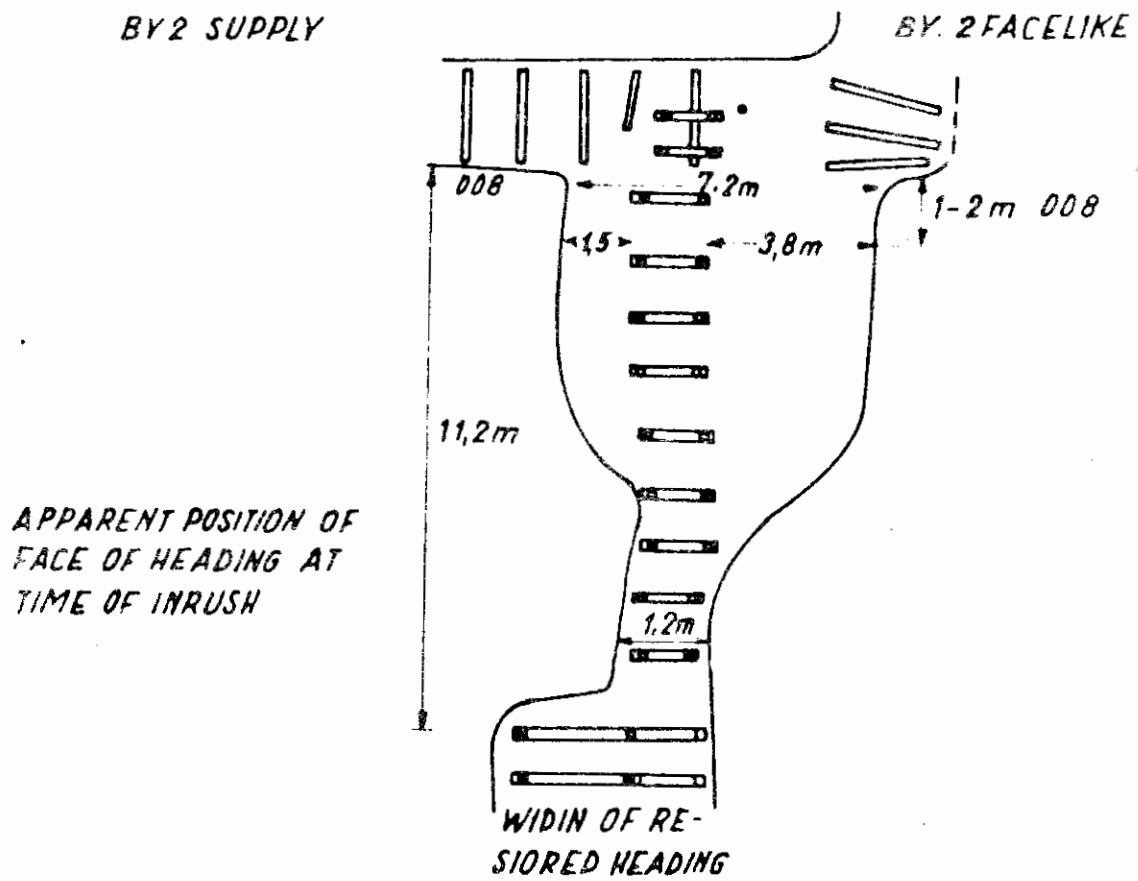
Fig. 4

19. It took nearly three months to restore and complete the development heading. Most of the supports had been washed away and the sides had been gouged out to widths of up to 2.5 m. It was found that at the time of the inrush the face of the heading was in fact 10 m from the ribside of the BV2 roadway, which was 1.2 m further away than the rib as shown in Figure 4, but the sandstone roof had been strong enough to span all the enlarged sections and there were no major falls of roof. Coal taken from the sides of the funnel through which the inrush came contained much outburst type coal, as did the face and sides of the original heading. This type of coal is so weak that a lump can be reduced to powder with mild pressure from the fingers.
