## SUMMARY REPORT ON THE GEOLOGICAL AND HYDROGEOLOGICAL ASPECTS OF THE LUSAKA WATER SUPPLY AND THE IMPACTS OF POLLUTION

D.C.W. NKUWA, Aachen University of Technology, Lochnerstr. 4-20, W-5100 Aachen, Germany.

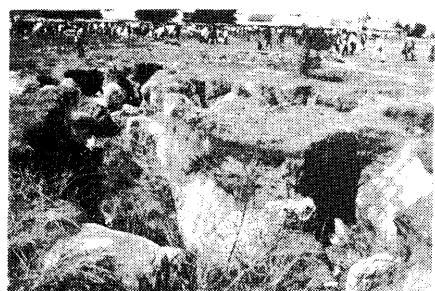
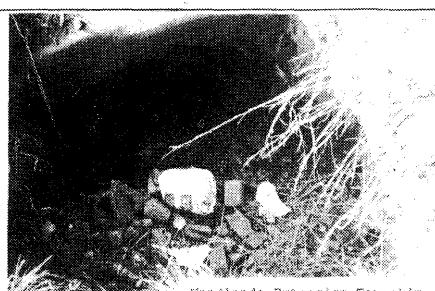
The city of Lusaka is built on marble (see map on page 4), generally referred to by the local geology as the **Lusaka Dolomite**. The marble is cut by a network of fissures (called karsts) which have remained either as open hollows or been filled with soil (Plate 1A). These fissures manifest themselves on the surface as pits, sinkholes and caves. The presence of karst features in marbles (and indeed other soluble rocks like gypsum/anhydrite and rock salt) makes them very vulnerable and susceptible to a very wide range of environmental problems.

A vertical channels/conduits in marble

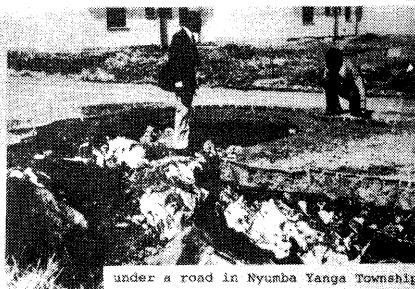
under a road in Nyumba Yanga Township

1. the performance of completed engineering structures (houses, roads) since karst processes and landforms often pose many problems for construction and other land usages. Every nation with karst rocks has had its share of embarrassing failures such as collapse of buildings and roads (Plate 1B), or construction of reservoirs that never held water<sup>[5]</sup>

with the drought which has ravaged the entire sub-continent, has a drastic effect of very rapidly depressing the water-table. Consequently, this causes a reduction in the buoyant force of the water, resulting in piping or consolidation of the soil. This situation creates increased probabilities of ground-collapses. Some of these may take place under engineering structures (Plate 1B), the result of which is obviously fatal. A number of structures on Kabulonga Hill may suffer such devastation within the next few years.

B Ground collapse in marble

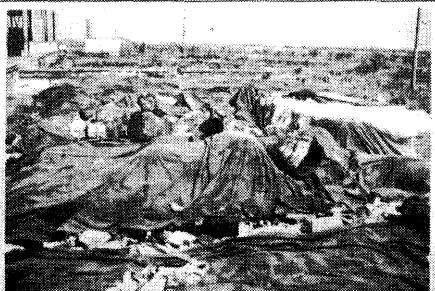
herbicides, fungicides, insecticides, veterinary products discarded by the disbanded National Agricultural Marketing Board (NAMBoard) lies outside the Zambia Cooperative Federation (ZCF) premises in the Industrial area (Plate 1C). During the rainy season, percolating surface waters seep this waste to the groundwater table,

C: Toxic Dump near ZCF shed (Industrial area)

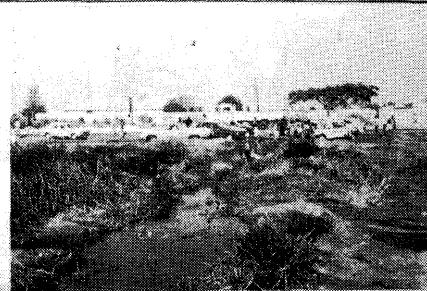
3. the car wash centres along Kafue road generate 'quantities' of waste waters everyday (Plate 1D) which finally drain into the subsurface (Plate 2A), to find their way into the aquifer(s),

D: Waste waters from car wash centres along Kafue Road
