OPERATIONAL AND ENVIRONMENTAL WATER PROBLEMS AT MARINERS UNDERGROUND NICKEL MINE, KAMBALDA, WESTERN AUSTRALIA.

Keith Berry

WMC Resources, Dept. Exploration
PO Box, 91
Belmont, WA 6104, Australia
Phone: + 61 8 94798454, Fax: + 61 8 94798482
e-mail: keith.berry@wmc.com.au

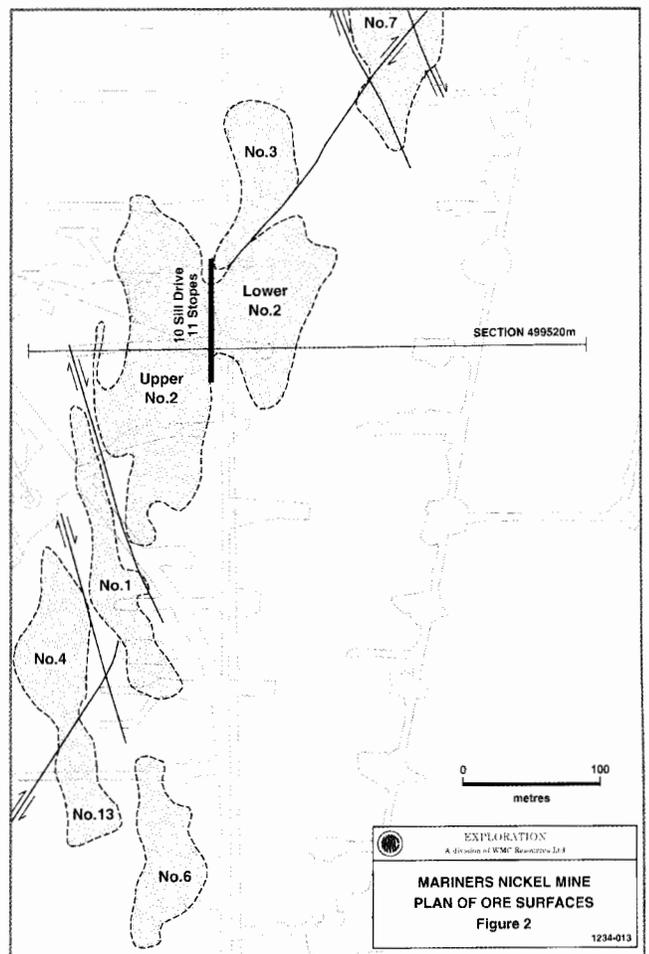
Figure 2. Plan of ore surface.

level by the Albatross Fault (010/45E) where the Ultramafic is downthrown to the east. A series of NNW and NNE trending dextral wrench faults cause the mineralised zone to be broken into a series of en-echelon ore surfaces which plunge to the NNE (Figure 2). The geometry of interflow sediments (Chert) in the hanging wall is complicated by deposition and structural discontinuity, with the effect that thin bands of Archean sediment occur almost randomly over an 80 m thickness above the Ultramafic (Figure 3).

The cone of drawdown had now shifted to be centred directly over the crown pillar of the upper NO2 ore surface (Figures 2 & 4). The period of reduced inflows (24 l/s) had evidently been transient, while water flowing from the sediments in the east gradually filled the void which was previously drained by DRD250. With a continuous hydraulic gradient from east to west, a steady flow situation was re-established.

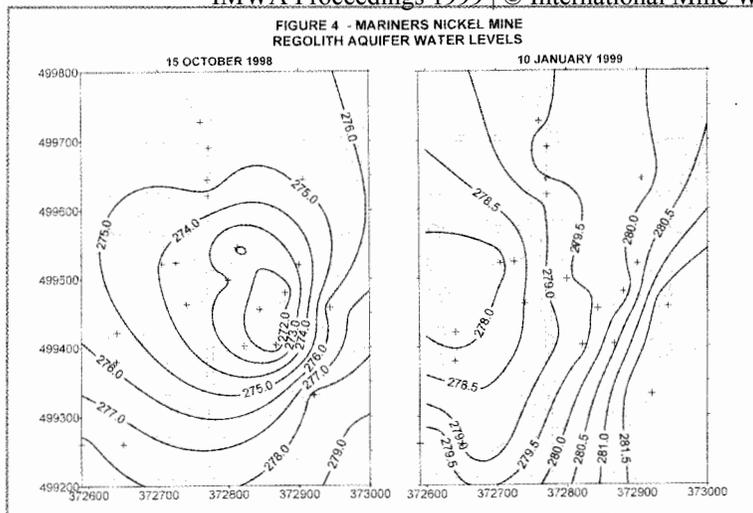
Figure 4. Regolith aquifer water levels.

From October 1998 the Regolith aquifer water levels were in seasonal recession. This allowed the emerging water level pattern to show much better resolution than during the winter period of high water levels. The centre of the cone of drawdown was now more localised and associated with the trajectory of a single old exploration drillhole DRD250 (Figure 4).

Previous and renewed efforts to re-enter and grout this hole were unsuccessful, with the drill string wandering off the hole due to obstructions. It was decided to drill a piezometer onto the trajectory of the hole to confirm the leakage path. As the hole was drilled and cased through the target zone a marked reduction of inflows to the mine workings occurred. The drilling had partially blocked the hole and the annular sealing materials used in construction of the piezometer had also added to the seal.

Due to the change in the shape of the potentiometric surface, the array of surface piezometers was no longer effective in defining the centre of the cone of drawdown. The zone of leakage from the Regolith Aquifer to the top of the mine was evidently less than 200 m in strike length, but may have been considerably more localised.
