# Investigations into seepage water acidification of a tailing dam of the tin ore processing

Werner Klemm, Yvonne Krellmann

Freiberg University of Mining and Technology, Institute of Mineralogy, Brennhausgasse 14, D-09596 Freiberg

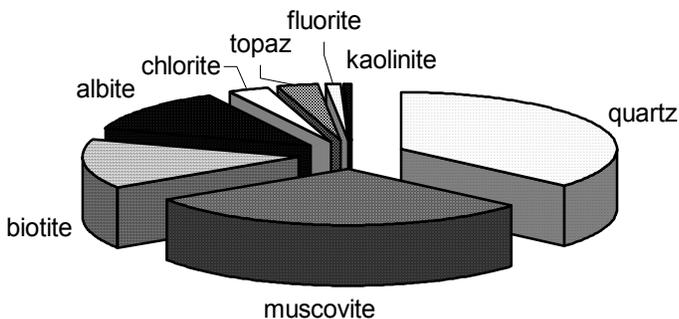
The tailing material mainly consists of quartz and micas (ca. 96%). Feldspars, fluorite, tourmaline, and chlorite, as well as remains of sulphides (arsenopyrite, pyrite, löllingite) are present in smaller amounts (Fig.1).

**Fig. 1.** Mineralogical phase composition of tailing of Tailing Dam 1.

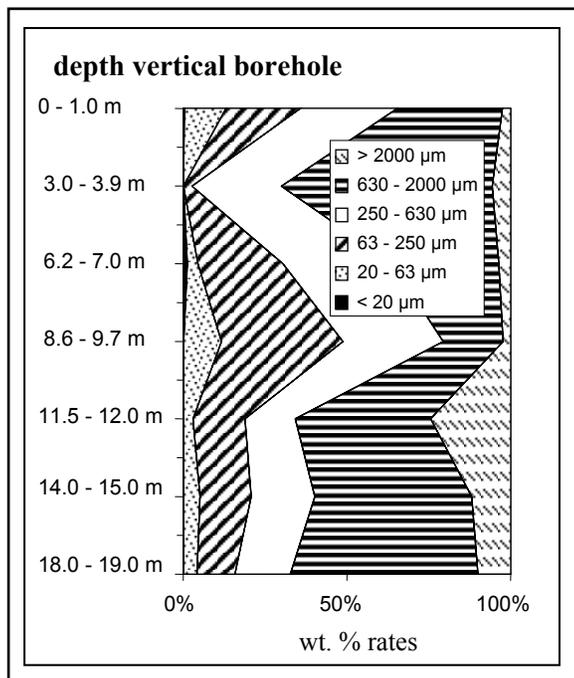
**Fig. 2.** Grain size profile of vertical borehole (from Krellmann 2001).

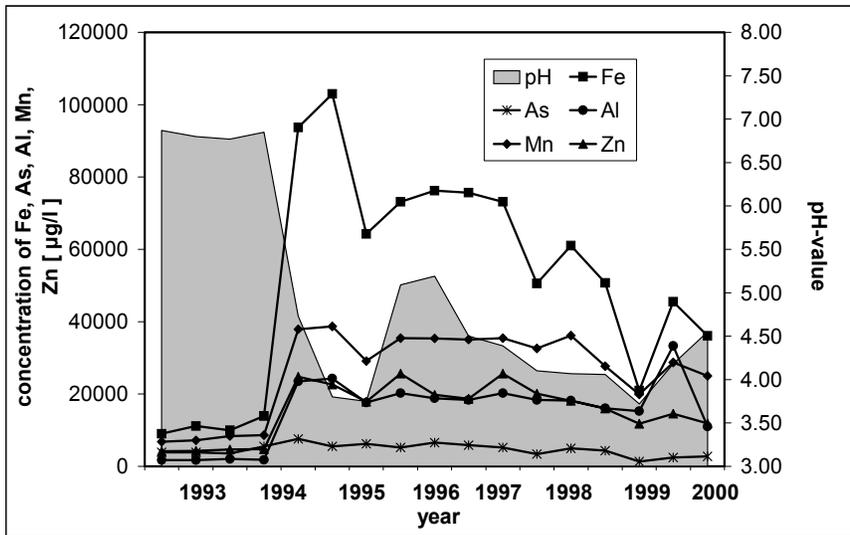
The pH value and several element concentrations were measured at the captation zone for the seepage waters (measuring point 33) between May 1993 and March 2000. Between August 1993 and April 1996 the pH value, which until then had only been slightly varying, dropped from 6.8 to 4, a phenomenon that was accompanied by an increase in concentration of main components and trace elements, like Fe<sup>2+</sup>, Al, Mn, As, and Zn (Fig. 3). Nickel and cobalt have only been measured from March 1996 onwards, hence an increase in their concentration can only be assumed.

**Fig. 3.** Time dependent concentration trend of pH, arsenic, aluminum and heavy elements (Mn, Zn, Fe; from Krellmann 2001).

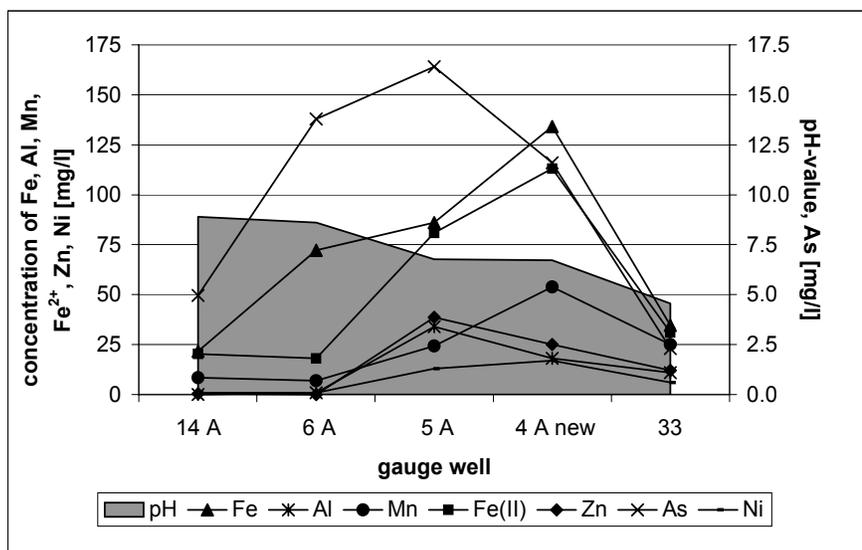
Gauge wells in the tailing dam enabled measurements of the groundwater level and samples to be taken (Fig.5). Geochemical analyses showed a clear increase of the overall mineralisation ( $\text{Ca}^{2+}$ ,  $\text{SO}_4^{2-}$ ) as well as of the concentrations of Fe, Al, Mn, As, Ni, Co, Zn occurring alongside a decrease of the pH value from 9 to 6.3 in the direction of flow of the groundwater (Fig.4). This tendency only changed in the area of the dam slope between the gauge well (4A<sub>new</sub>) and the seepage water captation zone (measuring point 33). Together with the decrease of the pH value from ca. 6 to 4 the concentrations of the elements diminished irregularly. Whilst the values of Fe and As showed a sharp decrease, the changes for Al, Mn, Ni, and Zn were only moderate. Reasons for this could be a higher flow velocity of the seepage water because of the coarser grain fraction in this area and the lateral influx of seepage waters, which may dissolve the dam water because of its lower pollution. Also the lower compression of the dam slope offers much better pathways for the influx of air, thus intensifying the oxidation processes.

Fig. 4. Variation of pH value and trace elements concentration in the ground water of the Tailing Dam 1.

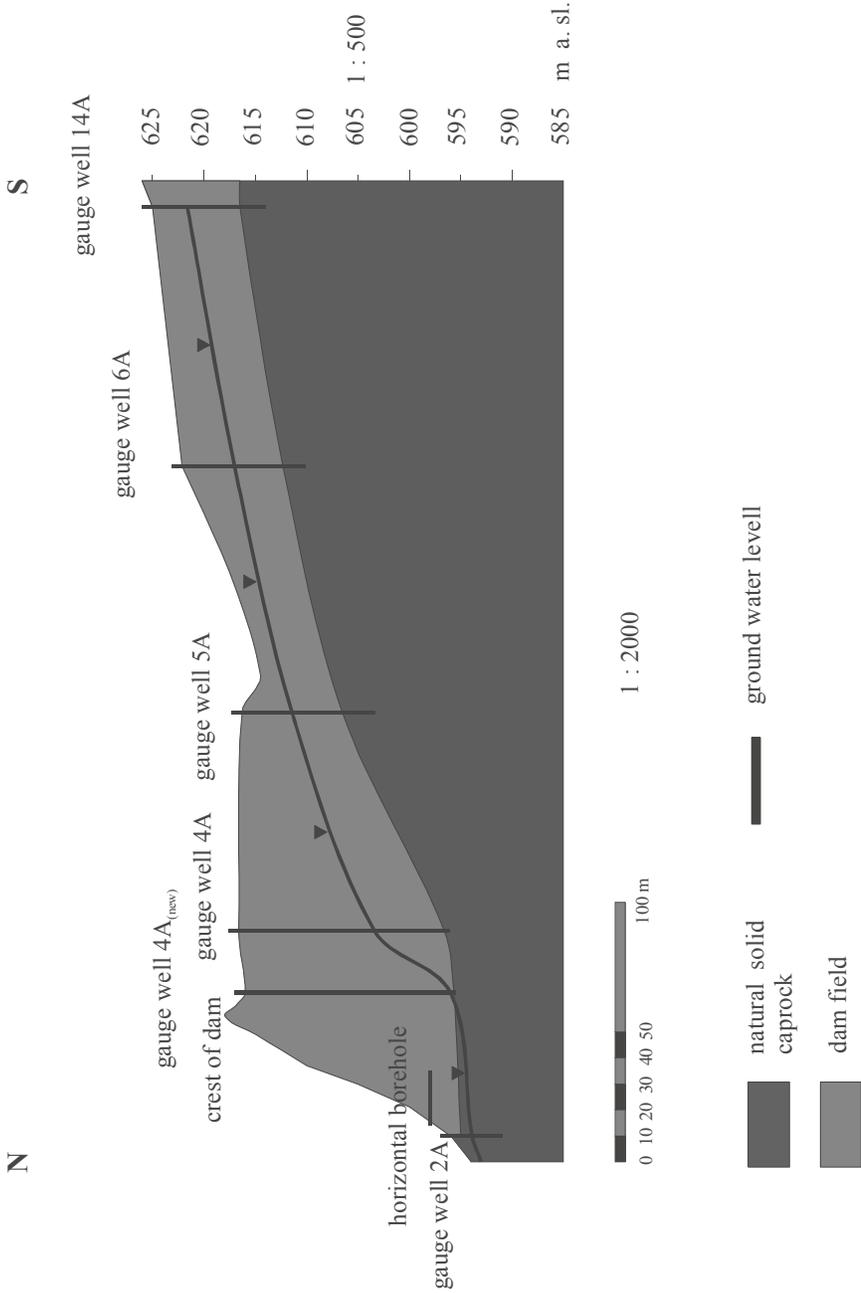
Fig. 5. Profile of Tailing Dam 1 (from Krellmann 2001).

In the years 1993—1996 a ditch was dug at the dam base during clean-up operations of the seepage water captation zone. As a result of these works the seepage water emanated at a level 1.5 m lower than before. The pH buffering was subsequently limited because the loss of the water tailback in the dam base had reduced the dwell time of the water and the originally existing reaction time accordingly.

- Reduction of the water throughput through the dam by branching off of accruing groundwater before its entry into the dam body with suitable drainage systems and sealing of the tailing dam surface against meteoric water
- Increase of the dwell time of the seepage water in the dam body in order to improve the pH value buffering by the restoration of the original water outlet level by building in packing material at the dam base

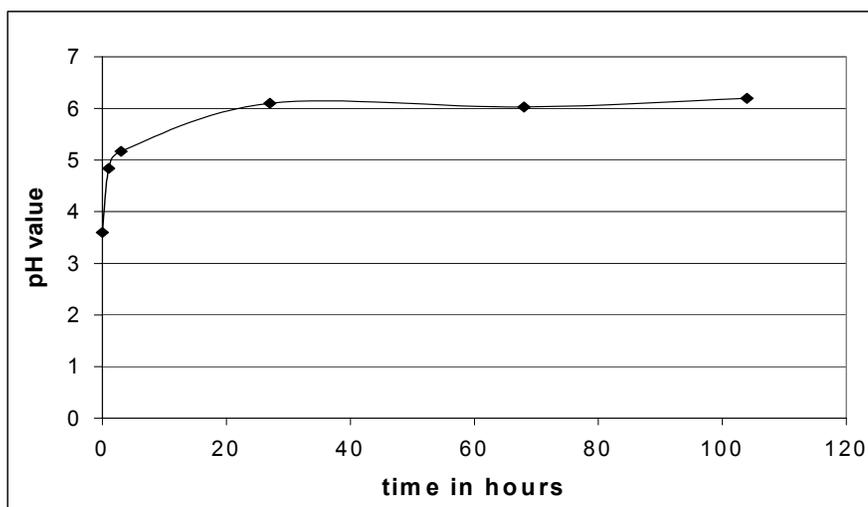
If this is to be seen as the dominating process for the diminution of the pH value, changes in the buffering capacity of the area under consideration must have taken place. However, laboratory experiments with tailing material showed that in batch experiments with seepage water (pH 4) after ca. 20 hours an almost constant pH value of 6 is reached (Fig.6).

**Fig. 6.** Buffer effect of the tailings in shacking experiment with seepage water from the Tailing Dam1.

Besides evidence of a sufficient buffering capacity of the tailing material the experiment provided some indication as to the necessary reaction time. If this is undershot, decrease of the pH value of the emanated seepage water is the result.
