# Forecast of emergency situations owing to excessive water inflows into tailings ponds

#### O. Sammarco, M. Ovi and M. Costabile

Bureau of Mines, Dept of Earth and Environment, Tuscan Region, Via Goldoni 6, 58100 Grosseto, Italy

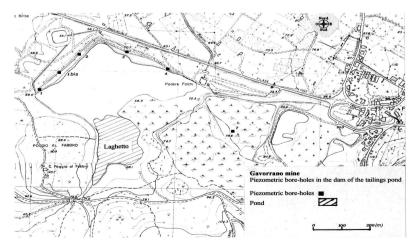
Figure 1. Tailings pond of the Gavorrano mine

The stored material is supported, to SW and SE, by the hills upstream, while to NE and NW by a dam raised using the "upstream" construction method. As to stability, this method is the least reliable of the usually adopted other ones (Figure 1).

The above-mentioned amounts, which are lower than the actual ones, are enough to point out at the high risk we would run if the system draining capacity were reduced further. The pond material is not at all consolidated actually. Its low viscosity degree is due to the high inflow of water and reduced permeability of the dam downstream. This last circumstance is stressed by the high piezometric level in the dam itself, where water finds itself at a slightly lower depth than two metres (Sammarco 2003a).

- 1958: failure of the dam of the pond downstream during its initial filling step;
- 1997: flooding of the southern eastern part of the pond.

- 1. If possible, and with due care, take away the piezometric surface from the external dam or at least lower it, by replacing the material on the dam floor with some draining material.

- 2. Improve the external dam stability by increasing its size up to having a base, which is at least twice as large as the present one.
- 3. Prearrange effective drains behind and on the floor of the parts of dam, to be assembled over the existing dam.

- 4. Shape the dam slope in such a way as to have some terraces, designed to carry out piezometric controls. This also aims at enabling some pumpings in order to lower the piezometric surface, in case of need and even after the mine abandoning.

- 5. Realize some suitable anchorage system for restraining firmly the dam to the soil.
- 6. Control the conditions of the internal dams and, if necessary, implement some measures to increase their stability (Sammarco 2003b).

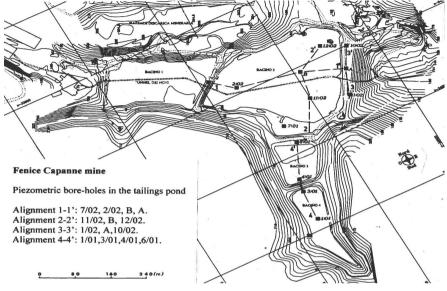
Figure 2. Tailings pond of the Fenice Capanne mine

respectively and were both built according to the upstream method. The remaining ponds, are on slightly higher quota than the first ones and are supported downstream by weak dams (Figure 2).

- 1984: Settling in the above-mentioned tunnel;
- 1987: Failure of the pond 4 dam part and
- 2002: Flooding of this pond and the one immediately upstream.

At present, the above-mentioned ponds stand for the greatest risk, due to the easiness with which water inflows into them and the reduced resistance of their dams. If these last fail after some heavy rains some tailings slurry waves might actually thus pour onto the pond part below, thus compromising the system stability (Sammarco 1993).

To reduce risks of tailings flow slides as much as possible, some works have been planned (Sammarco 2002 a) and are being carried out to reduce water inflow into the ponds, without preventing, but rather promoting, water outflow. Some solutions are also being searched, to improve the static situation of the most downstream dam as much as possible.

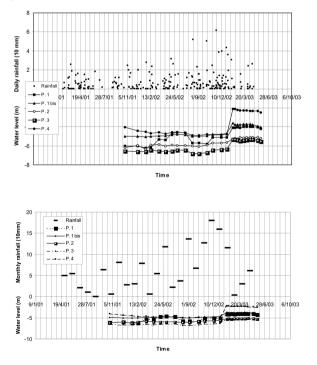
Figure 3. Gavorrano mine. Water level from the surface in piezometric bore-holes in the dam of the tailings pond, above and below, daily rainfall, above, and monthly rainfall, below.

To try of highlighting some correlations we have drawn, in figure 3, water levels measured in the bore-holes in the most downstream dam of the Gavorrano mine tailings pond, daily rainfall, above, and monthly rainfall, below. This figure points out that these levels depend on the rainfall, but evident repercussions of single days rainfall on them do not occur.

After a period of heavy rainfall, the highest water level increases occurred in the piezometer 1 and mainly in the piezometer 4, both near the dam ends while in the piezometer 2, located in the dam central part, only slight increases occurred: water levels kept still high during some months after the above-said period.

The water level in the dam of the Gavorrano mine pond is presumably affected by rains, which fell 4 or 5 months before. The most critical situation, due to overtopping might occur near piezometer 4, where an amount of rain, slightly higher than 380 mm, which should fall during one month, can, after 4 months, increase the water level up to the dam top (Table 2). This is confirmed by water level consistent increase in this piezometer, which actually occurred after a period of heavy rains (Figure 3).

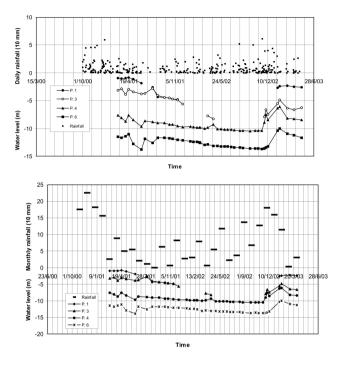
Figure 4. Fenice Capanne mine. Water level from the surface in piezometric bore-holes of the alignment 4-4', above and below, daily rainfall, above, and monthly rainfall, below.

In figure 4 we have drawn water levels in bore-holes located in the vertical section, which runs through the ponds 3 and 4 of the Fenice Capanne mine along the alignment 4-4', daily rainfall, above, and monthly rainfall, below. We began monitoring these levels, which are still being monitored at present, soon afterwards the flooding of the aforesaid ponds which occurred in January 2001.

Also if it is evident the influence of the rainfall on the piezometric levels, one does not distinguish clearly the effects of the single days rainfall on that levels. This is obviously due to the irregularity with which the rainy days follow one another and to the different rainfall from one to another of these days. This with the exception of the level increases on the following dates: 27.06.01; 19.04.01; 27.11.02; 03.12.02; 22.01.03 and 31.01.03.

These increases are presumably due to heavy rains during in previous days. This is also shown in table 1, where a water level increase of 2.89 m in the piezometer 6, measured on 22.01.03, after 30.6 mm rain on the day before, can be seen.

The water levels in the piezometers along the alignment 4-4' of the Fenice Capanne mine pond do not seen to be affected by previous rainfall in the same way: by moving from upstream, P. 1, to downstream, P. 6, the sensitivity to the most remote and most recent rains seems to decrease and increase respectively. Water level would rise up to the surface near piezometer 1, if 260 mm rain fell three months back. This is confirmed by the following event: water, which flooded the above-mentioned pond in January 2001, grew higher than the mouth of piezometer 1. On this particular occasion, rainfall amounted to 182.8, 225.8 and 175, 2 mm in December, November and October 2000 respectively.
