Overcoming the Pitfalls of abandoned mine workings in the Sydney Coalfield

Dave FORRESTER, Bruce NOBLE

AECOM, 164 Charlotte Street, Sydney, NS B1P 1C3

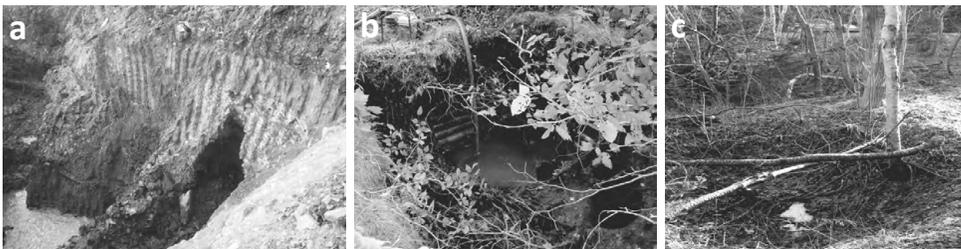
The ability for cavities to form and migrate up to impact the surface is also largely depth related with the specific stratigraphy playing a key role. For example, thin weak beds facilitate sinkhole development while strong hard beds bridge cavities and arrest such development, see Figure 2.

Figure 2 Old Abandoned Shallow Workings: a) Sinkhole; b) Spencer Test Slope; c) Port Morien

A test adit from the 1920s in the Emery Seam near the Gowrie Wash Plant Site was abandoned without filling it. Then flooded and reforested, representing a remote but significant hazard to hunters. It was filled using CBDC protocols with provision to continue to drain into the natural drainage system (Figure 3c).

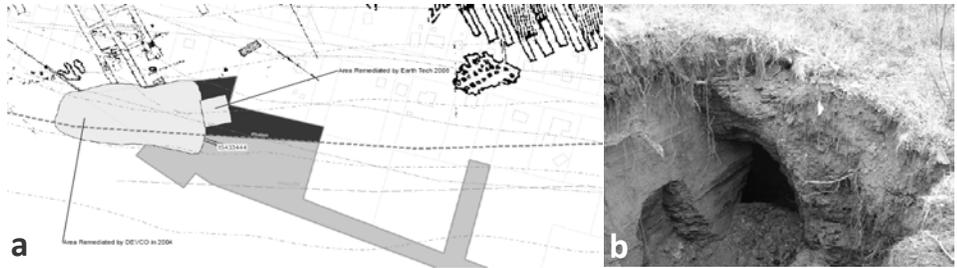
Figure 3 Dominion No.3 Site – mining hazards: a) hazard map; b) hidden shallow workings

The site of the former Dominion No.3 Colliery comprised three mine tunnel entrances on the Phalen Seam outcrop and a former rail track to take the coal to the nearby No.11 site. This Colliery was also undermined in the Emery Seam. The site has a history of bootleg mining in the Phalen Seam (Figure 3a), resulting in safety hazards. Those associated with open workings and a few sink-holes were remediated by CBDC in December 2004. However, an additional remediation was undertaken using the CBDC Mine Workings Protocols after a test pit for environmental sampling purposes, located adjacent to the CBDC remediated area, gradually collapsed into shallow bootleg workings, during this field program (Figure 3b). The opening was opened up to define the hazard extent, large clean fill was packed into the openings and the excavation backfilled in layers using an excavator for compaction and restored to grade. Due to such unknowns of shallow bootleg mining, the north eastern part of the site is still classified under CBDC Mine Workings Protocols as a high risk zone and is subject to long-term visual monitoring of future subsidence and sink-hole development. The underground mine workings in the Phalen Seam are generally not flooded under the Site, any groundwater entering these old workings draining away underground to the

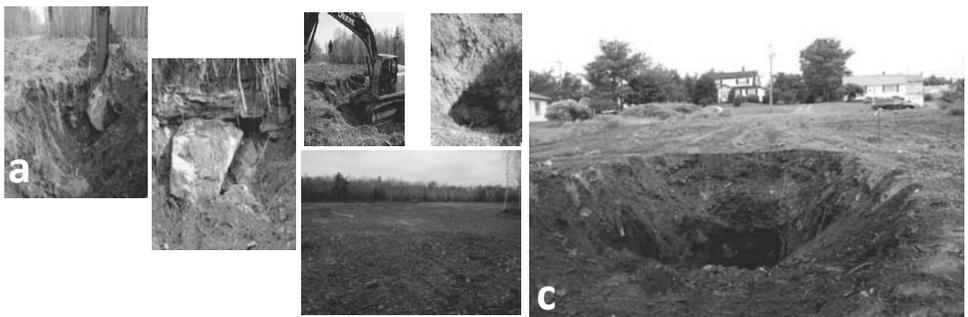
Figure 4 a) Kaneville - Site Mine Remediation; b) Dominion No.5 Remediation

This Site was the location of the former No.5 & No.10 Collieries, housing the bankhead and shafts and slopes. Similar to No.3 there were several mine tunnel entrances on the Phalen Seam outcrop on the site with bootleg mining known locally however not within this site. The hazard here was different as it was associated with sinkhole development from collapse over the near-surface portions of the main access tunnels (No.5 Main Slope). They were located and remediated to CBDC Protocols, see Figure 4b. Elsewhere on adjacent sites bootleg or illegal shallow mine workings are known, with the most significant surface effects having been remediated, any un-remediated areas along the Phalen outcrop being subject to long-term visual monitoring.

The Kaneville site was different again, comprising many 'bootleg' pits from the 1940s or 50s covering approximately 500m of seam outcrop in a band approximately 50 m wide. The property was largely reforested with no buildings and no evidence of acid drainage, with some seepage at the downstream end. AECOM undertook the assessment, design, tendering and construction administration for the remediation of the existing health and safety hazards on the Kaneville (HSOK) site related to abandoned 'bootleg' mine workings. An initial exploration exercise exposed abandoned underground bootleg coal mine workings in the Harbour Seam, at depths of \approx 2m to 7m. The rooms were flooded and not all collapsed. This work lent confidence to the remediation method subsequently used successfully. This comprised: clearing and grubbing; temporary access roads; erosion and sediment control measures; cleaning out and filling both closed-bottom and open-bottom holes; and restoring the site through re-grading, soil amendment and hydro-seeding. This was done from early March to mid May 2009 and was successfully completed within the anticipated time frame and safely, with zero onsite injuries, see Figure 4a.
