## **Advanced Prospecting and Composite Identification Method for Ultrahigh Pressure-Loaded Water-conducting Hidden Collapse Columns**

*Renlou Coal Mine, Wanbei Coal & Electricity Group Co., Ltd., Suzhou, Anhui, China*

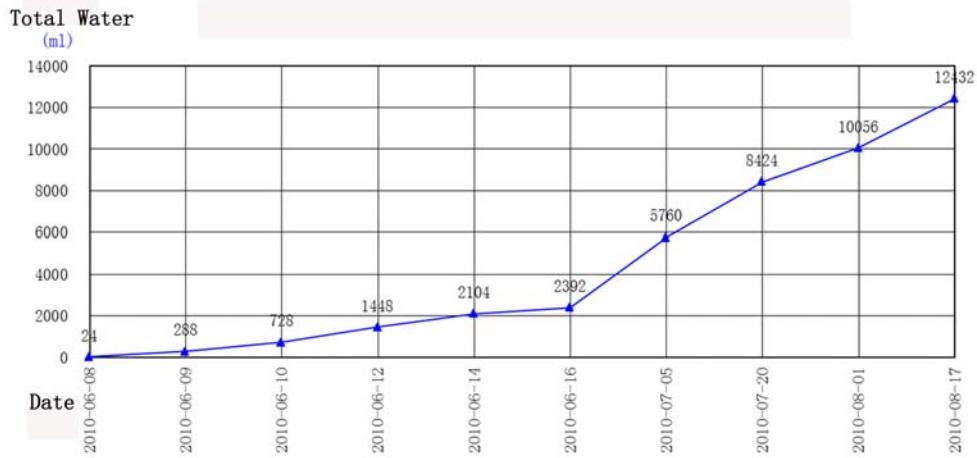
Water inrush occurred at an initial flow of roughly 1 m<sup>3</sup>/h where an anchor bolt of the roof in Roadway II5<sub>1</sub> is located roughly 28 m ahead of Point G<sub>33</sub>. The flow climbed slightly at 31.5 m ahead of G<sub>33</sub>, with three water detection holes in the roof coming to an aggregate flow at rate of about 30 m<sup>3</sup>/h. The single hole (size: Ø32 mm) featured a maximum rate of 16 m<sup>3</sup>/h,

which stands steadily at  $8 \text{ m}^3/\text{h}$  after initial grouting and sealing, indicating no tendency of a downturn. See Fig. 2 for details of the observed water flow.

**Fig. 2** Aggregate flow curve of the water point 28.5m ahead of Roadway II5<sub>1</sub> (-720 m)

The comprehensive analysis of stable make-up water sources are made based on the increases of effluent water and stability of water flow after being sealed.

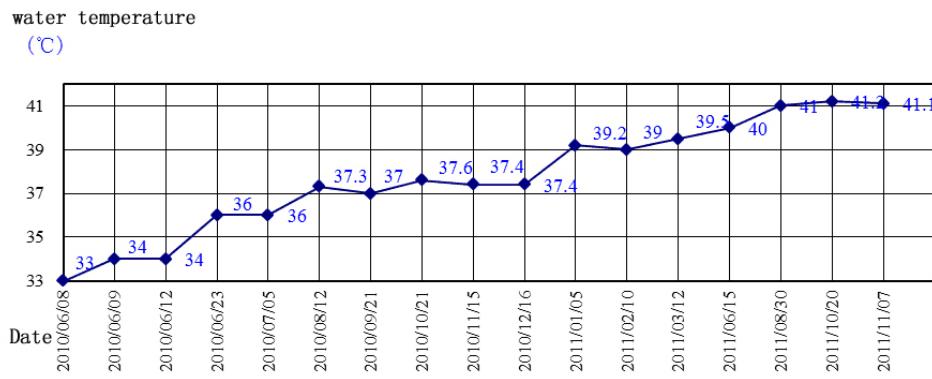
The water temperature stood at 33°C on 8 June 2010, then, it was increased gradually, it reached to 41°C on Nov. 29, 2011 (see fig. 3 for details). Normally, the geothermal gradient of the Renlou Mine features an increase of 3°C/100 m; therefore it can be inferred that the local normal geothermal temperature stood at 34-36°C, indicating an abnormality of water temperature in Roadway II5<sub>1</sub>.

**Fig. 3** Water temperature change curve of the water inrush points in Roadway II5<sub>1</sub>

Considering an abnormal water temperature which exceeds the normal geothermal temperature, it is preliminarily concluded that the water source is a deep-lying high-temperature water source.

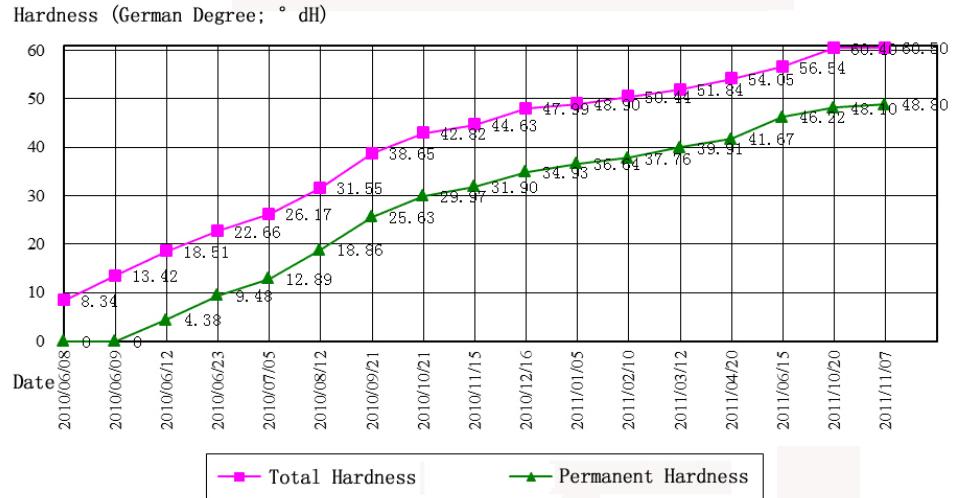
and there was no permanent hardness. During the night shift on June 10, permanent hardness began to occur until the total hardness increased to 60.58°dH and the permanent hardness stood at 48.81°dH on Nov. 7, 2011. Between initial water inrush on June 8, 2010 and Nov. 2011, the total hardness increased from 8.34°dH to 60.58°dH and the permanent hardness increased from 0°dH to 48.81°dH. On the whole, there was a trend of increases in total hardness and permanent hardness (see fig. 4).

Fig. 4 Water hardness change curve of the water inrush points in Roadway II5<sub>1</sub>

Because of the occurrence of permanent hardness plus the general trend of increases in total hardness and permanent hardness for the water inrush in the roof of Roadway II5<sub>1</sub>, there might be a makeup of deeper-lying high-hardness water (Ge et al. 2007).

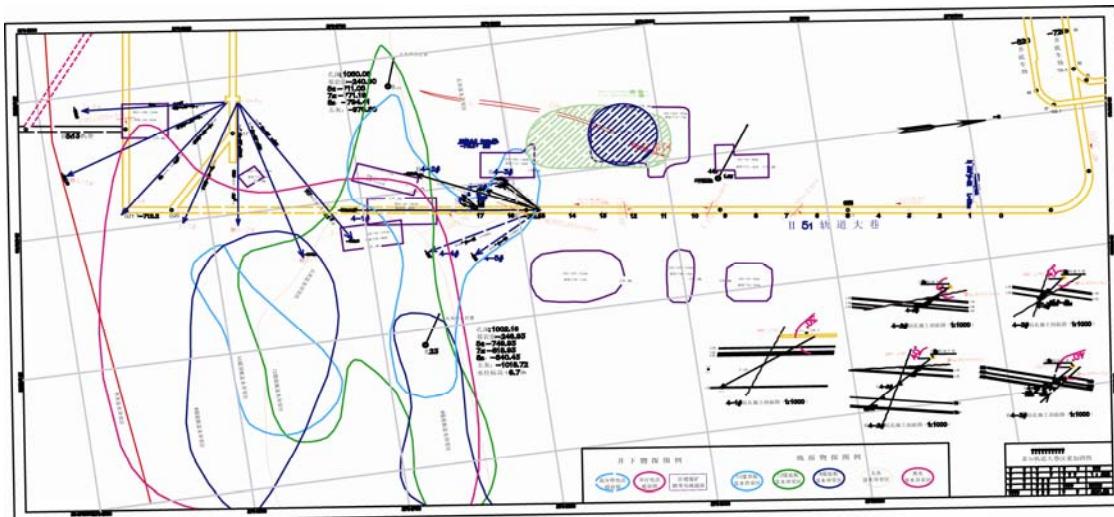
**Fig. 5 Composite geophysical figure for the water-conducting collapsed column**

Based on the comprehensive analysis of the above geophysical prospecting achievements and other data, the water-conducting passage of Roadway II 5<sub>1</sub> is a water-conducting collapse column, which is located 65-115 m behind Roadway II 5<sub>1</sub> and 38-65 m horizontally away

from the roof according to preliminary analysis (see fig. 5). The above results may be used as the target area of prospecting in surface drilling.

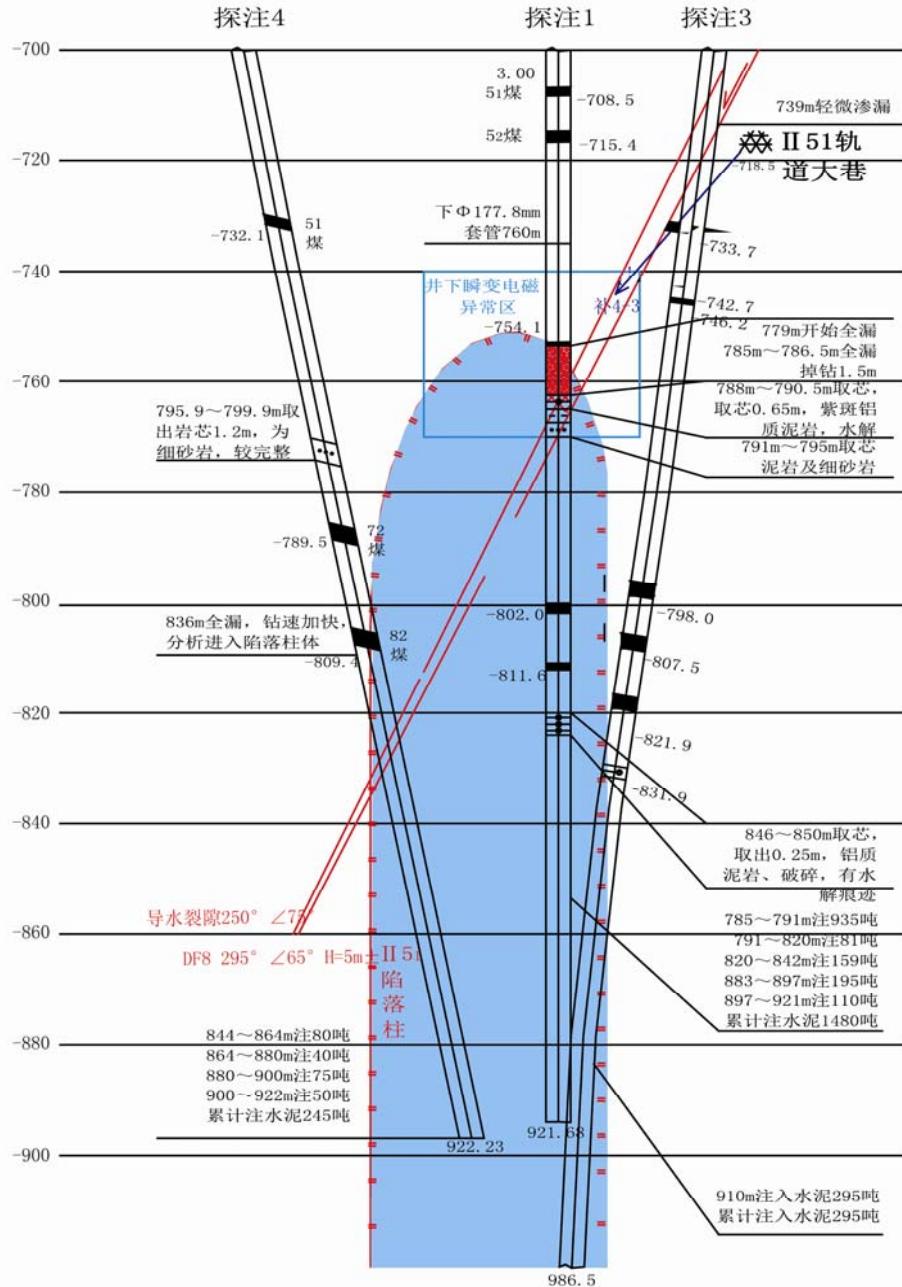
(2)Surface Directional Drilling (or cross drilling; see fig. 6): Altogether four holes are drilled to explore the collapse column (the first of these holes succeeded in revealing the column) and one branch hole is drilled to explore the superimposition abnormality of the subsurface geophysical prospecting. All four holes of the former type succeeded in revealing the collapse column.

The above drilling operation succeeded in precisely identifying and delimiting the spatial location, boundary and height of development of the collapse column. Meanwhile, the drilling operation proved the reliability and effectiveness of the judgment & exploration method for hidden collapse columns, thereby providing an important reference of the identification and spatial locating of hidden collapse columns.

*Fig. 6 Surface direction drilling-based delimitation of the concealed column (part)*
