Tailings and Waste Disposal—Seepage, Contamination, Regulations, and Control

## **Case Histories of Different Seepage Problems for Nine Tailings Dams**

by K. E. Robinson, Partner,  
Dames & Moore,  
North Vancouver, British Columbia, Canada,  
and G. C. Toland, Partner,  
Dames & Moore,  
Salt Lake City, Utah, USA

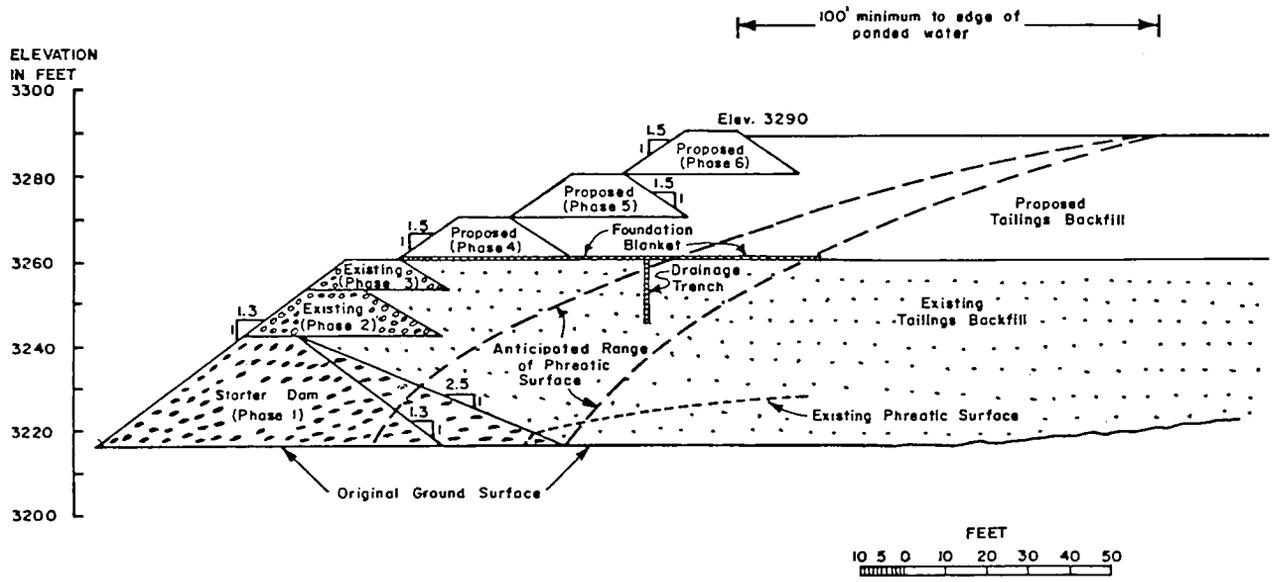
PROJECT I  
TYPICAL  
DYKE SECTION

Problems associated with the design of the raised embankment included: stability considerations because of the steep existing outer slope, slime pockets near the embankment face, control of the phreatic surface and development of a suitable decant system for the raised sections.

Piezometers installed prior to, and during, our investigations indicated that the phreatic surface was very low within the impoundment area and close to the foundation sand and gravel in the vicinity of the perimeter embankment. Standard flow net analyses indicated that the phreatic surface should be higher. Fortunately, it was possible to complete a full-scale, insitu, constant head permeability test for a period of about 6 weeks. A pond of water was maintained over about 50 percent of the tailings impoundment area by pumping water at the rate of 450 gallons per minute for about 16 hours per week. By monitoring piezometers it was possible to establish that the predominant seepage path is downward through the tailings backfill and into the permeable foundation gravels. This indicated that there are sandy areas vertically connected throughout the backfill

near the embankment face which intersect slimes pockets that could otherwise cause perched water zones. This observation agrees with experience on other projects where granular foundations underlie tailings impoundment facilities.

Based on the field investigation and full scale permeability and laboratory tests, the raised embankment cross-section shown on Figure 3 was designed. This design included excavating a drainage trench through the upper area of the existing tailings to cut through some fairly continuous slimes zones to provide more positive interconnection between sand zones. The overall slope was flattened to 2 horizontal to 1 vertical from the original slope of 1.3 horizontal to 1 vertical. With the drainage provided, a range of phreatic surfaces as shown on Figure 3 is anticipated. Under these conditions the dam will be stable, even under design seismicity which was studied in detail as discussed in a paper by McKee, Robinson and Urlich (1978)\*. To determine actual phreatic surfaces and provide for remedial action, if necessary, such as further slope flattening or keeping the pond more than the design requirement of 100 feet from the crest of the dike at any stage, a series of piezometers have been installed and additional piezometers will be placed during future extensions of the dam. Water level monitoring is vital to the design concepts discussed above, and requires specific mine action.

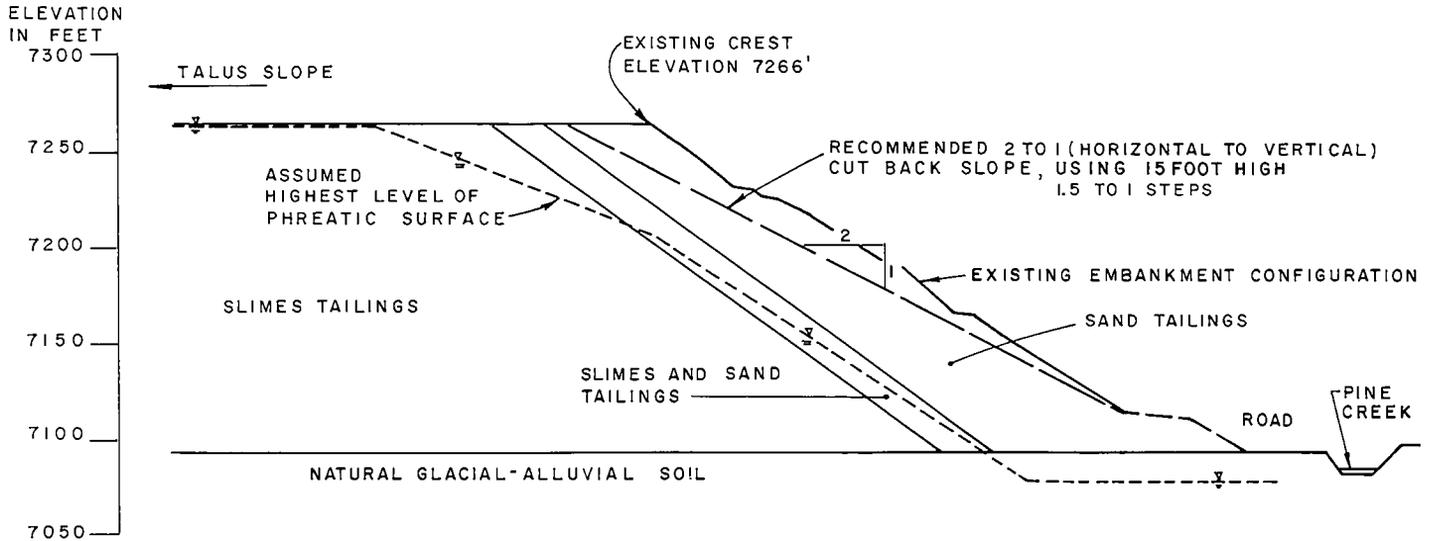
**PROJECT 2  
TYPICAL  
EMBANKMENT  
SECTION**

With this highly permeable zone at the back of the impoundments, it was assumed that the phreatic surface was very low within the tailings near the embankment face and that this was the reason for the long term stable condition of the embankments. However, high water level readings in old piezometers resulted in our recent investigation. The purpose was to determine if the phreatic surface was high and, if it was, what remedial action to take, if any. Fortunately, our investigation, which included the installation of a number of isolated piezometers in each boring, detected only nominal perched water levels in some areas where slimes had been allowed to accumulate near the face of the dam. Overall stability was not adversely affected.

Back stability analyses of the slopes using the actual earthquake loading conditions confirmed that the phreatic surface had to be extremely low, as indicated on Figure 4, and there was significant apparent cohesion in the sand zone near the face of the dam. Tailings disposal by spigotting from successive upstream construction lifts resulted in a series of three zones of tailings including an outer sand zone, an intermediate silty sand to sandy silt zone, and an interior slime zone as indicated on Figure 4.

This project indicates that under extremely favorable site conditions a very economical structure can be utilized to store tailings to relatively high final elevations. However, our investigations did indicate that long term stability should be improved slightly by flattening the overall slope as shown on Figure 4 to 2 horizontal to 1 vertical. This flattening can be completed efficiently and economically by utilizing the stripped material to raise successive lifts of Pond 4 which is presently only 30 feet high.

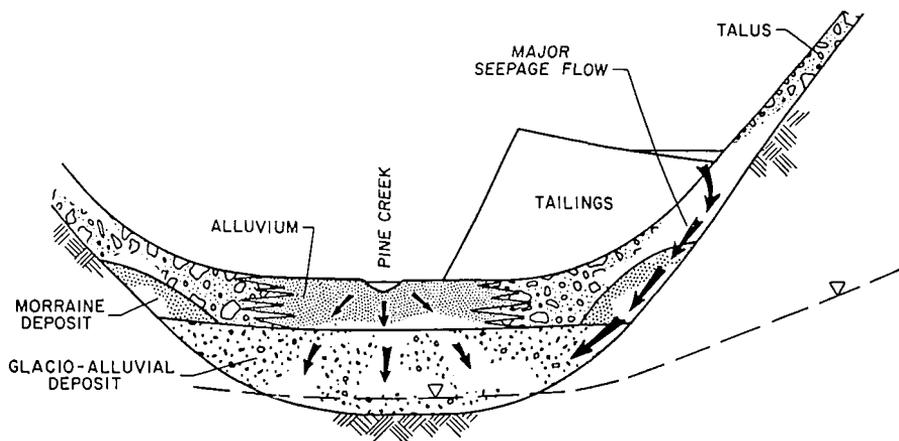
**PROJECT 2**                      **SCHEMATIC OF VALLEY PROFILE**  
FIGURE 5

Foundation conditions below the tailings ponds consist of a combination of talus from the adjacent mountain slopes and finer grained, glacio-alluvial soils. The permeability of the foundation soils ranges from moderately low to high. However, the back boundary of all the ponds is formed by highly permeable talus which provides direct drainage into the more highly permeable foundation soils, as indicated schematically on the valley profile shown on Figure 5. Decanting of liquids from the pond surfaces has not been required because of the permeable nature of the talus backing. In Pond 3 where the talus tends to be somewhat less permeable, infiltration wells have been installed to provide decanting directly into more coarse talus at lower elevations.

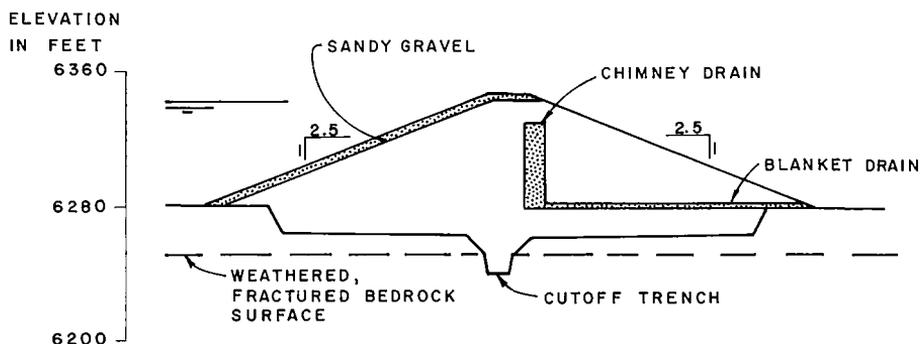
**PROJECT 4  
MAXIMUM  
CROSS-SECTION**

After filling, red stained water seeping beyond the toe of the dam caused concern to regulatory agencies. Upon further investigation, it was apparent that the approximate 150

gallons per minute of observed seepage was indicative of water losses from the reservoir which passes into fractures that extended below the impervious cutoff toward the abutments of the dam. While the total volume of seepage was not exceptional, and was within the limits of reasonable estimates, the effect on environmentalists was significant because of the color and its visual impact.

For this project remedial action was not required because of the existence of an old pond at a lower elevation down valley from the dam under consideration. This dam acts as a secondary evaporation pond with excess water pumped back to the upper pond. However, the significance of minor geologic features such as interconnected fracture zones beneath impoundment areas which could extend around abutments or under the main fracture zone, that would be sealed by an impervious cutoff, for these types of dams must be given careful consideration in future projects. It is probable that the best solution would include a small holding pond downstream to collect and return seepage thereby reducing the need for a comprehensive cutoff below the dam which may be next to impossible to provide.

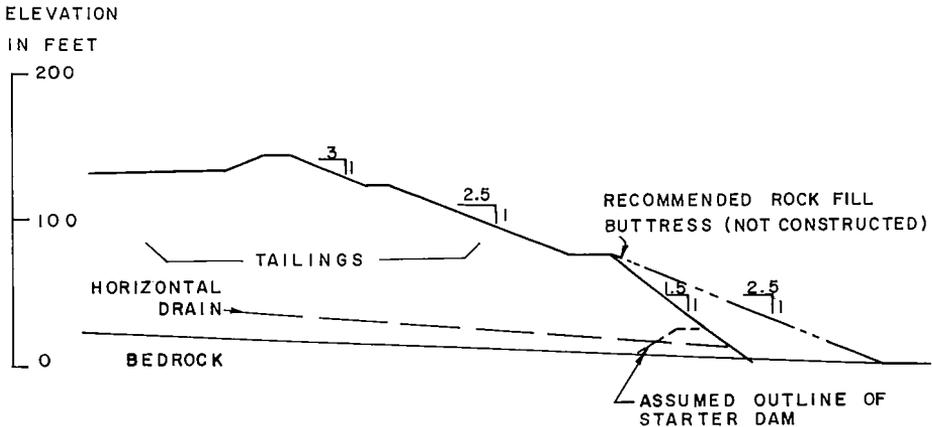
**PROJECT 6  
TYPICAL  
CROSS-SECTION**

The outside face of the dam varies in slope from 1.5 to 3.0 horizontal to 1.0 vertical with the flattest sections at the higher levels of the embankment as shown on Figure 7. The steep lower dam section rests directly on relatively impervious rock, resulting in seepage at the toe of the section and some erosion and degradation. A slide in one section of this lower slope occurred as a result of seepage buildup combined with surface freezing which raised the water level against the steep slope. We investigated the dam and concluded that the factor of safety under steady state seepage conditions was 1.2.

To improve stability and eliminate potential erosion and piping at the toe of the dam, we recommended that a rockfill berm be placed on the downstream face, as shown on Figure 7, and the pond be operated to keep decant water as far from the face as possible. The rock buttress fill has not yet been

constructed. As an alternative to this remedial treatment, the owner requested a test section of horizontal drains be installed which, if successful, could provide a more economical solution to the seepage problem. Based on the test section, it was apparent that drain spacing would have to be less than 5 feet along the dam which was too expensive an undertaking. The close spacing would be required because of the permeability of the sands of about  $10^{-4}$  centimeters per second, and the random pockets and layers of slimes that were within the zone requiring drainage. This can be a common problem for dams using "upstream construction" unless spigotting is completed under controlled conditions, with sufficient spigot points to minimize ponding near the crest where slimes would be deposited. The most significant factors affecting this project were the impervious rock foundation and the proximity of the pond to the dam crest.

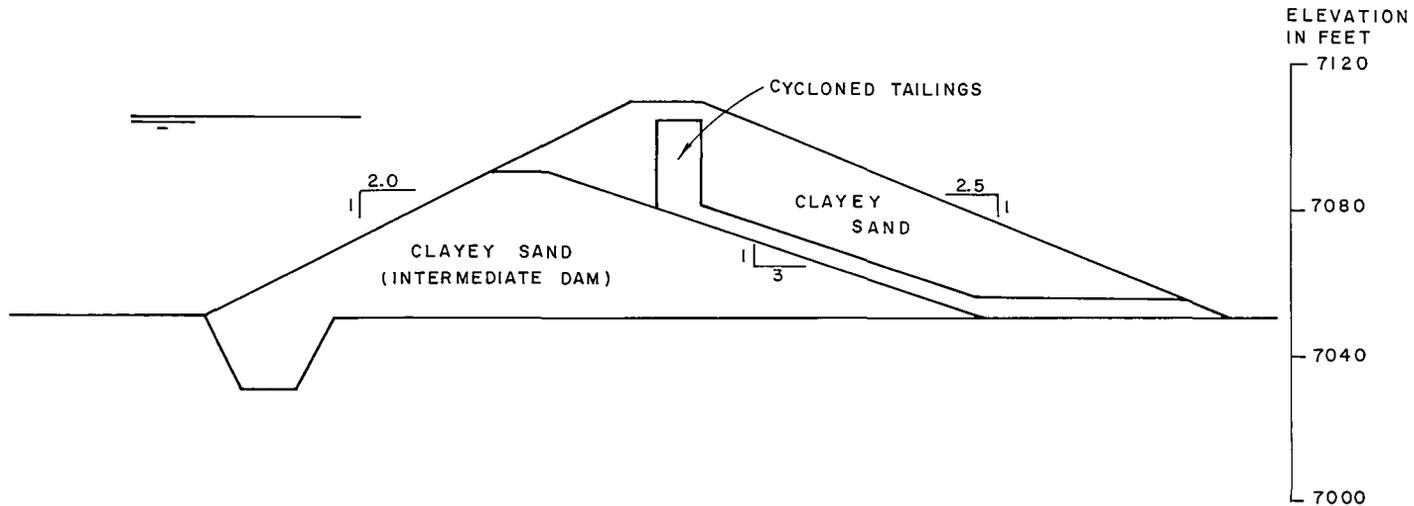
**PROJECT 9  
TYPICAL SECTION  
EMBANKMENT  
HEIGHT GREATER  
THAN 30 FEET**

This tailings disposal project, located in the Shirley Basin, Wyoming, also involved uranium tailings. Foundation conditions consist of poorly indurated claystones and sandstones having relatively low permeability. The design included a maximum dam height of 60 feet, upstream and downstream slopes of 2 horizontal to 1 vertical and 2.5 to 1, respectively. The structure was raised in 3 stages with an impervious cut-off trench located at the toe of the first embankment stage. Succeeding stages were built in the downstream direction as shown on Figure 8. The main embankment section was constructed using a relatively low permeability clayey sand.

Of significance for this project was that the design required control of the phreatic surface with a chimney drain. Because it was not possible to find a suitable graded borrow material in the area that would satisfy filter criteria and provide the required drainage, it was necessary to satisfy

the authorities that cycloned uranium tailings would be suitable. This was done and the chimney drain was connected to a blanket drain also constructed of cycloned sands. This material provided a stable dam section. Seepage passing through the structure is being collected by ditches just downstream of the toe where it is directed to a sump and pumped back to the reservoir.
