SUBMERSIBLE PUMPS IN MINES DURING EMERGENCY SITUATION

O. Sammarco

Italian Bureau of Mines, Ministry of Industry - Corpo delle Miniere, Via Goldoni 6
58100 Grosseto, Italy

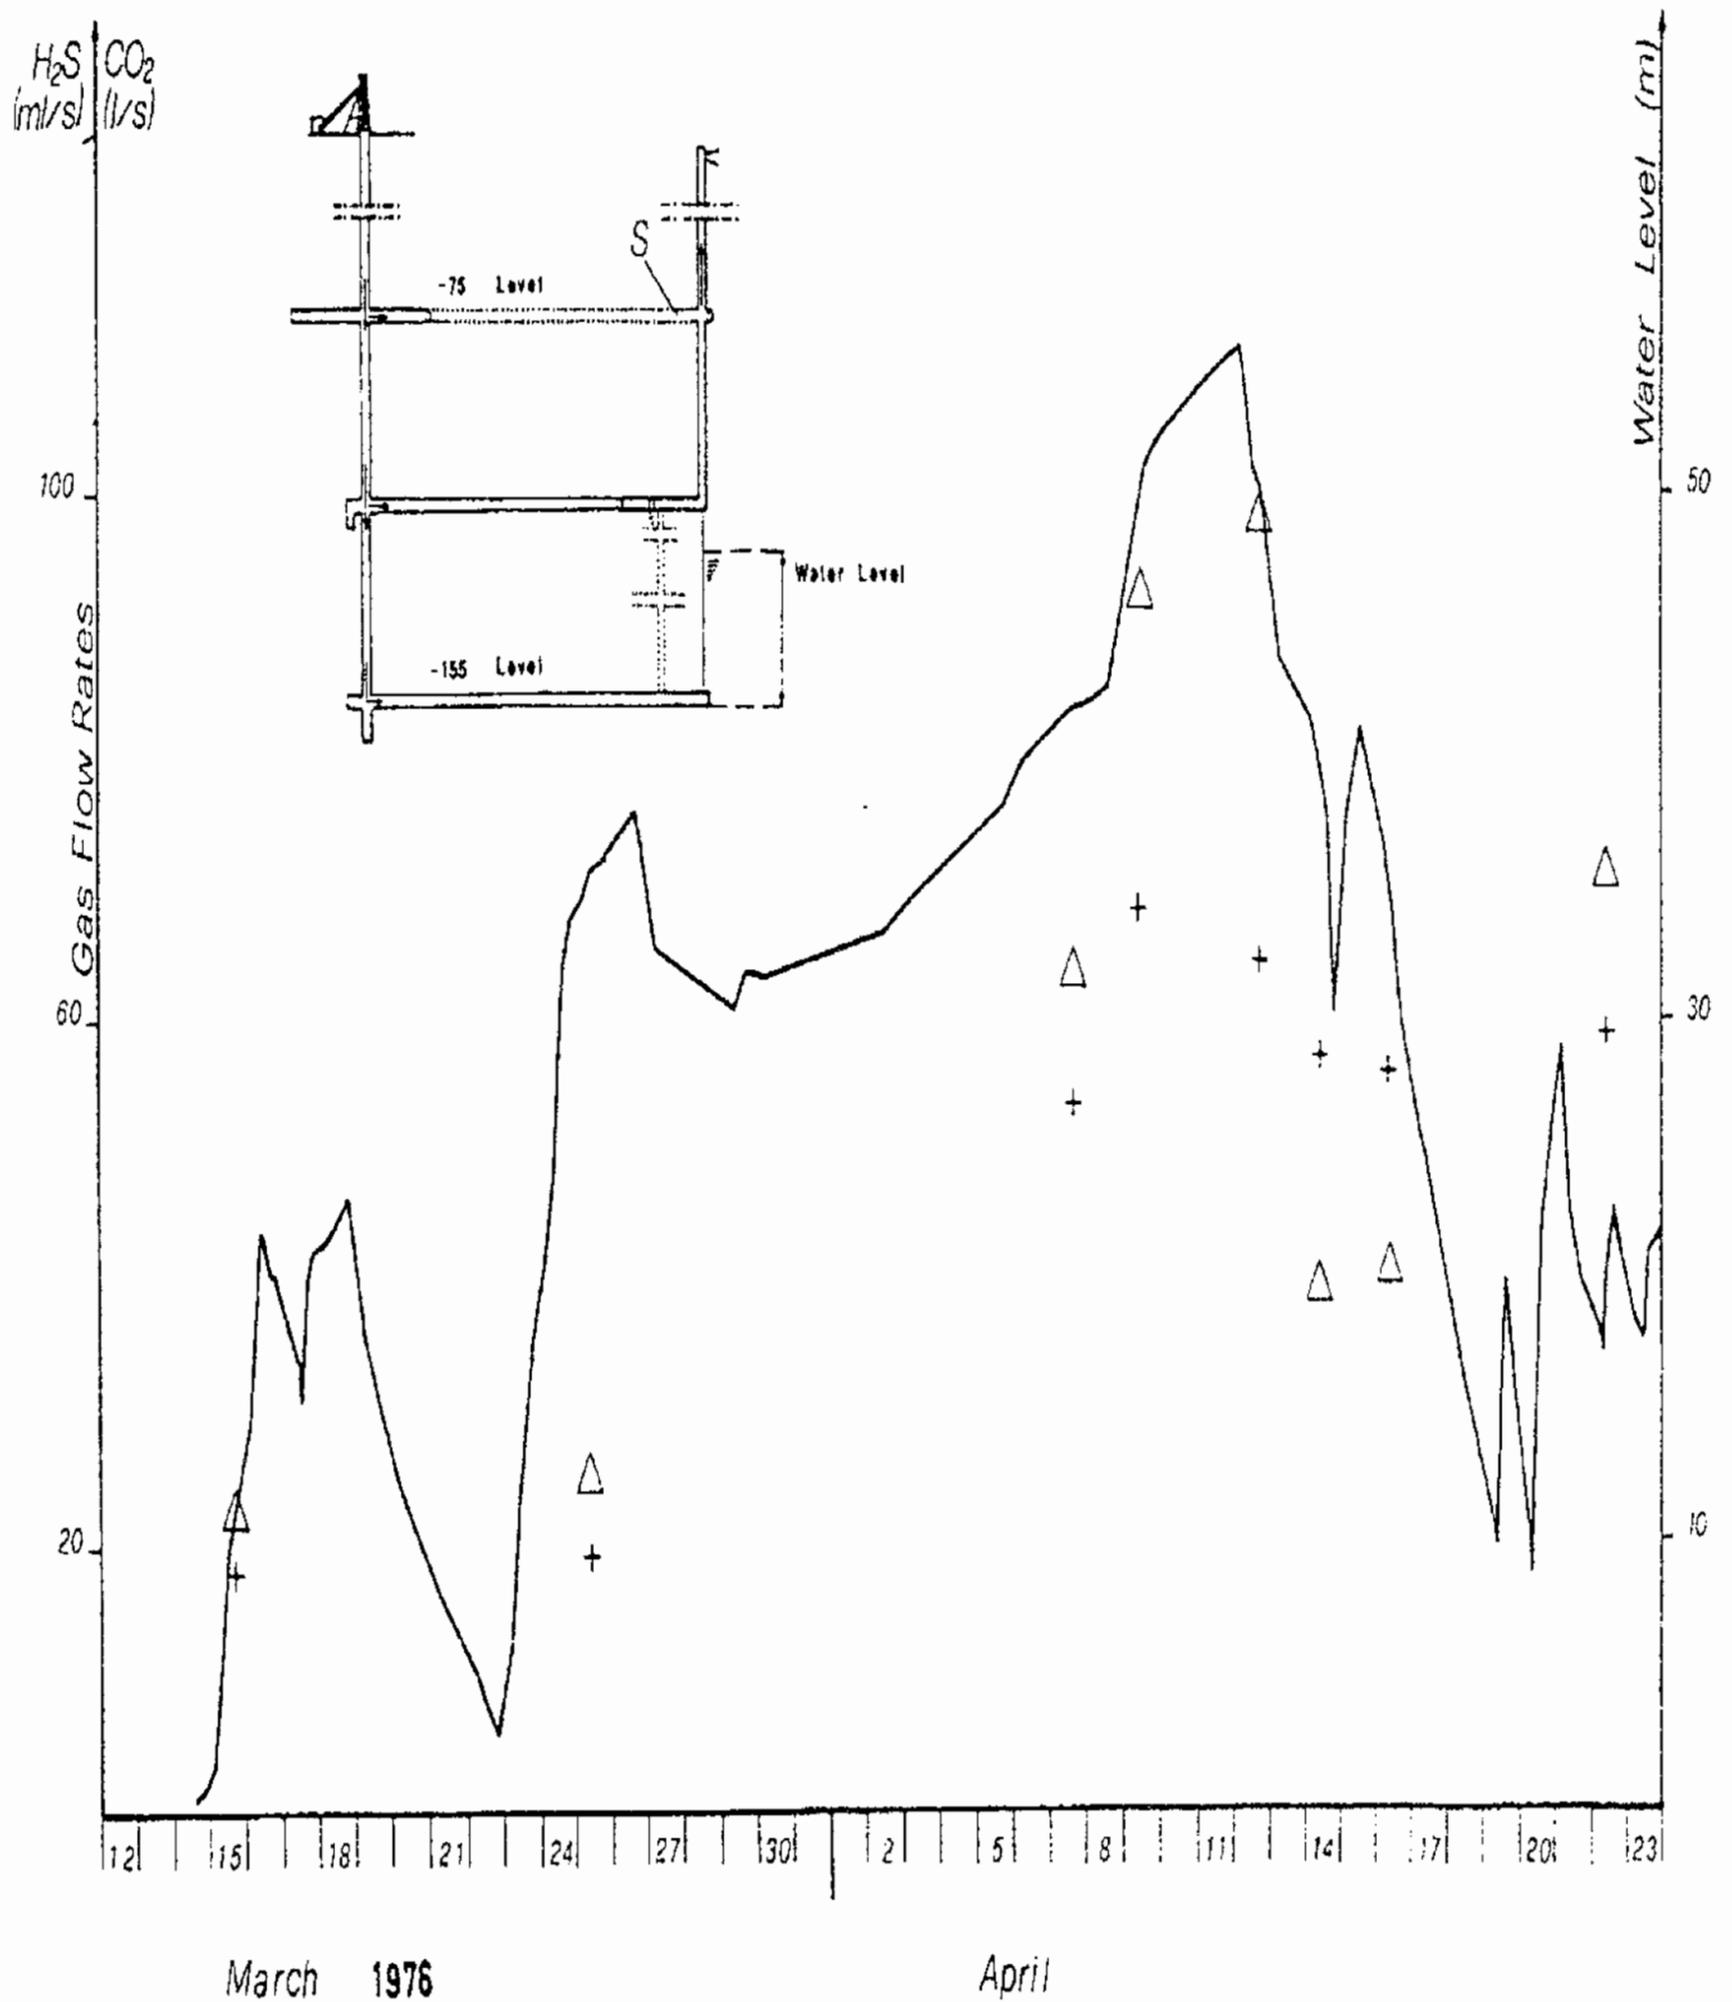
Picture 1 indicates the changing of the water level in the mine through time during the first flooding stage. The minimum and maximum levels, with the exception of those of the 16, 22, 26 and 29 March and the 23 and 25 April, which indicate a reversal of the direction of the water level determined by rain, correspond respectively to pump failures due to faults and repairs.

After the flooding, CO₂ and H₂S gas flows increased notably due to their continuous inflow into the mine (picture 1). Such increases, which had enabled floods to be predicted, had been explained by linking them to hydrodynamic evolutions that used to happen frequently in that underground area after the first episode but had been stopped thanks to their timely forecast

Figure 1. Bagni San Filippo Mine. Water level in mine and flow rates of the gases CO₂ (triangles) and H₂S (crosses) obtained by taking in the cross section S air flow rates and gases concentrations.

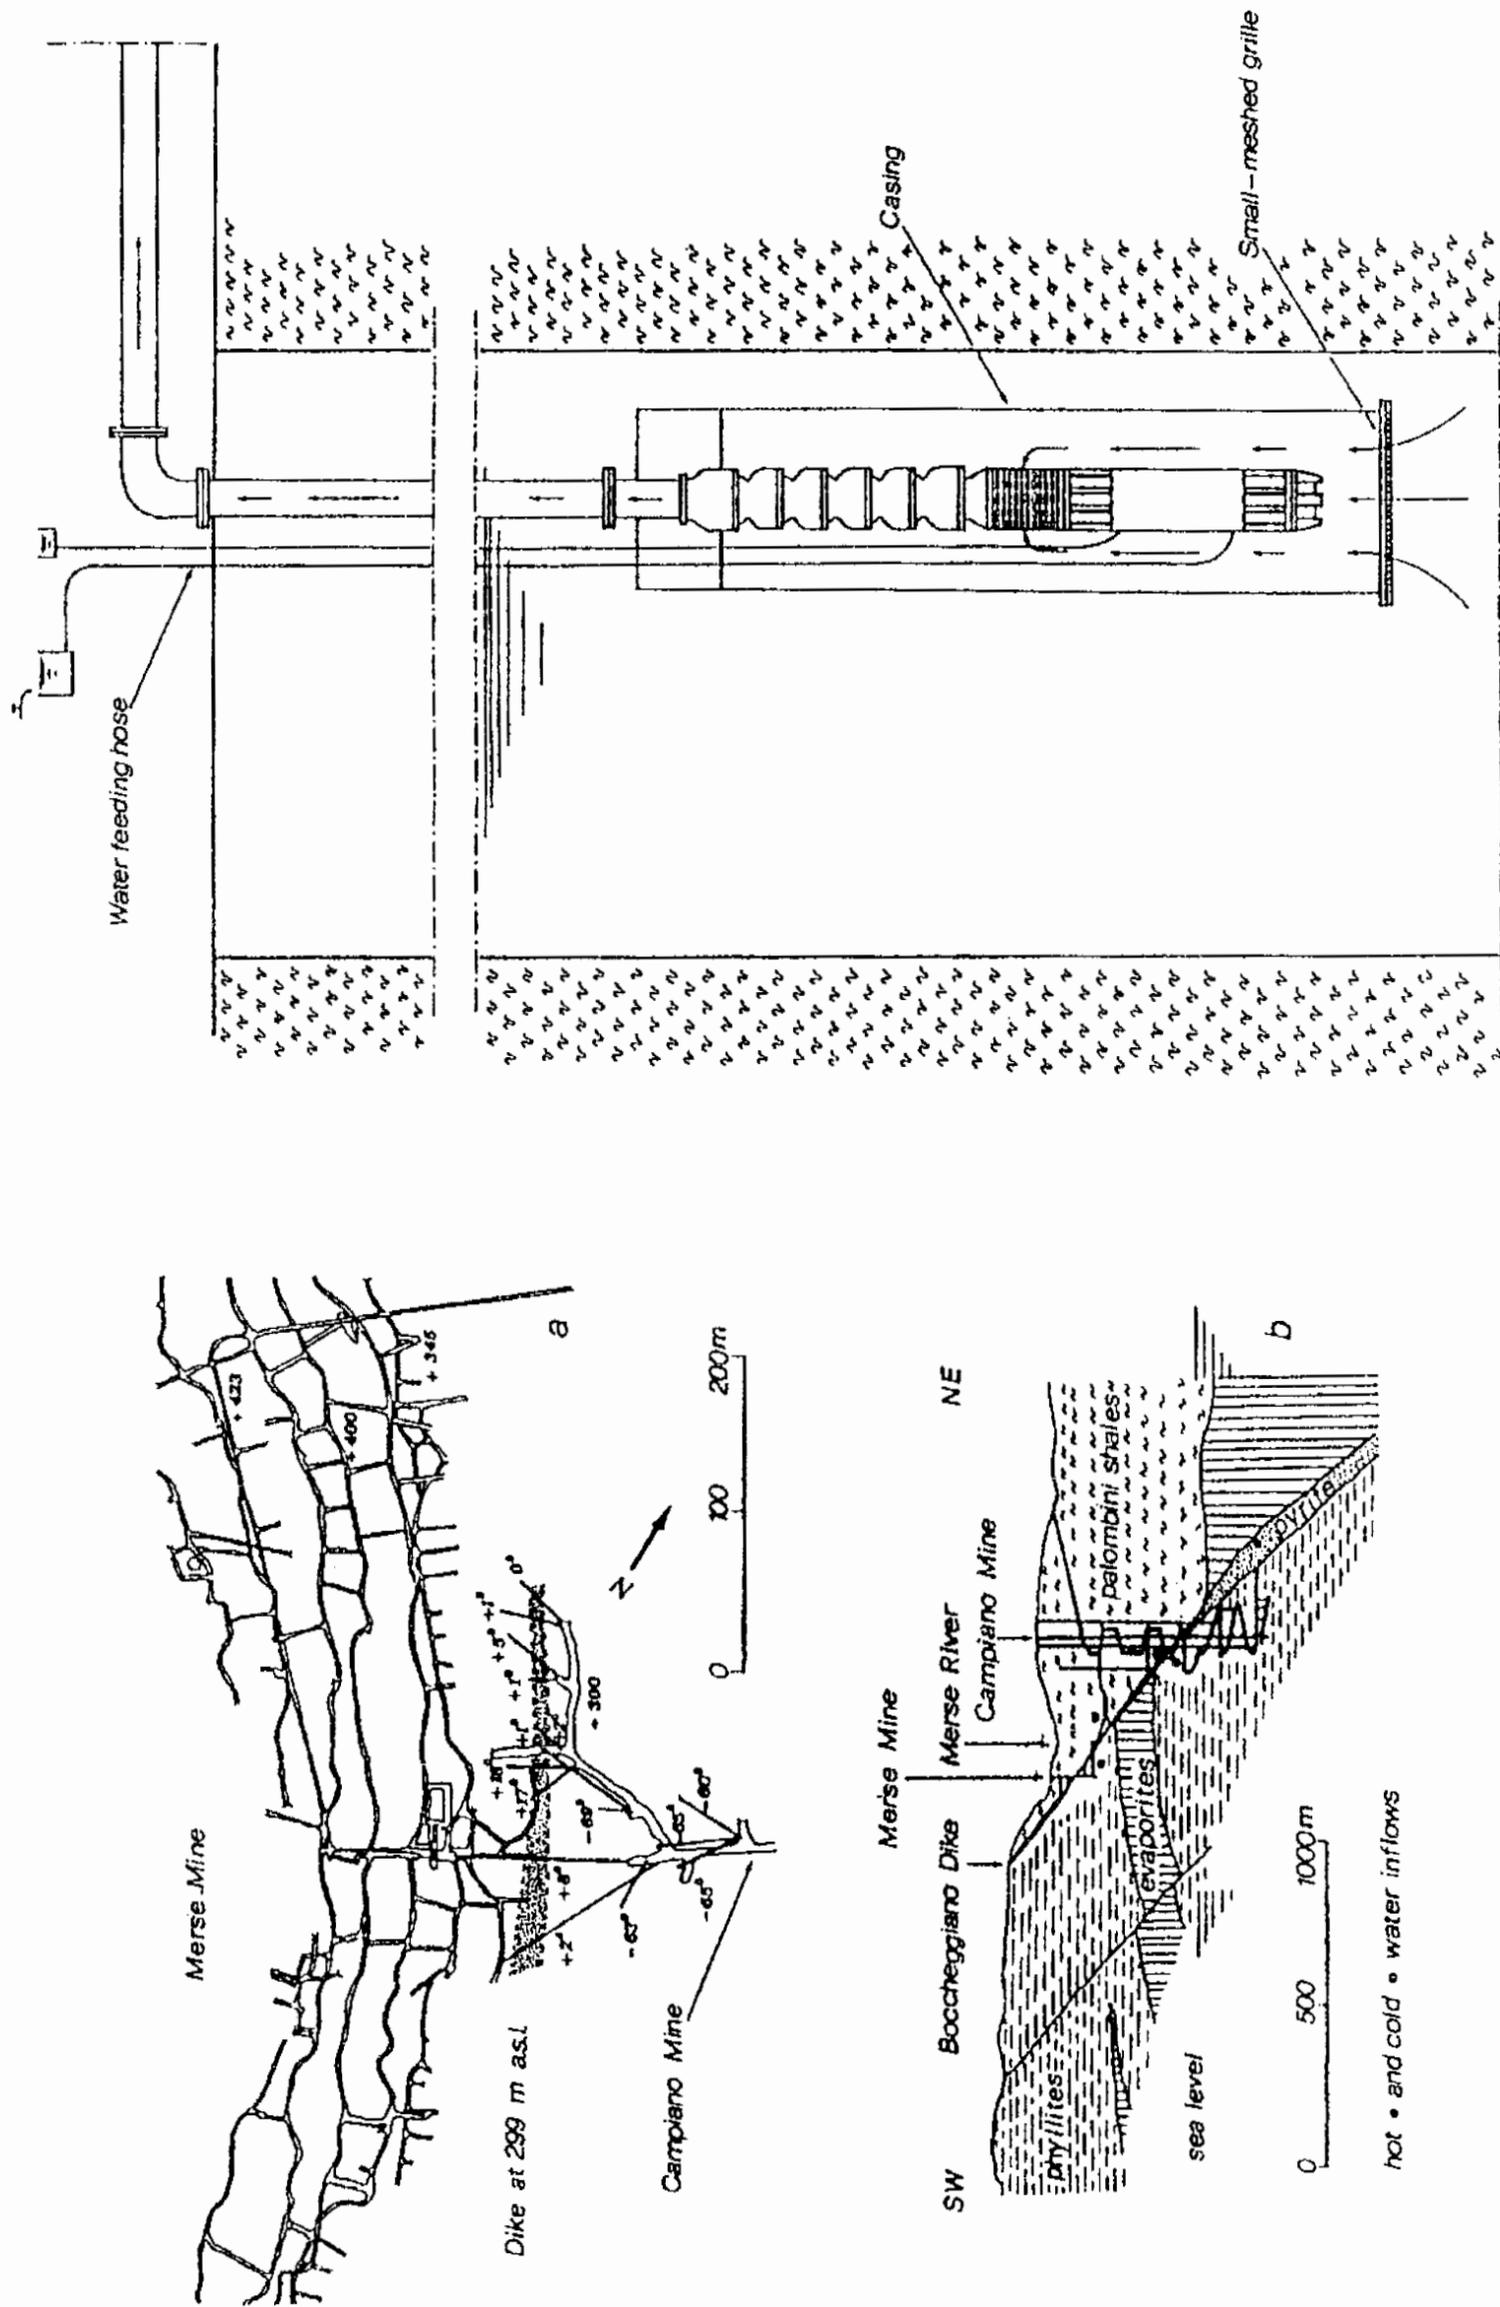
At the beginning the draining was not performed on a regular basis: the flow of the extracted water was irregular and sometimes the water level on the ramp would start rising instead of falling. This used to happen because the submersible pumps of the pumping stations set up in the wells in order to handle emergencies, would fail frequently for the following reasons:

- high temperature of the pumped water which was initially 52°C, fell only to 45°C during the emptying stage which lasted about 7 months;
- incrustation formations on the engines surfaces;
- presence of slime in the sucked water, although the pumps had been kept below a certain water level in order to avoid cavitations;

- penetration of mine water in the motors;
- excessive acidity (PH < 2) of the waters pumped out from the Serpieri well of Merse mine.

The first two listed factors were causing the deterioration of the stator winding insulation of the electric motors, while the third and fourth factors would have damaged mechanical parts and therefore overheating due to overcurrents and short circuits. The excessively acidic water then corroded the pump installed in the Serpieri well of the Merse mine to such an extent that it was beyond repair.

Figure 2. On the left: the Merse Mine and the Campiano Mine, flooded in 1901 and in 1977 respectively. On the right: devices for avoiding breakdowns of the submersible pumps used for dewatering the Campiano mine.

The faults were avoided and the regular drainings were guaranteed by adopting the following measures (picture 2), which eliminated or disabled the causes of the above mentioned faults.

Around every single submersible pump a casing was placed, thus obtaining a greater heat dissipation between the motor and the mine water: before the casing, the pump was placed and in a watertight substance, the water would flow towards the aspiration grid of the pump and it was forced to pass between the outer surface of the motor and the inside surface of the casing at a sufficient speed in order to avoid a temperature increase that could have hampered the necessary cooling of the motor. With such a system another aim had been reached, namely that of reducing the formation of incrustations on the motor's body which were hampered by the water flow.

Each casing base was provided with a thick grid that reduced notably the pumping out of silts.

Through two flexible pipes of reduced diameter, one for the inflow and one for the outflow, which would serve as a link between the surface and the inside of each electric motor - which squirrel cage-like rotor was completely immersed into the water - the inside of the motor could be kept at sufficient pressure to avoid the penetration of mine waters.

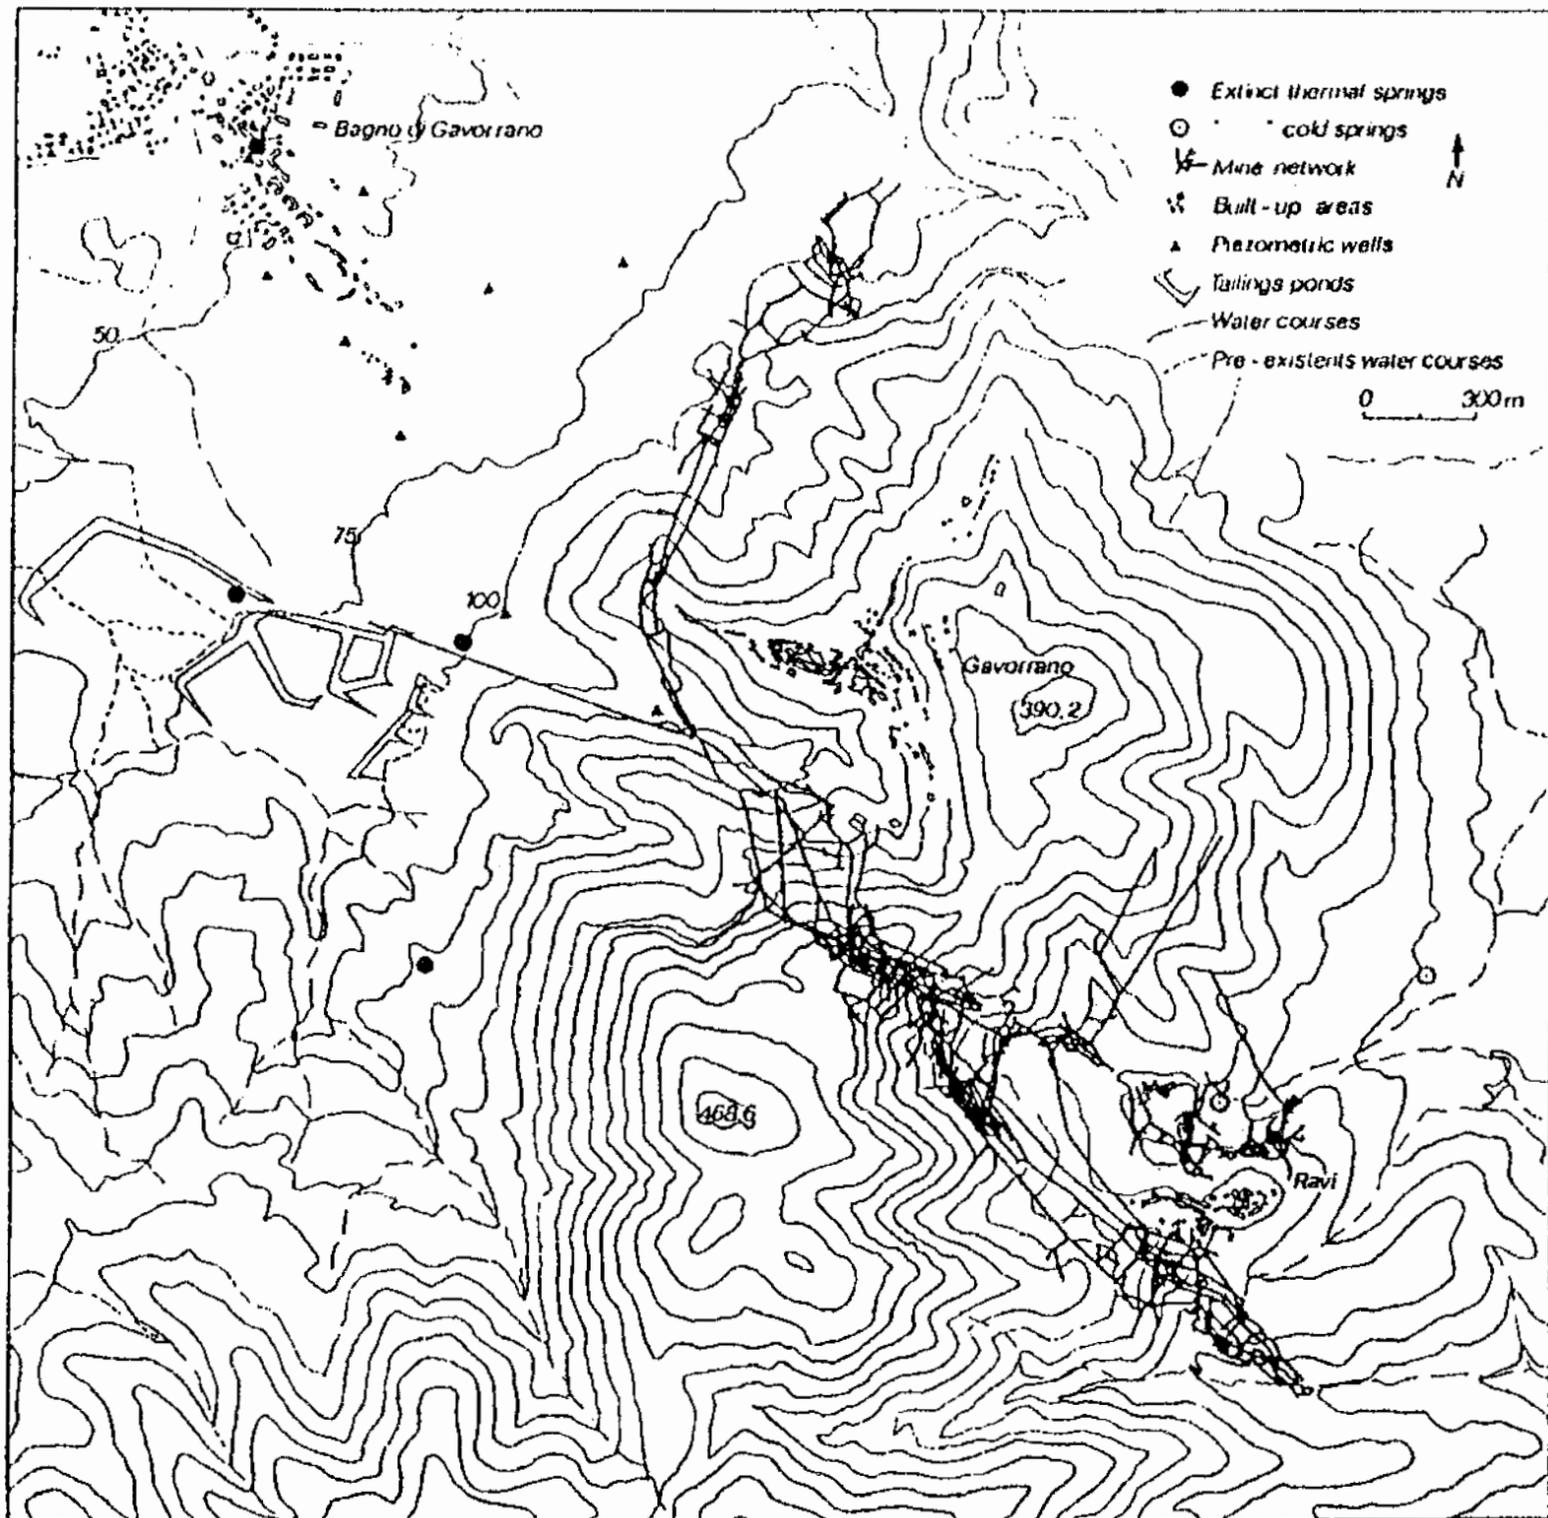
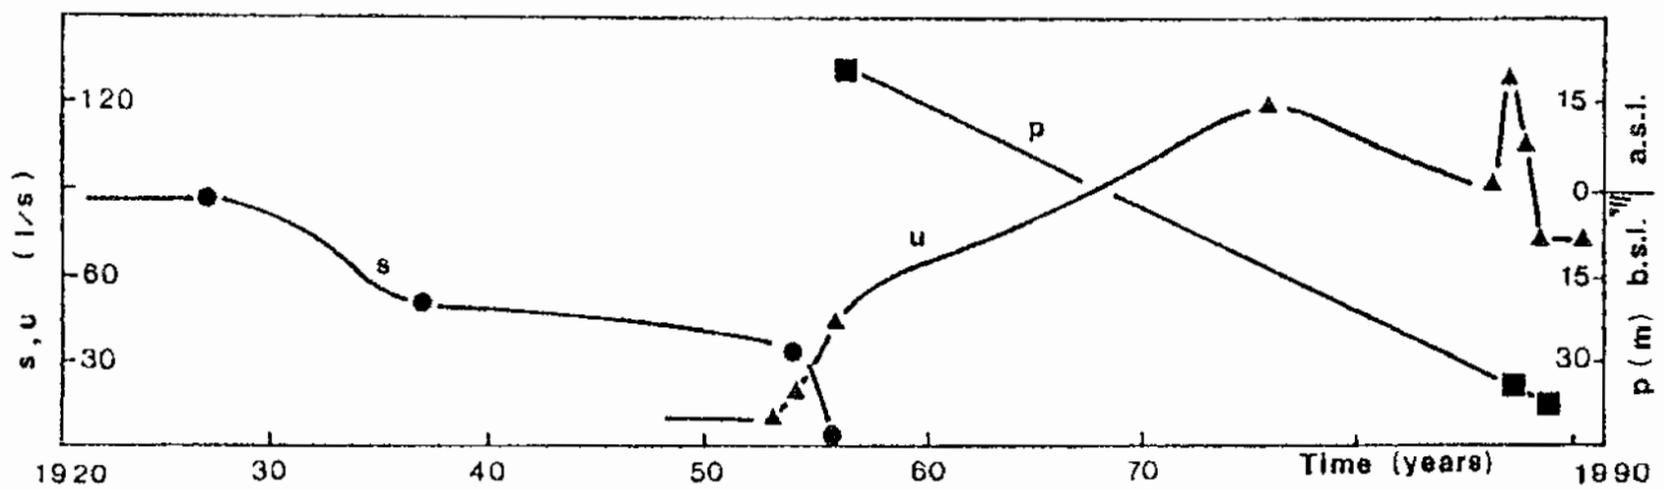
deep consequences on the hydrodynamics of the territory, causing the disappearance of hot and cold springs, indicated in picture 3 with black and white circles respectively, and reducing superficial water ways due to the penetration in the mine of waters that would earlier flow into them. Such repercussions become clear when comparing the trends of the most intense hot spring flow, s , the flow of the water extracted from the mine, u , and the height of the water table in the proximity of the aforementioned spring, p .

Since, in the meantime, the situation in the territory had changed, risky circumstances would have appeared. In fact, in the vicinity and around the most intense disappeared spring, which flow before the mining activity was of 80 l/s, a settlement was built. The buildings could have given way as a consequence of the rising of the water level. Besides, above a second spring and in the proximity of other disappeared springs, mud setting lagoons have been built, containing 1.5×10^6 m³ of material, which stability after the flooding of the mine, could have been strongly compromised by the water, which rise would have resulted in its penetration into the basins and the increase of the superficial water flows if they had not been able to flow into the basins themselves (picture 3) due to an inadequate and inconsistent embankment.

Figure 3. Gavorrano Mine. Above: mine network, morphology of the surface over and round the mine, pre-existent and actual situations. Below: correlation between the water flow-rate pumped out, u, and the hydrodynamics of surface, s and p.

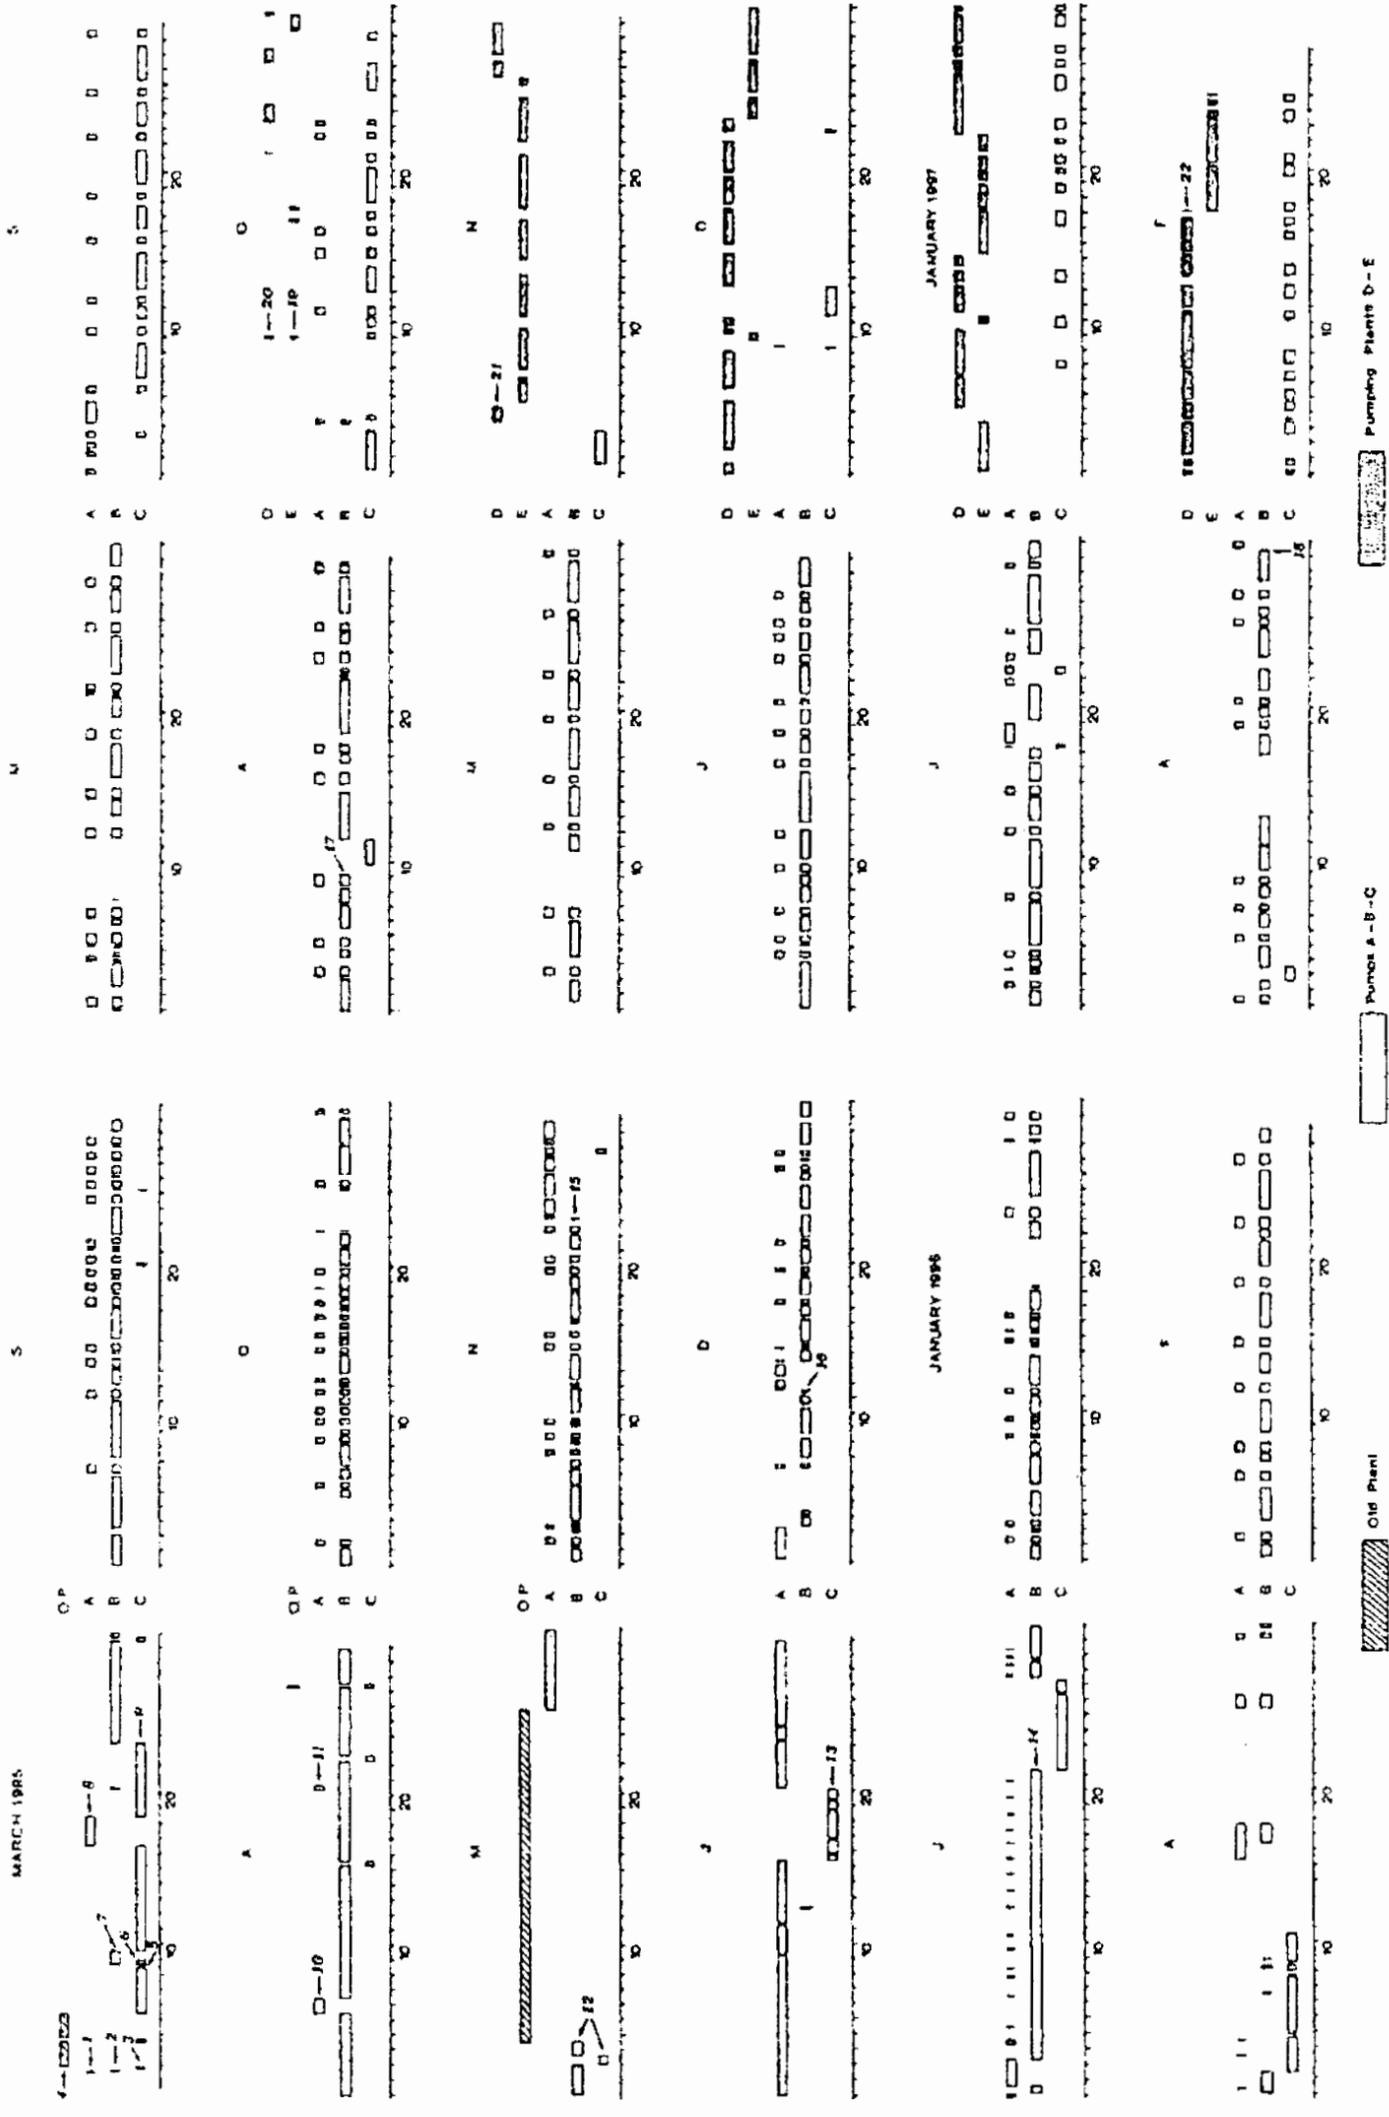
Picture 4 shows the operation periods of the old plant and of the pumps of the new one over the past two years. During this period the water level has been forced up to 143 m below the sea level, while the new plant was being tested and faults and anomalies thoroughly scrutinised in order to improve its reliability. The arrows indicate failure induced pumping stops. The faults, which have been numbered according to their occurrence, have been summarised indicating, in the most significant cases, the intervention methods and measures adopted to avoid them.

1. Leak in the supply duct at the level of a flange coupling.
2. and 3. Pumps failure due to badly insulated relay switches, set at 50 kohm.
4. Pipe bursts in 4 points, detected when old plant had been reactivated, after the failure of the new pumps which had operated for less than an hour. A watertight door had been immediately closed to avoid, in absence of pumping, the flooding of the control level situated at 200 m below the sea level; by-passes had been applied to use less corroded piping sections and delay the closure of automatic valves to reduce hydraulic shocks.

5. Pump failure caused by an isolation switch on a 6kV line upstream of the transformer. Old electric cables have been replaced and the overloading of the pumping lines with other users has been avoided.

6. and 7. Pipe bursts.
8. Spontaneous failure due to short-circuit of the statoric winding caused by excessive absorption, caused in turn by the heavy wearing of the thrust bearing.

9. Failure due to badly insulated relay, which intervention current together with that of other pumps relays has been reduced from 50 to 10 k ohm to extend the operation of the same pumps by tolerating lower insulations.

10. Manual stop, having realised that the absorption was excessive. An unusual wear of the thrust bearing has been noted.
11. Failure caused by badly insulated relays; the insulation of the statoric winding has been damaged by excessive absorption current caused by the unusual wearing of the bearing-bush, the latter caused in turn by the rotor jumping out of its axis.

13. and 14. Failures due to anomalous wear of thrust bearings, wearing caused by excessive vibration of the supply ducts.
15. Failure due to the breaking of the diaphragm which determined great mechanical damage and the increase of the absorption until the activation of the maximum current relay. The motor has been repaired by substituting the diaphragm, the stator and its winding, the

18. Pump failure due to short-circuit of the statoric winding, probably caused by the abrupt deterioration of the insulation and not by motor overloads, since only the badly insulated relay has tripped and not the maximum current relays; no insulation reduction has been noticed an hour before the failure. At present it is not possible to clearly determine the circumstances and the causes of the fault, since the pump has not been recovered yet because access to the mine has been banned, due to recently detected high water level fluctuation.

Figure 4. Gavorrano Mine. Working periods of the old pumping plant and of the new pumps: the arrows show pumping stoppings due to failures that haven't, however, absolutely prevented the continuous control of the water level in mine, owing to the high level of reliability of the system adopted for realizing that control (fail-safe).

12. Failures induced after detection of scarcely insulated statoric windings. Both pumps' windings have been reconstructed and subsequently those of all other pumps, insulating them with a double layer of polyethylene instead of a single layer of PVC.

16. and 17. Gasket break between the flanges of a coupling. Once the cause has been detected all other couplings have been checked in order to avoid other similar cases.

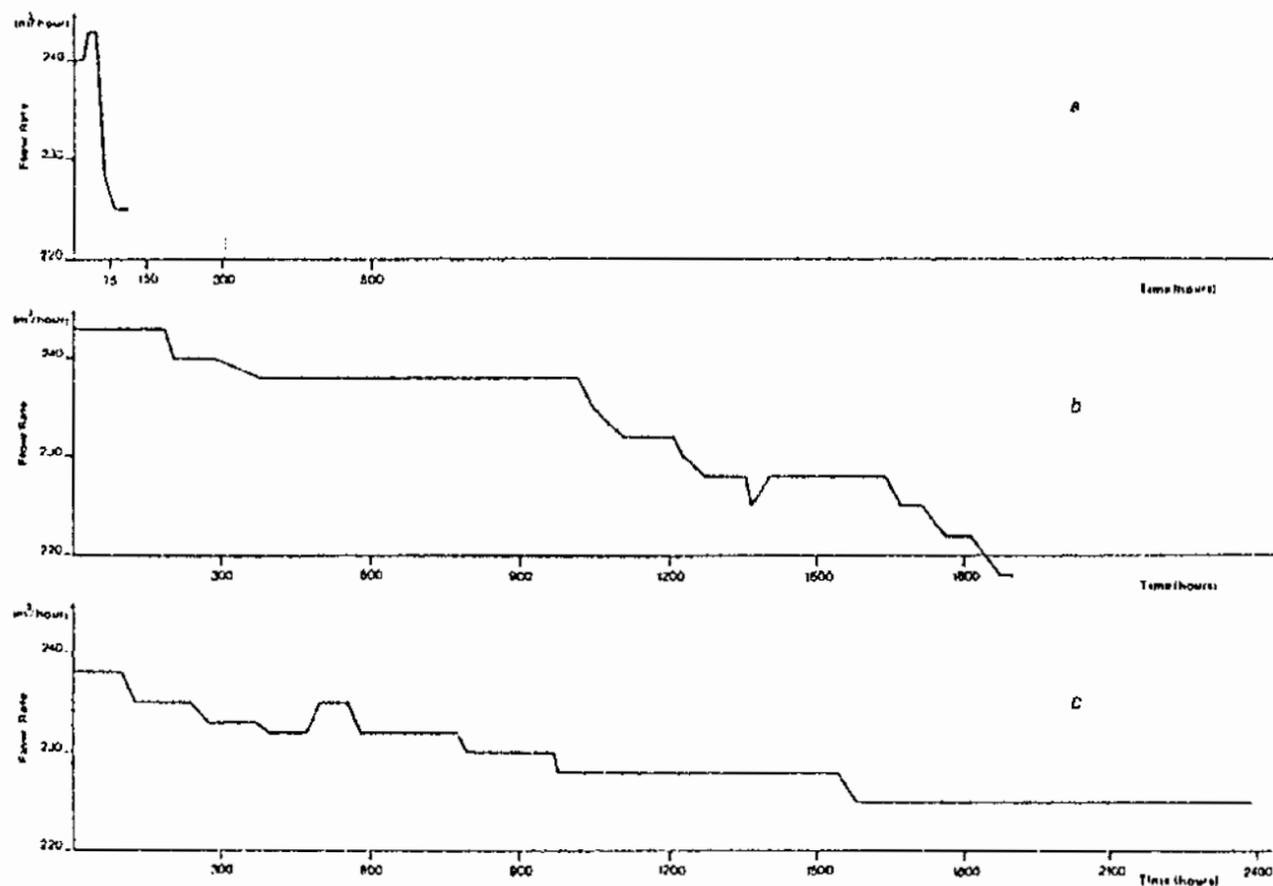
Some gaskets, placed on a flanged coupling at the base of a connector, have also been severely damaged. The latter appeared to be necessary to avoid cavitation of a pump, which was shorter than the one it was replacing. In picture 5, top, the trend of the flow of the water extracted by the mentioned pump can be seen:

- as soon as it starts operating, a;
- after an initial replacement of the gasket, as soon as an abrupt flow reduction had been detected and found completely severed in the intermediate point between two flange connection bolts, b;
- after a second replacement of the gasket, which hasn't been examined since the pump has not been recovered, carried out after a 10,3% flow reduction, c.

In the same picture, the periods in which the speed of the flow reduction increases correspond to the operation of the pump: clearly the pressure impulses obtained with the setting into motion, would determine abrupt deterioration of the state of the gaskets; the periods of the flow increase correspond to leaks due to gaskets for Victaulic coupling downstream of the measuring section of the flow. However, flow reductions similar to those visible in the picture can indicate, in similar cases, deteriorations and complete severance of the gaskets.

The gaskets would break because the surfaces of the defective flange were not parallel to one another. Therefore, the gaskets not being evenly compressed, would allow water leaks under pressure that would damage both gaskets and flange. In order to prevent this from happening again the surfaces of all the flanges have been thoroughly smoothed with a lathe, some silicon has been applied between the gaskets and the flanges and extreme care has been taken in obtaining an even locking.

Figure 5. Gavorrano Mine. Above: typical decreases of submersible pumps flow rates owing to breakings of gaskets of flange joints. Below: decreases of the PVC insulation resistance of the stator winding after a first starting, A, and after following statings, B and C; for the gradual deterioration of the insulation materials PVC that are subjected to high temperatures it is possible, by recording the values of their resistances, to foresee and avoid short circuits.

Damage to gaskets for Victaulic couplings, successfully used for several decades in mining, were detected when a faulty supply of gaskets was used: after an operation period varying from a few days to a few months, for 10% of such couplings, initially faint water leaks occurred, which grew stronger if the gaskets were not immediately replaced. Such inconvenience has been removed after substituting the faulty gaskets.

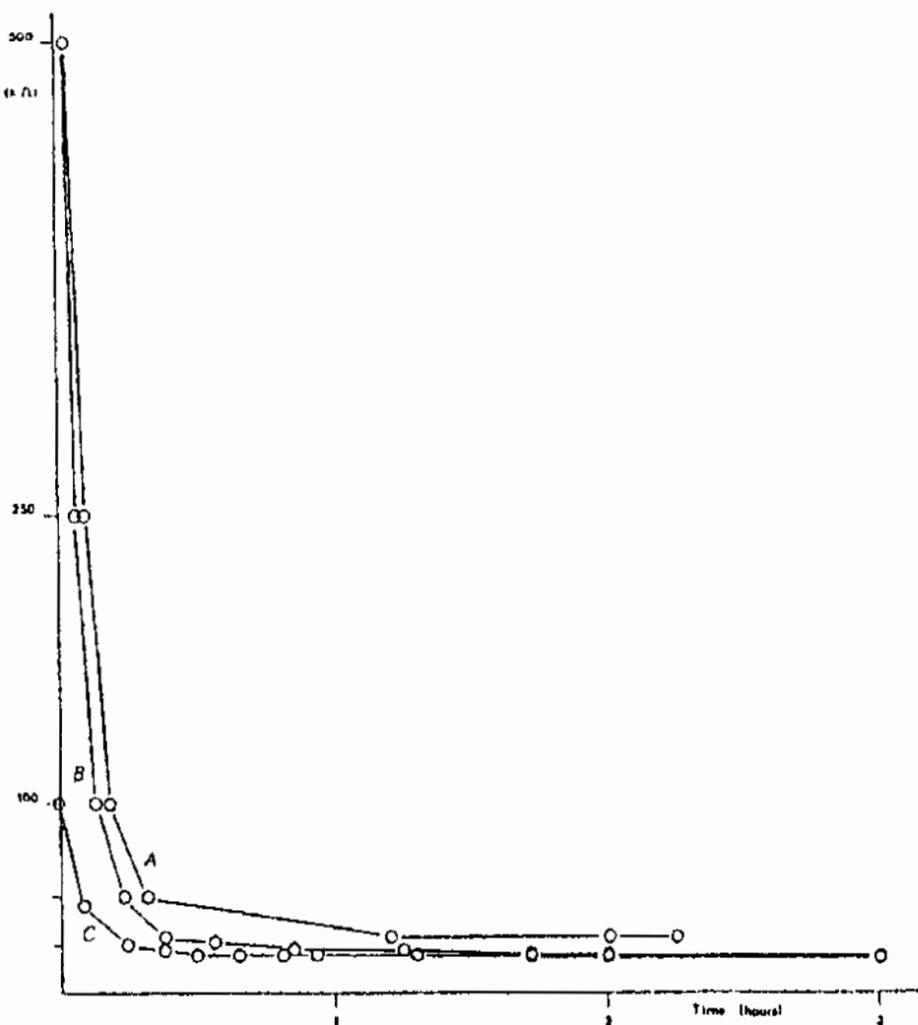
From the beginning of the testing it appeared that the values of the PVC insulation resistances of the statoric windings of the motors of the submersible pumps in the Impero well would rapidly reduce after start-up down to 50 k ohm; the safety relay had also been set to this value.

Subsequently, after the activation threshold of such relays had been dropped to 10 k ohm, the following conclusions were drawn: the values of those resistances would reduce during the operation of the pumps, as shown in picture 5, below; with the increase of the number of start-ups the decreasing speed of the values would increase (picture 5); even in such a precarious situation pump B would fail after 750 hours and pump C after 410 hours.

After the windings of all motors have been reconstructed by using for insulation not one single PVC layer but a double layer of polyethylene (Hellman and Tams, 1986), the mentioned inconvenience reappeared only on one other occasion, where a short-circuit of the statoric winding occurred without notice; the contrary would apply in the case of PVC insulated windings through the reduction of the insulation resistance values. This reduction was rapid at first then slower and slower before the motor would stop (Sammarco et al., 47-95).

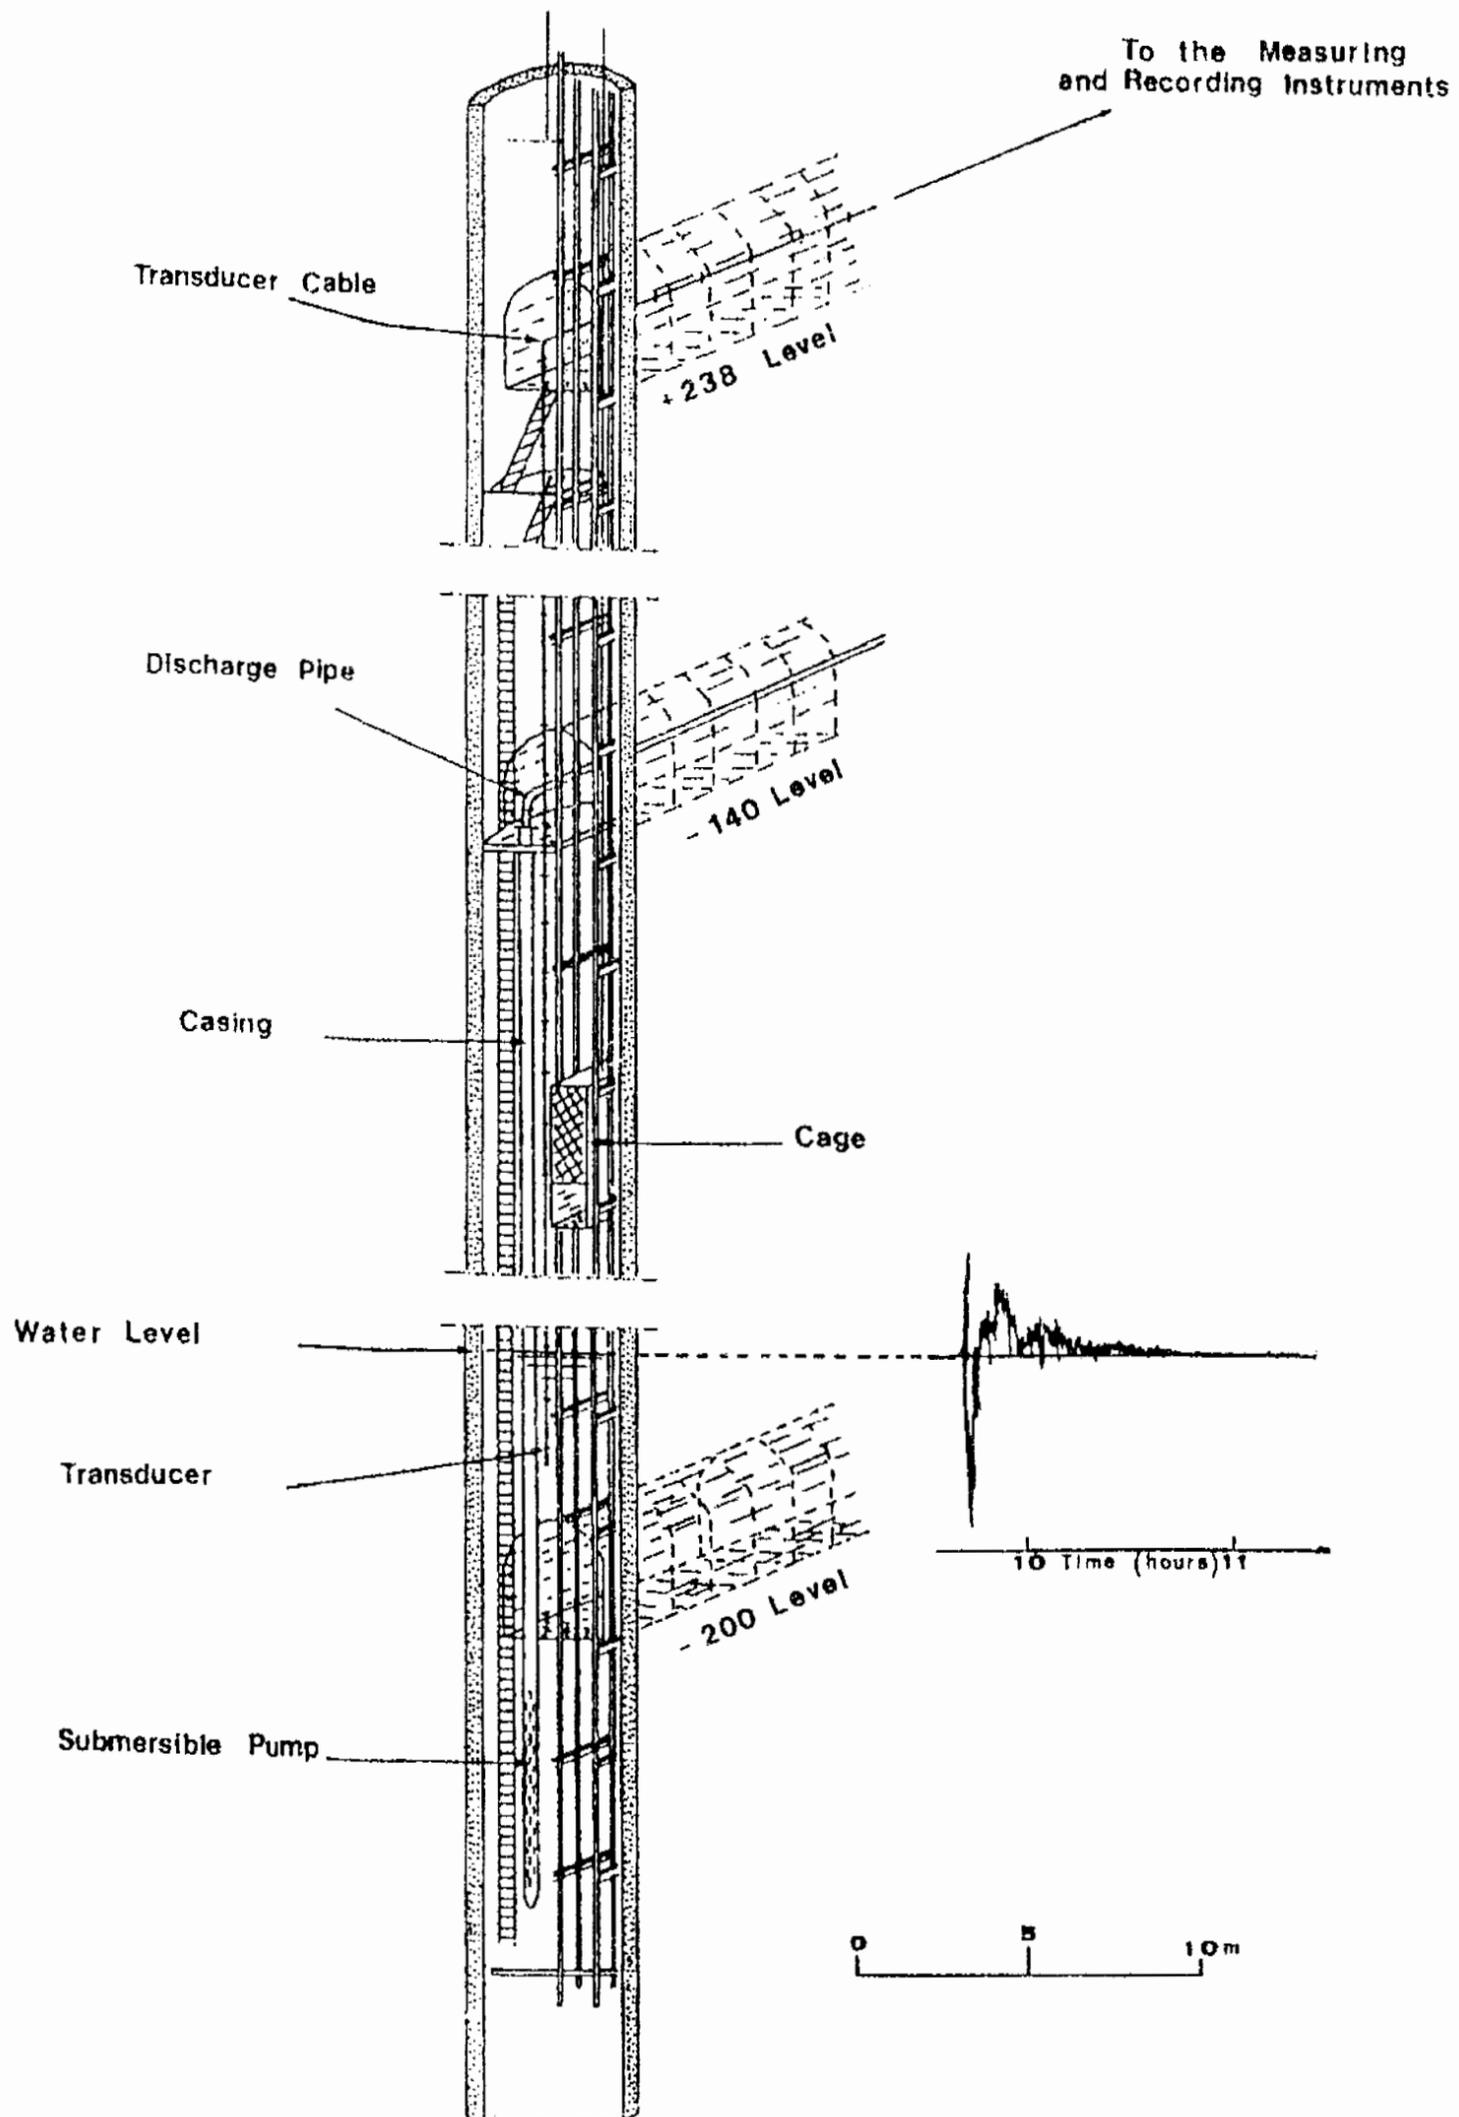
The same picture shows the movement of the water level in the well, occurred after a collapse in the mine cavity during the flooding.

Figure 6. Transducer in a shaft of the Gavorrano Mine for recording oscillations of the water level, in correspondence to this level the oscillations that occurred on the eleventh of June 1996 in consequence of a landslide have been drawn.
