CONTROL OF THE LIMESTONE WATER NUISANCE FOR KUZHULIN COAL MINE

Yang Chunlai

China Coal Research Institute
District 13, Hepingli,
Beijing, China

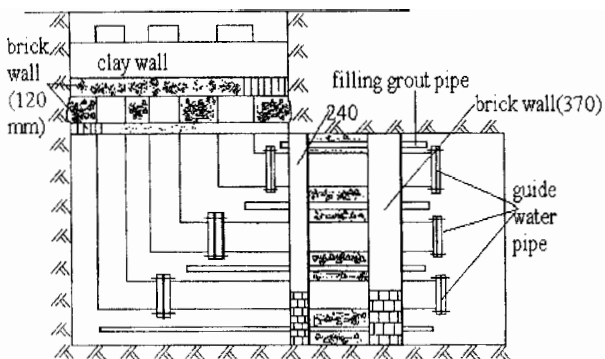
Fig 1. The diagram of construction of guide water pipe and concrete wall for No.1 suction well

The No. 1 suction well was of 1.5m in diameter and 5.5m deep in which a big fracture about 200mm wide existed. Meanwhile the suction valve of the water pump was 200mm higher than the well bottom. All these made it difficult to construct a concrete plug to ensure the quality of the concrete plug and the normal pumping.

What measures should we take? Firstly, we installed 3 guiding water pipes of 108mm in diameter to drain water from the sump to No. 1 suction well, and built up two concrete walls on the roadway from the sump to the well (see Fig.1).

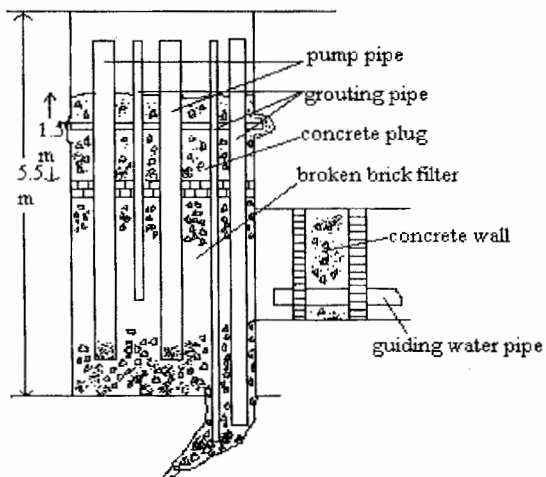
Fig 2. The diagram of construction of concrete plug of No.1 suction well

water flow and the pressure gauge installed in the suction pipe in No. 1 suction well showed that the pressure reached 0.6Mpa, the construction of the concrete plug was proved successful. The water outflow was stopped under the concrete plug.

After finishing the concrete wall, a concrete plug for the No. 1 suction well should be made. First, in order to make the filter layer we constructed with No.8 steel wire 15 cages whose diameter was 250mm and height 400mm, Then put them down to the suction well near the suction valve. All the cages were full of broken bricks. Immediately after that, more crushed bricks were thrown upon the cages until it appeared above the water table. Second, we set a layer of whole bricks covering the crushed brick level, then a layer of asphalt on top of the whole bricks. Finally, the concrete was poured on the asphalt. The height of the concrete layer was 1.5m (see Fig.2). The pump was operating non-stop during the course of constructing the concrete plug and its curing.

After 10 days curing, the pump and the valve of the suction pipeline were closed to stop drainage. Then the water in the No.1 suction well was drained back to the sump through 3 guiding water pipelines. When the valve of 3 guiding pipelines were closed to check the
