## A study on groundwater flow and chemistry of mine waste dams

**Abstract** The groundwater flow and its chemistry were investigated at three closed mine sites to adopt an appropriate remediation method. The contaminated seepage water from a mine waste dam at one site primarily originated from the mine waste itself whereas those at the other two sites were affected by the surrounding ore zones. This indicates that hydrogeological conditions control the chemistry of the seepage water from the waste dam.

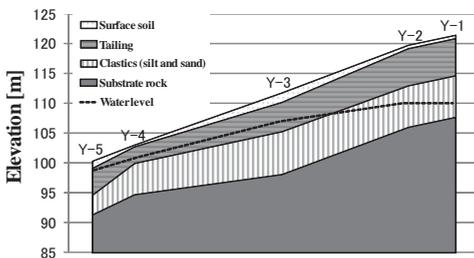
**Figure 5** Geological section of the tailing dam at Y mine

The geological section of the tailing dam at Y mine is shown in Fig. 5. The width of tailing is approximately 5 m. The groundwater level was in the tailing from Y-3 to Y-5 while it was below the tailing from Y-1 and Y-2. The value of the metal contents and the dissolution test at Y mine are less than those of A mine and O mine except for Cu. The dike was broken and the tailing was discharged by an earthquake in those days, and the discharged tailing was replaced with the surrounding soil. That is why the sediment is heterogeneous and the contents of the heavy metals are relatively lower. Table 5 lists the results of chemical analysis of the groundwater samples at Y-1, Y-2, Y-3, Y-4, and Y-5 and the seepage water. The pH decreased and heavy metals and sulphate concentrations increased along the groundwater flow pathway. Considering this two-dimensional section, this indicates that the tailing is the main source of the contamination of the seepage water.

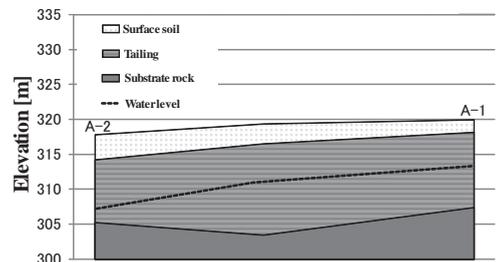
**Figure 6** Geological section of the tailing dam at A mine

Figure 6 shows the geological section of the tailing dam at A mine. The tailing is located from ground level (GL) -3 m to GL -16 m, and the groundwater level was in the tailing. From the result of the metal contents and dissolution tests of the tailing, the contamination potential of groundwater was small at the site. Table 5 shows that the results of chemical analysis of the groundwater samples at A-1, A-2, B-1, and B-2 and the seepage water. The heavy metal concentrations of A-1 and A-2 were lower than that of the seepage water. The pHs of A-1 and A-2 were approximately neutral although those of B-1, B-2, seepage water were acidic. The chemical properties of B-1, B-2, were similar to the seepage water.

Thus, the groundwater was not contaminated at the site, and the flow of the groundwater did not pass through A-1, A-2, and seepage water but passed through the ore zone, B-1, and seepage water. This indicates that the contamination source of the seepage water is not the waste dam but the upward ore zone.

The pH of the spring point was 5.77, and that of the river next to the dam was 6.83. This indicates that the groundwater of A mine is partially provided from  $\alpha$ , and goes to the river without being contaminated by the tailing.

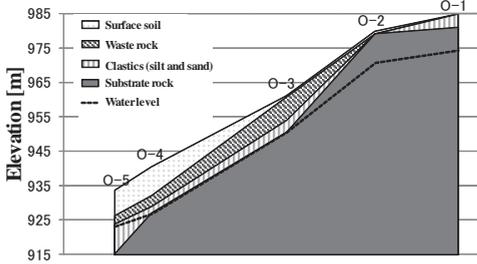
**Figure 7** Geological section of the waste rock dam at O mine

The waste rock is located from GL -0.5 to -5 m, and the groundwater level in the dam was GL -10m as shown in Fig. 7. Thus, the groundwater level was below the waste rock. Three wells (O-3, O-4, and O-5) are located inside the dam. The results of chemical analysis of the groundwater samples at O-1, O-2, O-3, O-4, and O-5, and the seepage water are shown in Table 6. The groundwaters of O-1 and O-2 located outside the dam were already contami-

nated. This is due to runoff rain contaminating the ground water by dissolving weathered minerals from an outcrop upstream. The O-3, O-4, O-5, and the seepage water were acidic and contained significant concentrations of heavy metals, and were more contaminated than that of O-1, and O-2.

Meanwhile, because the waste rock has sufficient contamination potential of groundwater from the results of the metal contents and dissolution tests of the waste rock, this means that the contamination of the groundwater results from not only the ore zone outside the dam but also the rainfall which infiltrates the waste dam.
