Independent investigation of reclamation at exploration drill holes at the remote Pebble copper prospect, Alaska

Kendra Zamzow¹, Dave Chambers,²

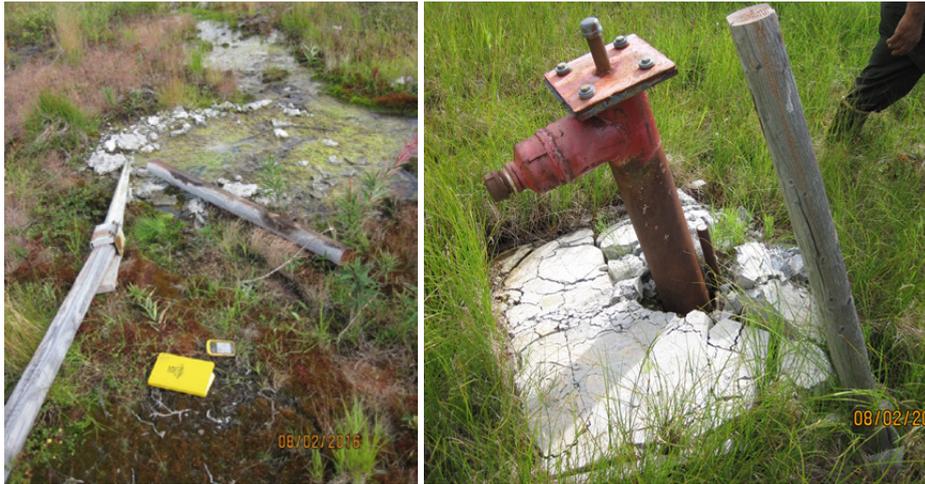
Artesian upwelling was observed at seven sites; including sites with and without drill casings (Fig. 1). Analytical samples were collected at five artesian sites. Although pH was generally consistent (pH 5.2-7.4), chemistry was not (Table 2). Only two were elevated in copper. Not shown are DDH 4202 and DDH 5330. These open drill stems were wet at the base; both had sediment elevated in copper and molybdenum but only DDH 4202 had elevated metals in water – it is likely both had been leaking at one time, but DDH 5330 is now under control.

Figure 1 Artesian site. Artesian water welled up at a site with two markers (Site DDH 7380/7386) where the casing has been removed. Some casings, like DDH 8410 pictured with a base of cracked cement, had plugs or plates bolted to them, presumably to prevent artesian flow. A similar bolted casing was artesian through a broken ball valve.
