Preventative methods to avoid Blow-out at Cwm Rheidol Adit 9, Ystumtuen Mine Sett

Peter Terry¹, John Leyland¹, David Mason¹, Heilyn Williams², Liz Jones²,
Richard Carline¹, Peter Stanley²

Abstract

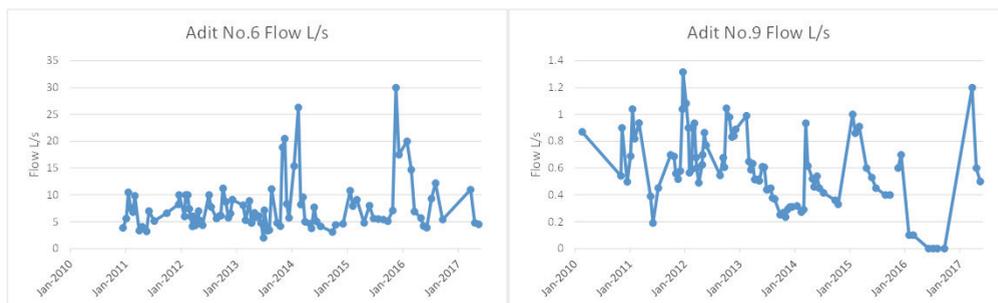
Analysis of flow and chemistry data for both discharges since 2010 showed little variation in chemistry, excepting a period from January to May 2012 when Pb increased at Adit No.9 (Coal Authority 2017). Adit No.6 has had flows measured volumetrically typically in the range 3 to 12 Ls⁻¹ dependent on seasonality but has shown occasional large spikes of 20 to 30 Ls⁻¹, indicative of direct surface water inflows. Adit No.9 has generally been consistently at or below 1 Ls⁻¹ except for the period following the sudden outburst in March 2016.

Figure 1 Mine Water Flows at Adits 6 and 9 from 2010 to 2017 (Coal Authority 2017)

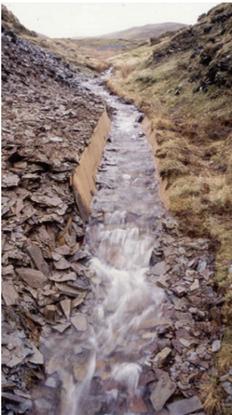
Adit No.9 has a known history of blow-out or outburst. In October 1969, during enabling works for exploration drilling an outburst caused the Afon Rheidol to turn red down to Cardigan Bay (Jones et al. 1975). In 1992, a shale dam had formed from a roof collapse within Adit No.9 holding back an estimated 2,273m³ of acidic mine water. Subsequent intervention works in March 1993 required draw down of mine water to a lagoon, in order to replace adit roof lagging and install of 6 m of 225 mm diameter drainage pipe to competent ground (Mason 2011). When the mine water levels were reduced during these works, it was found that the legs of the support arches had rotted away. In November 1993, a ground collapse at Nant Bwlchgwyn occurred resulting in the stream flowing to workings and contributing to flow from Adit No.6, the increased flow across mine spoil resulted in mass movement that smothered Adit No.9 below. The surface water inflow was mitigated

through the installation of a halfpipe in the stream bed (Plate 1) spanning the collapse. Basic restoration around Adit No.9 was also carried out with mine water in the Adit No.9 tunnel kept elevated to prevent access. In 2008, the mine water levels in Adit No.9 were drained down to reduce risk of outburst and in 2009 rigid corrugated plastic pipes were installed at the adit portals to convey mine water from Adits No.6 and No.9 to the now failing filter beds. During maintenance (rodding) of the Adit No.9 drainage pipe in March 2016 a rumbling noise was heard and a sudden discharge occurred. The released water was directed toward the former lagoon area to dissipate.

Plate 1 Nant Bwlchwyn 1994 halfpipe (Mason 2011)

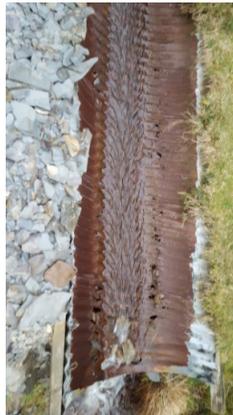
The condition of the steel halfpipe 1994 intervention (Plate 1)) had deteriorated over time with visible holes and opening lapped joints (Plate 2). Following removal and scanning the stone filled opening beneath, a replacement plastic half pipe with mortared headwalls was installed in September 2020 (Plate 3 and 4). Repeat flow gauging (Coal

Plate 2 Nant Bwlchwyn 1994 halfpipe (NRW 2018)

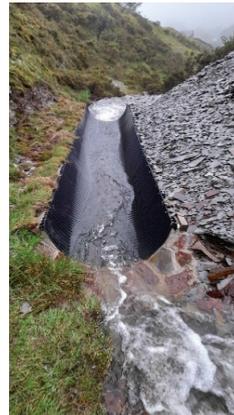
Plate 3 Nant Bwlchwyn replacement halfpipe (NRW 2020)

Authority 2021) during low flows indicated no losses on the Afon Tuen and no visible losses around the new half pipe though flows were too low to perform accurate flow gauging on Nant Bwlchwyn.

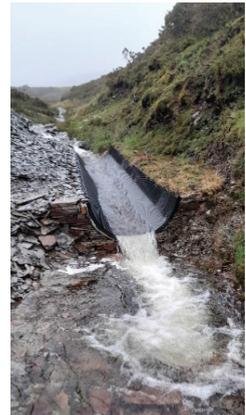
Plate 4 Nant Bwlchwyn replacement 6m x 900mm halfpipe (NRW 2020)

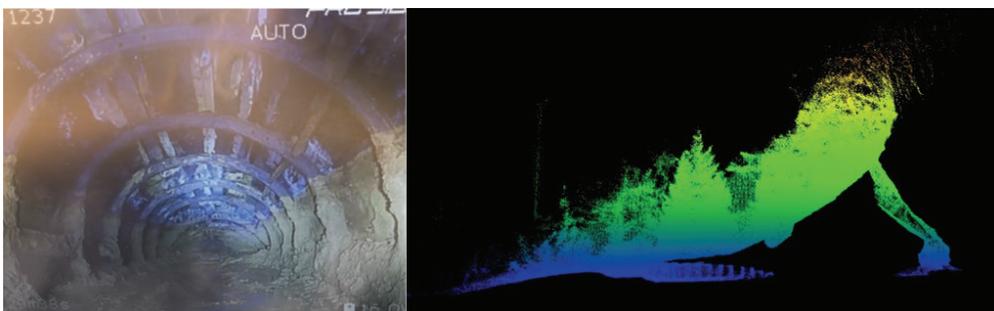
During a feasibility site walkover in February 2019 with Cambrian Mines Trust members and eminent mineralogist John Mason to record important mine heritage and features a roof collapse 15 m inbye of the portal was noted. The photographs available from reconstruction (Mason 2011) identify the steel arches on timber blocks. Using these and more recent photographs one can conject 0.5 m of ochre in the Adit No.9 portal. It is also evident that the steel arches have deformed over time.

The challenging conditions in the adit required the use of a push rodded floated craft to deploy robotic sewer CCTV camera with LED lighting and a GeoSLAM REVO mobile mapping laser scanner to access the adit from portal to blockage. Three survey control points were marked out around the adit portal and georeferenced using a Leica GPS RTK SmartNet GNSS receiver to OSGB 36 National Grid. Three spheres were placed over the survey control points and a laser scan survey of the spheres, adit entrance and adit surroundings carried out, using the GeoSLAM REVO mobile mapping laser scanner. The data from all laser scans were composited to generate a 3D representation of the surface and outer portion of the adit including the overlying collapse feature (fig. 2).

Later visits using roped access above the adit allowed laser scanning of the collapse feature, this data being added to the 3D model (fig. 2). The collapse feature was also installed with a telemetered pressure transducer to monitor and record water levels in the adit level inbye of the near surface blockages. This data has been used in conjunction with recorded mine plans, photographs and reports to estimate that 2,112m³ of mine water is trapped.

Figure 2 Adit No.9 roof & combined laser scanned imagery (Geoterra 2019)

The Phase 2 design aims to bypass the blockages in Adit No.9 by way of a 40 m long 1.5m diameter offset tunnel which will be progressed by means of pipe jacking. The tunnel is designed to enter the adit level behind support arches and props as recorded during original intervention work (Mason 2022). This work will entail the requirement to temporarily open the mine under the Mines Regulations 2014 with a designated Mine Owner, Mine Operator and Mine Manager (Competent Person). The new tunnel will include 160 mm diameter pipework with shut off valves to provide permanent blow-out resistant drainage, connected to existing mine water pipework. The original Adit No.9 portal and collapsed roof will be stabilised with cementitious grout or equivalent and with walling in local stone as recognition of the original feature.
