# Coal Acid Mine Drainage – Passive Treatment Lime Compost Drains – Three abandoned coal mined sites in Southern Illinois

Olga Moya Aranzubía<sup>1</sup>

<sup>1</sup>Illinois Department of Natural Resources, Office of Mines and Minerals, Abandoned Mined Lands Reclamation Division, 503 East Main Street, Benton, Illinois, 62812, United States of America, olga.aranzubia@illinois.gov

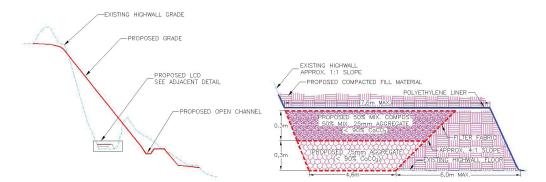
Figure 1 Lime Compost Drain (LCD), Typical Cross Section and Profile, Not to Scale (image: Olga Moya Aranzubia).

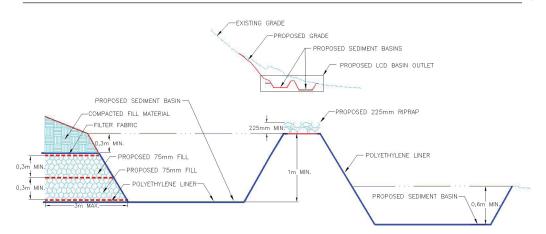
*Figure 2* Lime Cost Drain Basin (LCD), Typical Cross Section and Profile, Not to Scale (image: Olga Moya Aranzubia).
