Passive Treatment of Toe Drain Discharges from a Tailings Storage Facility using an Oxic Granite Bed

Robert Hedin, Jeffery Millgate, Brian Authurs, Ron Nunn Patrick, Vinath Khamsana and Neil Wolfe

1. *Hedin Environmental, USA;*
2. *Phu Bia Mining Company, Lao Peoples Democratic Republic*

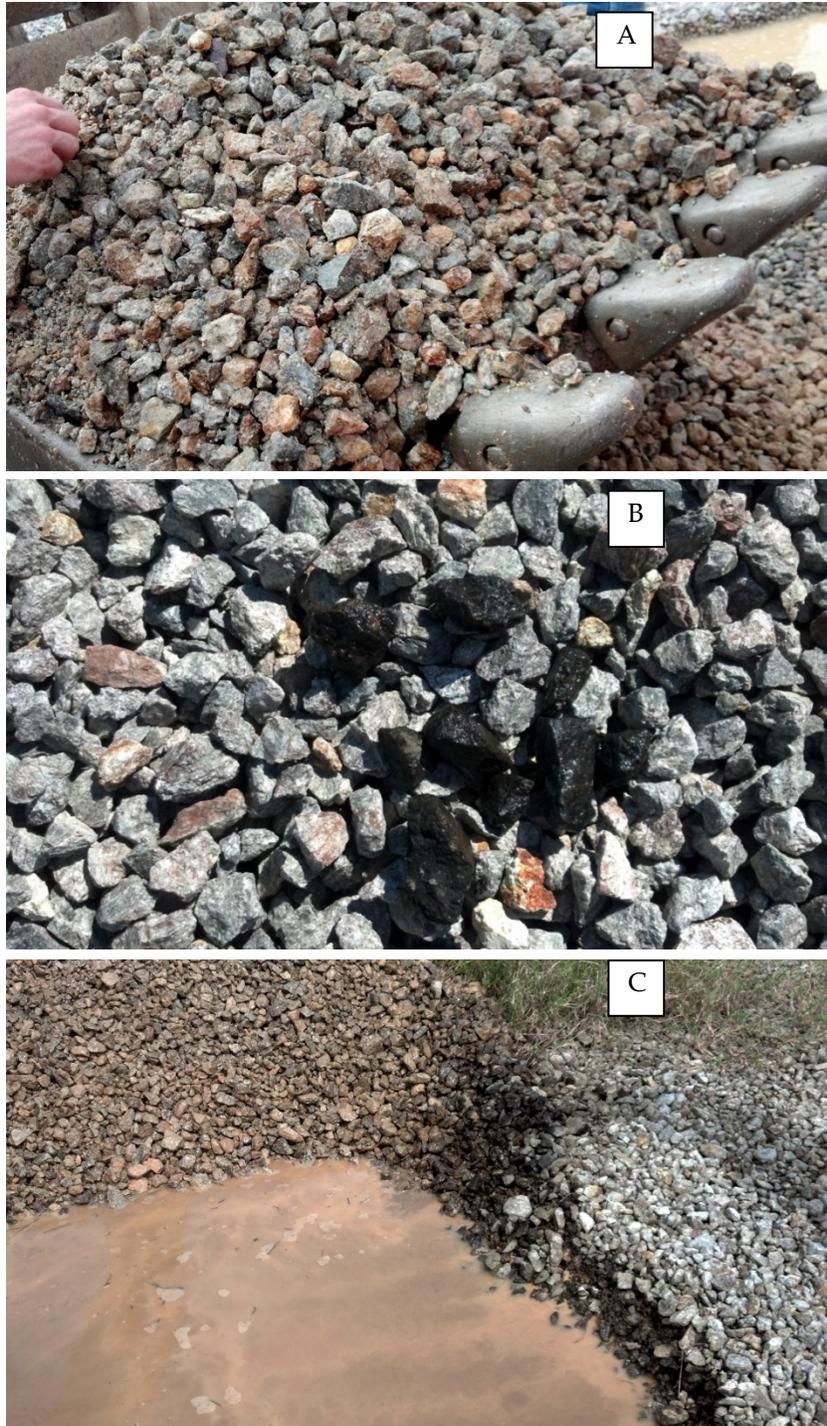
In mid-2014 water was observed flowing on top of a portion of the aggregate bed. In October 2014 an excavator was mobilised to investigate the change in hydraulics and also to investigate the condition of the aggregate. Flow on the top of the aggregate was limited to the first 25% of the bed. The investigation found algal growth on top of the stone that had created a dense biofilm that promoted flow of water on top of it. When the algal growth was disrupted by mixing the stone, water flowed into the aggregate and no longer flowed on the surface. The cause of the algal growth was suspected to be due to settling of the stone in the first portion of the bed, which allowed water on the surface during high flow conditions. During these conditions, algae growth was enabled. As a result of this observation, the effluent of the bed was lowered by 50 cm so that water would never flow on the surface and growth of algae would be inhibited.

The aggregate in the bed was inspected for signs of Mn removal. The raw granite is grey. Mn oxides form a black coating on the rocks. The aggregate in the final 25% of the bed did not have any black coloring, indicating that little Mn removal is occurring in this section (Figure 4a). As the investigation moved forward into the bed, stones stained black became visible (Figure 4b). In the first quarter of the bed, most of the stone in the top 30 cm was black (Figure 4c). The Mn staining was limited to the top 50 cm of the bed. Beneath 50 cm the aggregate retained its original grey color. These observations indicate that little Mn removal is occurring in the bottom 1.5 m of aggregate. When combined with the observations from the end of the bed, it was apparent that only 15% of the aggregate was involved in Mn removal. This condition likely has two explanations. First, removal of Mn is so effective in the first half of the bed that there is little Mn left for removal in the second half of the bed. This explanation suggests there is a large excess capacity for Mn removal in the second half of the bed which will be useful should Mn loadings increase. The observation that there is little visible Mn removal occurring below 50 cm suggests that flow is not well distributed through the bed. As the influent and effluent structures are both at the surface, there is an apparent preference of flow in the top 50 cm of the bed. This condition could be partially corrected by reconstructing the effluent as a perforated pipe placed on the bottom of the bed. There are no plans to make this change at this time.

Figure 4 Aggregate encountered during system investigation. A) clean granite aggregate at the end of the system. B) black Mn-coated granite placed on clean stone to show contrast; C) layer of Mn-coated stone found in the first half of the bed.
