PROBLEMS ASSOCIATED WITH THE RAPID DEWATERING  
OF A MULTILAYERED AQUIFER AND MINING OF A  
TRIAL COAL PIT AT BOWMANS, SOUTH AUSTRALIA

Armstrong D.

Department of Mines and Energy  
191 Greenhill Road  
Parkside 5063  
South Australia

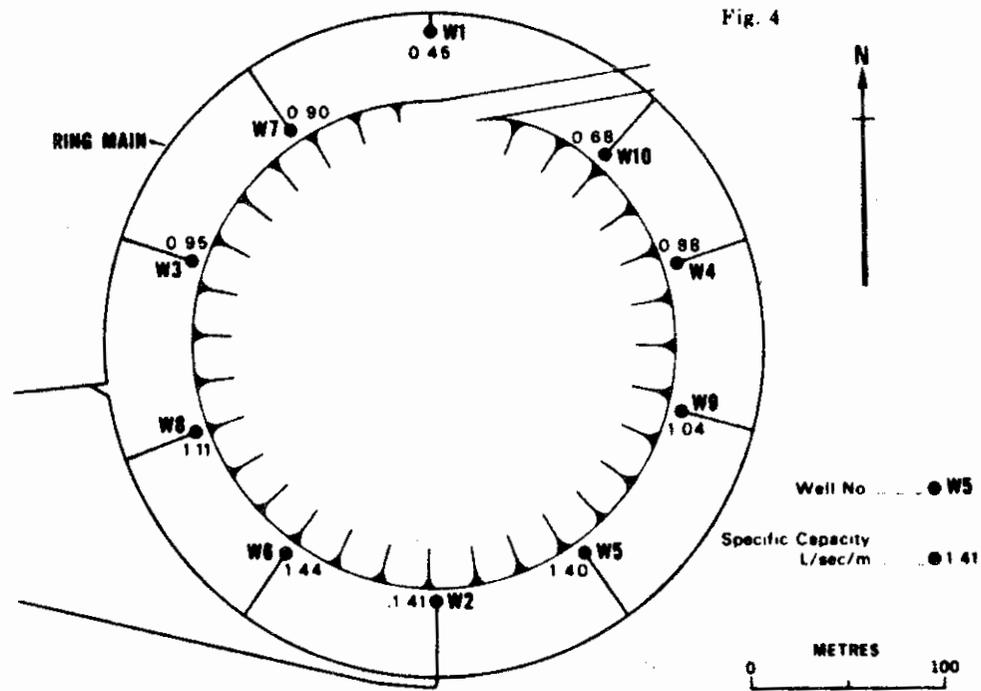
**Figure 4: Specific Capacity of 10 Outer Wells.**

with a minimum value of 0.45 l/sec/m at W1 and a maximum of 1.44 l/sec/m at W6/see Figure 4/. 5 wells were equipped with line shaft driven turbine pumps and 5 with electric submersible pumps with fibreglass column. All 10 wells were operating by mid Jan 1980 with a total pumping capacity of 2201/sec.

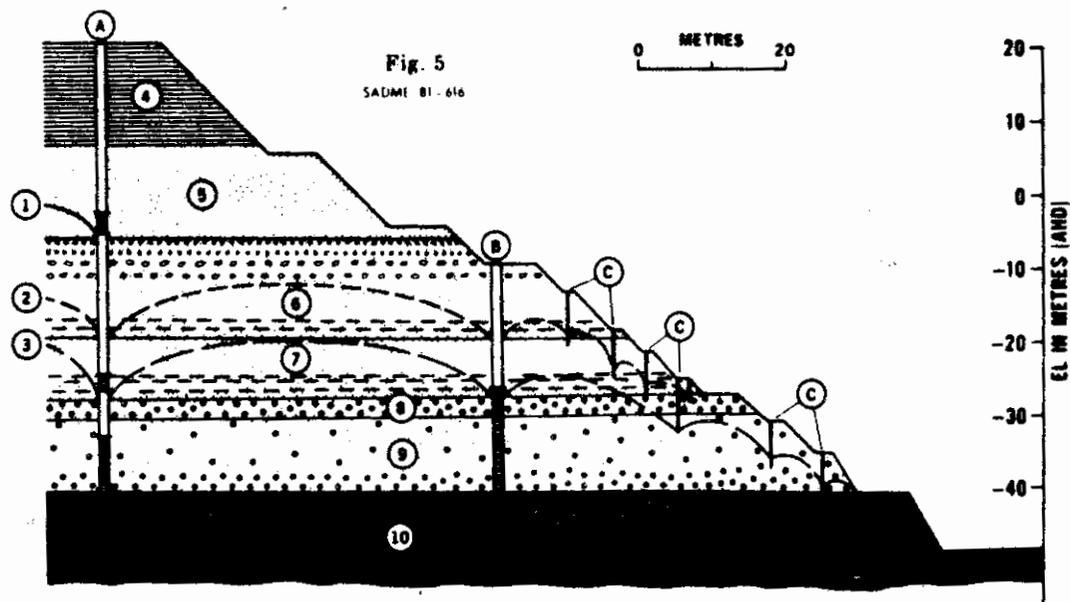
**Figure 5: Wells and Well Points Operating During Final Stages of Mining**  
 A/ Outer Wells  
 B/ In-pit Wells  
 C/ Well Points  
 1/ Water level Aquifer A  
 2/ Water level Aquifer B (upper)  
 3/ Water level Aquifer B (lower)  
 4/ Clay  
 5/ Aquifer A  
 6/ Aquitard  
 7/ Aquifer B (upper)  
 8/ Carbonaceous Sand Aquitard  
 9/ Aquifer B (lower)  
 10/ Coal

In early June 1980 when the major vacuum well pointing began, there were still 23 metres of saturated materials between the pit floor and the top of coal. Careful planning was required to select the most suitable level from which to install each ring of well points so that optimum dewatering effects could be obtained with a minimum of interruption to excavation during the installation of the well points. It should be noted that the well point system removed some of the pumping load from the outer 10 wells and the 11 in-pit wells/See Figure 6/ resulting in problems with the control of water levels in the pumping wells. The final stage of excavation of overburden was achieved with 6 overlapping systems of well points/see Figure 5/ at EL -15, EL - 19, EL - 22.5, EL - 26, EL - 32 and EL - 36 m AHD. An additional system of short well points was installed at EL - 26 in an attempt to control seepage at the base of Aquifer B (upper). Combined discharge from well points reached a maximum of 100 l/sec in August 1980 and declined to between 50 and 60 l/sec during September and October.

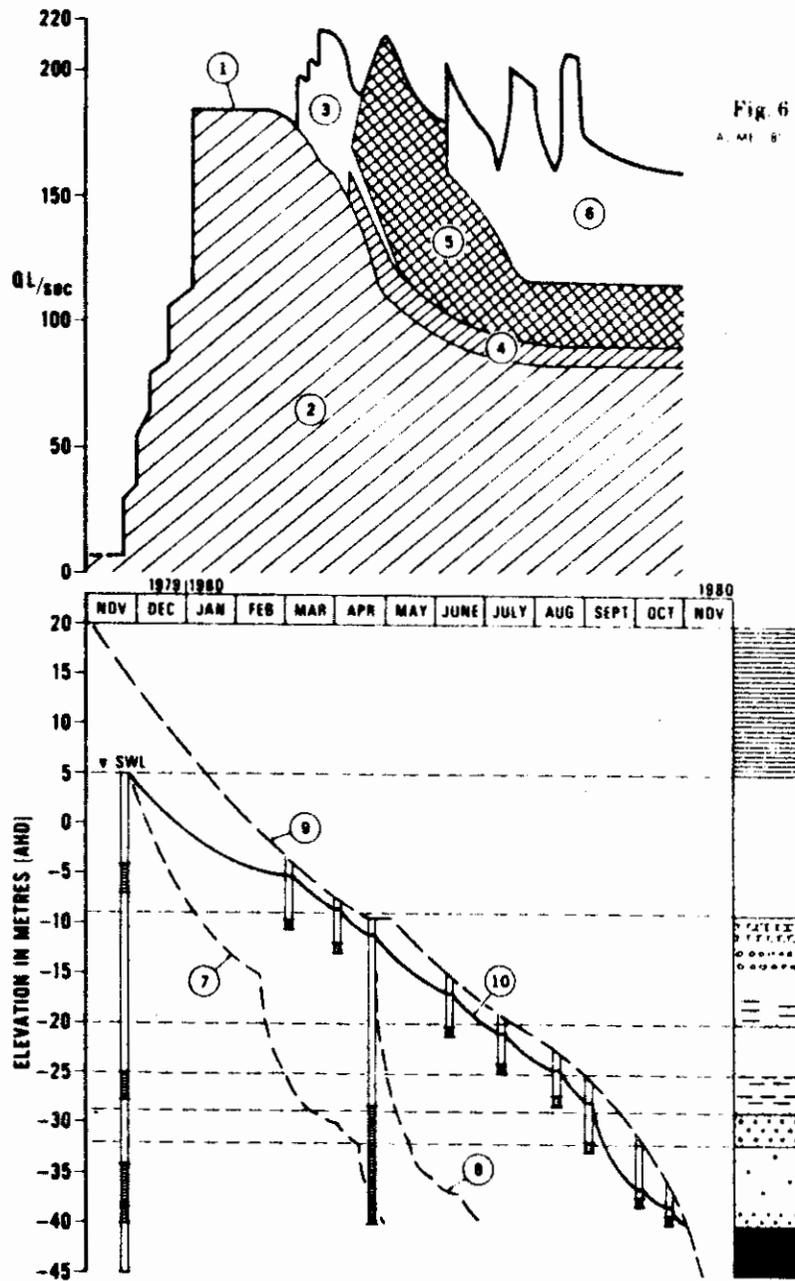
Less than half the anticipated drawdown had occurred by the end of January 1980/see Figure 6/ and the floor of the pit was rapidly approaching the saturated zone. In order to establish a bench at -9m AHD it was necessary to install 2 complete rings of vacuum well points at -5m AHD and -7m AHD. These well points were emplaced by jetting where possible but many required predrilling due to the presence of indurated sands at the base of aquifer A and the top of the aquitard. A combined discharge of approx. 50 l/sec was obtained from the well points/see Figure 6/ and the rate of drawdown was increased sufficiently for the -9m bench to be established in April 1980.

10 outer wells resulted in a drop in production of the outer wells from 160 l/sec to 110 l/sec /See Figure 6/.

**Figure 6: Synopsis of Water Level, Pit Floor Level and discharge during Project**  
 1/ Total discharge  
 2/ Discharge from 10 outer wells  
 3/ Discharge from -5m and -7m well points  
 4/ Discharge from sub-coal aquifer  
 5/ Discharge from 11 in-pit wells  
 6/ Discharge from 6 stages of well points  
 7/ Original design drawdown  
 8/ Modified design drawdown  
 9/ Pit floor level  
 10/ Actual drawdown

Once again actual drawdown failed to match predicted drawdown therefore the hydrogeological model needed revision and more drastic dewatering measures were required to ensure success of the project. Six percussion drilled piezometers were installed from the -9 m bench with careful sampling. These holes revealed the presence of a second aquitard from -29m AHD to -31m AHD, composed of highly carbonaceous sand with extremely small hydraulic conductivity. The six in-pit piezometers, three at the north side and three at the south side of the pit, measured piezometric levels immediately above the coal, below the carbonaceous sand aquitard and in the upper B zone aquifer. The piezometric level above the coal was found to be seven metres lower than in the upper B zone aquifer indicating that the 11 in-pit wells were depressurising the lower B zone aquifer but were having only a very limited effect on the upper B zone aquifer. It was clear that further progress in dewatering required a concentrated effort within the pit. Vacuum well points were selected as the best way of achieving dewatering and pit wall stability. Each ring of well points, though having the theoretical capacity to lower the water level by up to 6 metres, was found in practice to achieve 2 to 3 metres of drawdown within 7 days of commissioning and 5 m of drawdown approximately 3 to 4 weeks later.

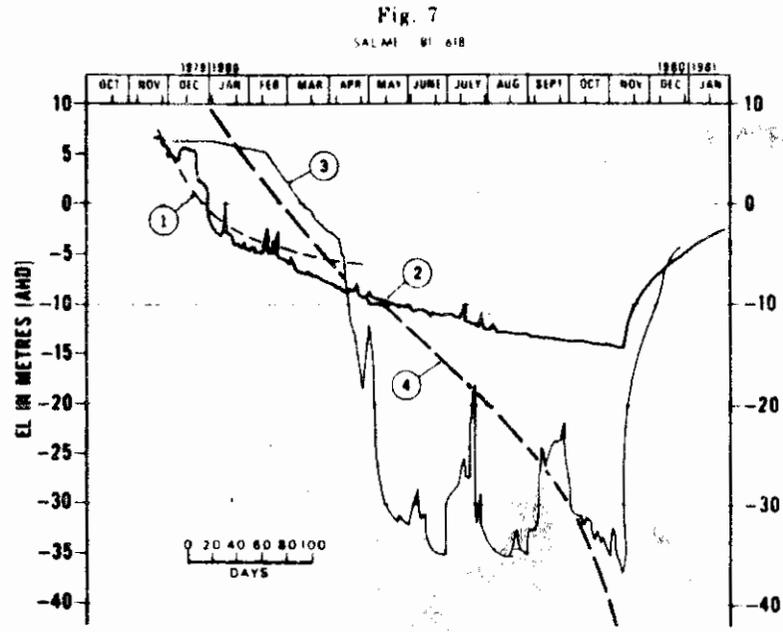
Figure 7: Typical Piezometer Behaviour  
1/ Aquifer A  
2/ Aquifer B  
3/ Piezometer D (Sub coal Aquifer)  
4/ Pit Floor Level

It was necessary to depressurise aquifers C and D, whose piezometric levels were similar to Aquifers A and B, in order to prevent uplift of the floor of the pit. This was achieved by constructing 5 wells which were pumped at a combined discharge of 10 l/sec and satisfactorily controlled pressures to the required levels/see Figure 7, piezometer D/.

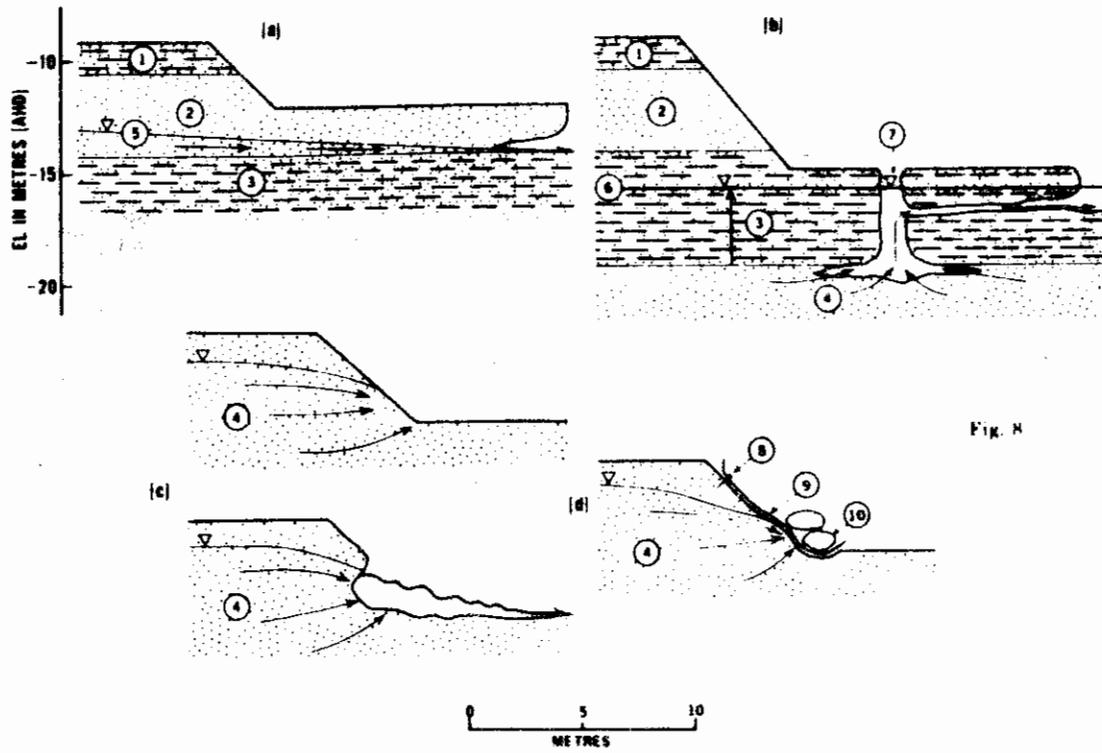
Fig. 8

Three major modes of failure were observed in the walls and floor of the pit. All were due to poor drainage or the development of high pressures associated with the horizontal layering in the materials.

Horizontal piping occurred at the toes of slopes where slightly more permeable material was subjected to a hydraulic gradient of more than five percent. /see Figure 8a)/. Collapse of horizontal pipes in several cases resulted in bench failures which were repaired by inserting a P.V.C. pipe into the natural opening and back filling with sand or gravel. The restored slope was then supported by drainage fabric (either filter cloth or hessian) and sand bags.

Vertical piping /see Figure 8b)/ was occasionally associated with horizontal piping where auger holes, drilled to determine water level beneath the pit floor,

had disturbed the horizontal layering permitting the flow from a lower aquifer to feed a horizontal pipe.

Slumping of newly cut faces occurred when drainage was incomplete, again governed by the horizontal layering. Filter cloth was layed over the lower part of the slope, held in position by metal pegs driven into the upper part of the slope. Sand bags were then placed on top of the filter cloth at the toe of the slope to prevent excessive movement of sand and to allow gravity drainage to occur. (see Figure 8 c) & d)/. The most concentrated repair work was associated with the seepage problem at the base of Aquifer B (upper) where the carbonaceous sand aquitard effectively prevented vertical drainage.

Figure 8a: Horizontal Piping Failure  
Figure 8B: Vertical Piping Failure  
Figure 8c: Face Slumping in Fine Sand  
Figure 8d: Slump Prevention  
1 and 3/Silty sand  
2 and 4/Fine sand  
5/ Water level in fine sand  
6/ Piezometric level in underlying fine sand  
7/ Vertical pipe at site of auger hole  
8/ Steel peg  
9/ Drainage fabric  
10/ Sandbags

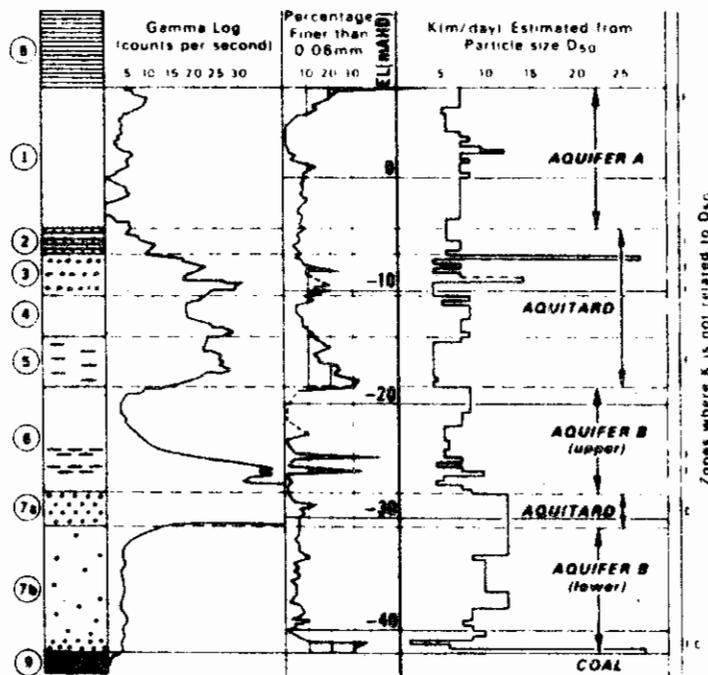
Fig. 9

During the final stages of mining the pit was mapped geologically by ETSA personnel [1] and a continuous series of 147 samples of all pit wall materials was collected. These samples were subjected to grain size analysis. The percentage silt size material (<0.06 mm) was compared with the natural gamma radiation logs from drillholes located close to the sample sites/ see Figure 9/. Hydraulic conductivities based on the median grain size ( $MD_{50}$ ) were also calculated/see Figure 9/ using the method of Masch and Denny [2]. Where silt content exceeds ten percent it is likely that the hydraulic conductivity of the material is controlled by the silt fraction, regardless of the median grain size eg in the aquitard separating Aquifer A and Aquifer B (upper). The gamma log is generally a good indication of silt content and is thus a good indicator of horizontal layering. The right hand column of figure 9 shows intervals in which hydraulic conductivity (K) is not proportional to  $MD_{50}$  together with an indication of the reason for the reduction in K. The carbonaceous sand aquitard separating aquifer B (upper) and B (lower) shows a very high gamma log response which is not related to silt content but is probably due to uranium associated with the carbonaceous material. A zone of reduced K which has no gamma response is the 2 metre thick zone of indurated sand between EL - 5 and -7 metres AHD. Carbonaceous fines immediately above the coal appear as a zone of greater than ten percent silt which has no gamma response.

In general terms the face sampling programme has shown that the gamma log is a good indicator of horizontal layering which, coupled with careful sampling of percussion holes should permit the construction of a more valid hydrogeological model. The suggested model for Bowmans overburden materials is:

Figure 9: Log of Pit Wall  
1/ Fine sand  
2/ Fine sand, 40% of interval indurated  
3/ Very fine sand with gravel bands  
4/ Fine sand  
5/ Silty sand  
6/ Fine sand with 2 silty bands  
7a/ Carbonaceous sand aquitard  
7b/ Slightly carbonaceous sand, medium grain size  
8/ Clay  
9/ Coal

- Aquifer A from 6 m to -4 m AHD; K 6m /day
- Aquitard from -4 to -19m AHD; K vertical = 0.01m/day
- Aquifer B (upper) from -19 m to -28 m AHD; K = 5m/day
- Aquitard from -28 m to -30 m AHD; K vertical = 0.001m/day
- Aquifer B (lower) from -30 m to -42 m AHD; K = 8m/day
