# Collapse of the adit “Rothschoenberger Stollen” as a result of the flood on 12 /13 August 2002

**Dr.-Ing. Jürgen Weyer**

Institut für Bergbau, TU Bergakademie Freiberg, Germany, 09596 Freiberg, Zeunerstraße 1a

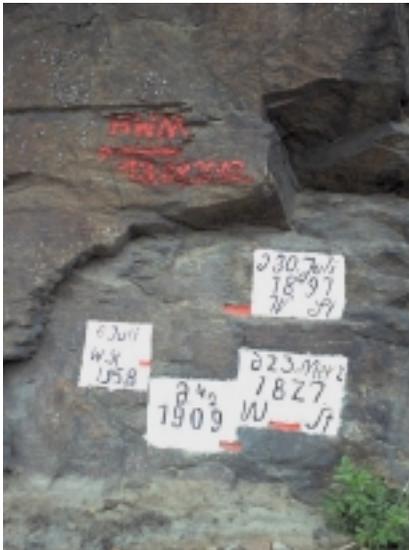
Figure . Recorded flood levels

The firefighters were not able to pump out houses; the only thing they could do was the closure of roads and the rescue of people from drowning. At the night the water exceeded the highest ever recorded level of 1897 by about 50 ... 60 cm.

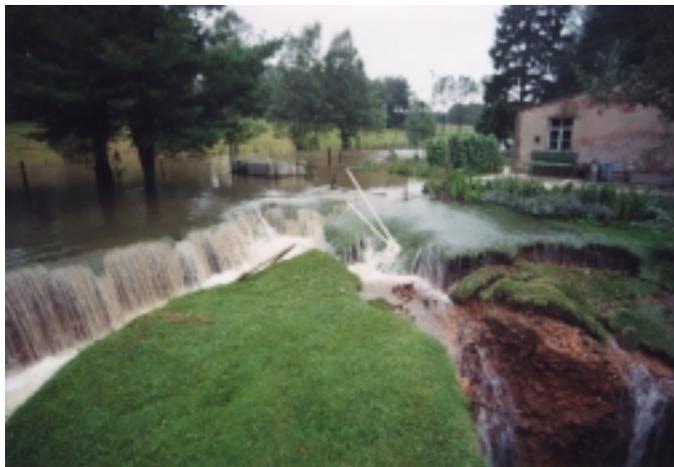
Figure 4: Breakthrough of the creek "Muenzbach" into old openings

Water from the river Mulde flowed into the adits, the creek "Muenzbach" broke through from the surface to underground openings.

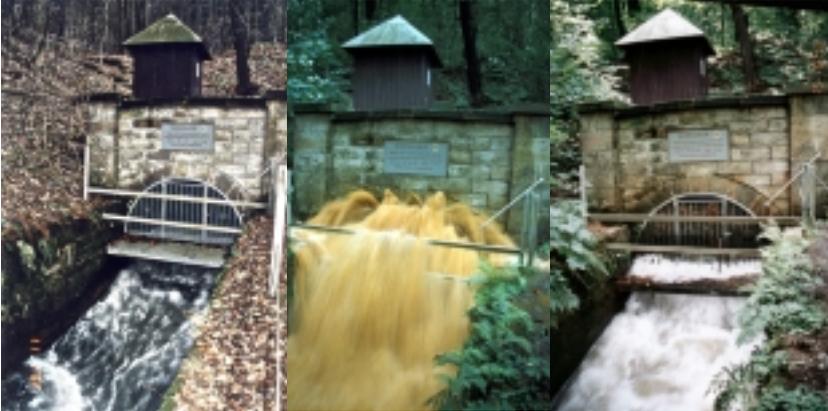
Figure 5: Outflow from the adit before, during and after the flood

The left picture shows an outflow of about  $1.1 \text{ m}^3/\text{s}$  in spring 2002 (which was one of the highest recorded levels). The picture in the center shows the outflow on 13 August 2002. The measuring instruments stopped measuring at  $10 \text{ m}^3/\text{s}$ , but we assume that  $12 - 15 \text{ m}^3/\text{s}$  left the adit. The re-calculation of the volume flow using the parable equation (parable of the water) gives some  $25 \text{ m}^3/\text{s}$ .

Miners from the teaching mine went into the shaft via the hoisting cage and suddenly stood in the water, without a possibility to communicate with the hoisting engine. At the mouth of the adit Rothschoenberger Stollen the water came out of the entire cross section of about 6 m<sup>2</sup>, but suddenly the volume flow declined to an almost normal level. At the same time the water level in the shaft "Reiche Zeche" was several meters above the adit level, giving an indication that an obstruction or collapse must have occurred.

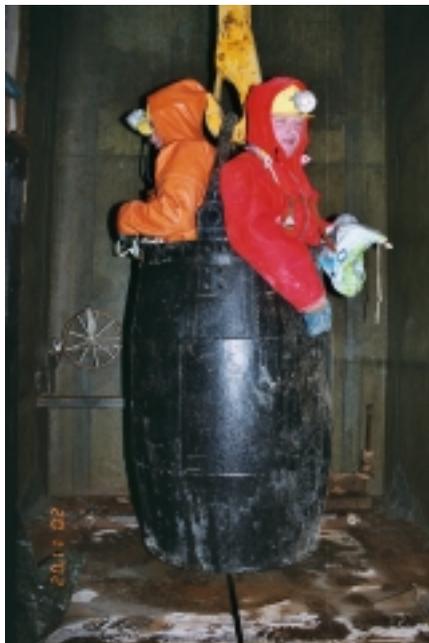
Figure 6: Hoisting bucket in shaft #8

The highest water level observed at the shaft “Reiche Zeche” was 23 m above the bottom of the adit “Rothschoenberger Stollen”. Although it was assumed, that the adit collapsed in the region of the ore vein “Halsbruecker Spat”, nobody knew what exactly happened and where it happened. There was always the risk that our boats – formerly fastened in the adit – or wood or other support (bricks, steel) caused an obstruction, which could break through, even if the water level sank. For this reason it was too dangerous to start the exploration from the air side, i.e. the mouth of the adit, immediately. A project group was formed by the Mining Supreme Authority in cooperation with the Institute of Mining Engineering of TU Bergakademie Freiberg, which coordinated all further work. As a first step the water levels at the air side and the water side (in the shaft “Reiche Zeche”) and the volume flow in the adit were measured for some weeks. The approach to a water level to about 3.50 m above the bottom and the comparison with volume flows in the adit over the last 3 years gave the go ahead for the first exploration of the obstruction or collapsed area. Meanwhile private persons had been in the adit. According to these persons, the adit collapsed at the intersection of the mentioned ore vein. Nevertheless it might be possible for private persons to descend to the adit. However, this is not allowed for employees according to strict safety regulations. For this reason first of all the shaft #8 had to be reopened. The entrance via ladders was not possible, some ladders and cross members in the shaft were damaged and weak. After considering different possibilities a temporary hoisting machine with a 400 l bucket was installed.

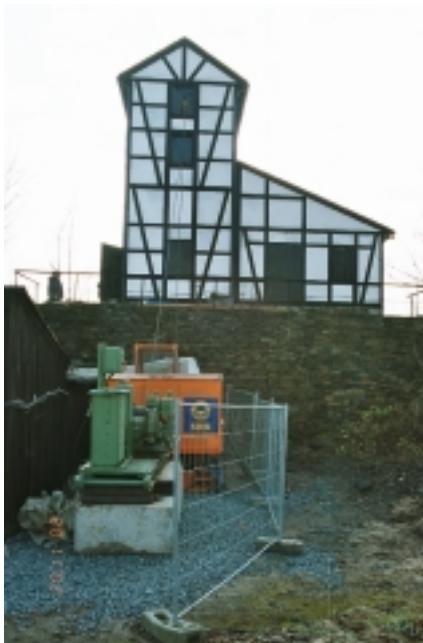
Figure 7: Hoisting machine at shaft #8

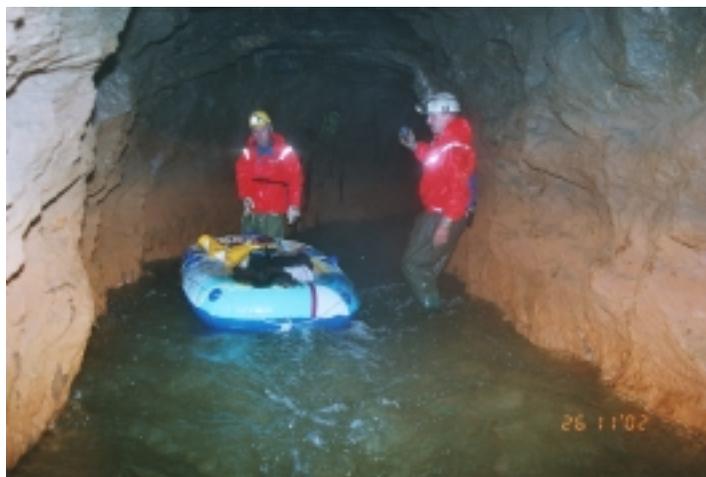
After 40 m the first rock mass which settled in the adit can be seen.

Figure 10: Settled rock mass (under water)

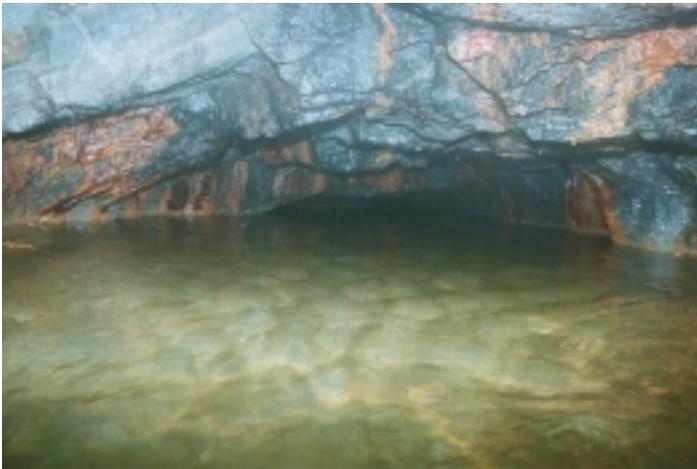
Figure 12: Rock mass and water filling the entire cross-section in the bypass

The exploration was repeated with compressed air bottles. Nevertheless it was not possible to reach the point, where the roof collapsed, because the settled rock mass became higher and higher and the remaining free space above water decreased.

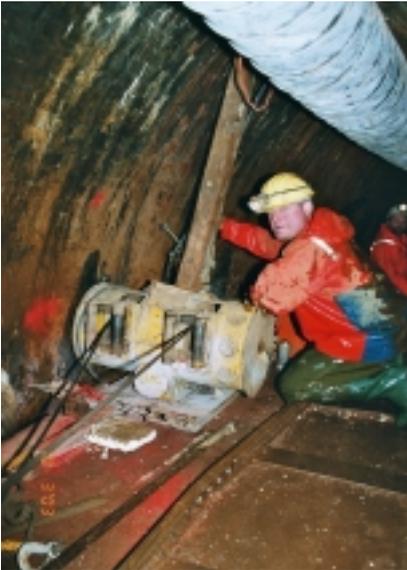
Despite some doubts of some people, the scraper was built in. The winch (11 kW power) was put on a wooden bearing, built in some cm above the water surface at a length of 40 m from the shaft #8 to the beginning of the rock settlement in the adit.

Figure 16: Scraper

The operation of the scraper was very successful. The fear that material could swap over the ramp was unfounded. Only wooden props and single big rocks had to be removed by hand. The material mainly consists of gneiss, sandy material, material from the ore vein, single bricks and steel members. The age of the props was determined in the laboratory. It could be shown, that this wood is 358 – 360 years old. Obviously this originated from an old stope.

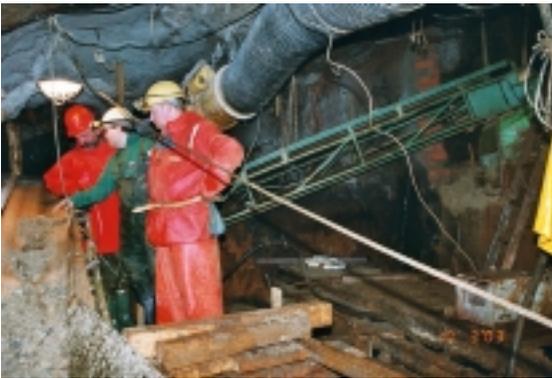
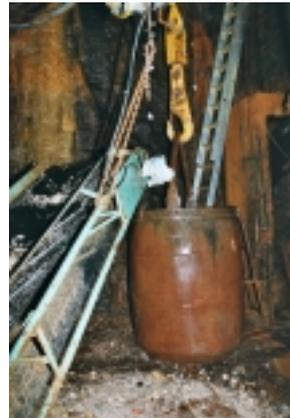
From the wagon the material is supplied to a short conveyor belt, which fills the material into the hoisting bucket.

Figure 19/20: Conveyor belts loading the bucket

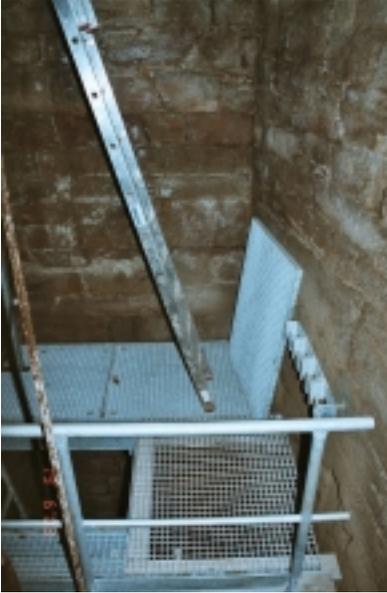
After the removal of the first rock from the adit the restoration of the shaft #8 was enforced. The old cross members and ladders were removed and new once built in.

Figure 21: New ladders and stages

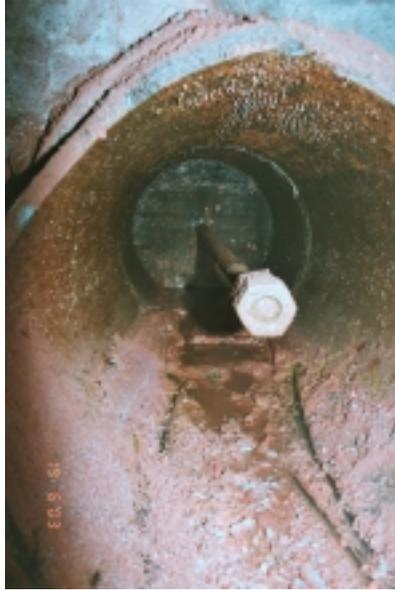
Figure 22: Manhole in the dam

Parallel to this some holes were drilled carefully in the dam at the north end (air side of collapsed area), but surprisingly not much water – or almost no water came out. For this reason it was decided to open the dam completely in June 2003. With the former removal of the rock in the straight part of the adit, the water level was lowered by about 1 m. Now the manhole in the dam could be seen. Unfortunately this cast-iron manhole could not be opened. So the bricks of the dam had to be removed. At first the Mining Authority did not allow any blasting, but revised its decision on a special request. On 26/06/2003 the last bricks were blasted using detonation cord. The next 20 m up to the hand-set backfill consists of waist-high mud. The face of the backfill was stable, only at the sides some water came out.

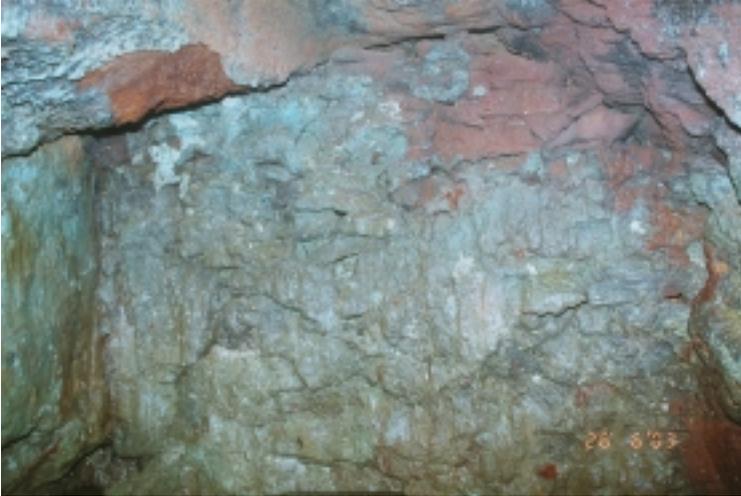
Figure 23: Stable face (gneiss plates in the vein region)

In July the removal of the mud started. For safety reasons it was planned to stabilize the face (gneiss plates) with shotcrete. Then holes should be drilled into the vein and through the gneiss plates into the former path of the adit. It was hoped, that the water level on the water side could be lowered. Depending on the results the gneiss plates will be rebuilt with or without a protecting injection around the region. With the following opening of the south dam the functionality of the adit will be established. Only then the restoration of the collapsed area can start.

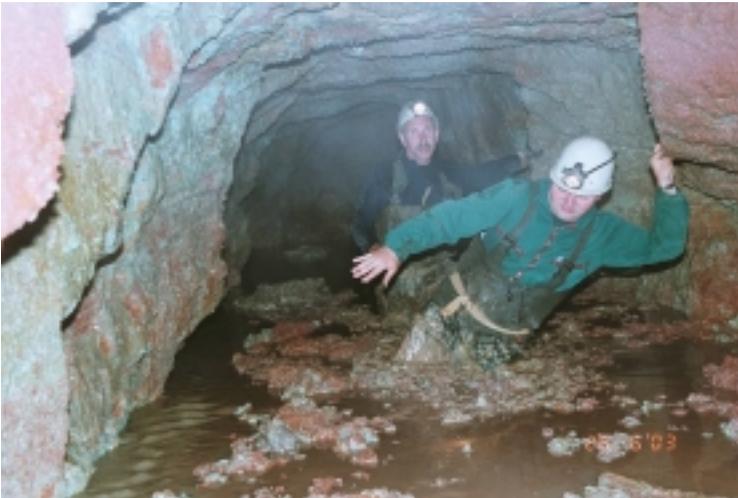
Figure 24: Walking in the mud (behind blasted dam)
