## Remediation of the Gowrie Wash Plant

Dave FORRESTER<sup>1</sup>, Mark KING<sup>2</sup>, Jeff HILCHEY<sup>1</sup>

**Abstract** Three centuries of commercial coal mining of the Sydney Coalfield has left a lasting legacy in Cape Breton, including the Gowrie Wash Plant, the site of a former coal washing facility, where a large stockpile of waste rock remained on site after operations ceased. Over time the waste rock pile eroded and weathered resulting in acid rock drainage which adversely impacted local groundwater and surface water. This paper outlines the remedial approach taken (from Phase I to VI) at the Gowrie Wash Plant site. The final solution is a shaped repository of waste material with an engineered cap surface which includes groundwater and surface water collection and treatment.

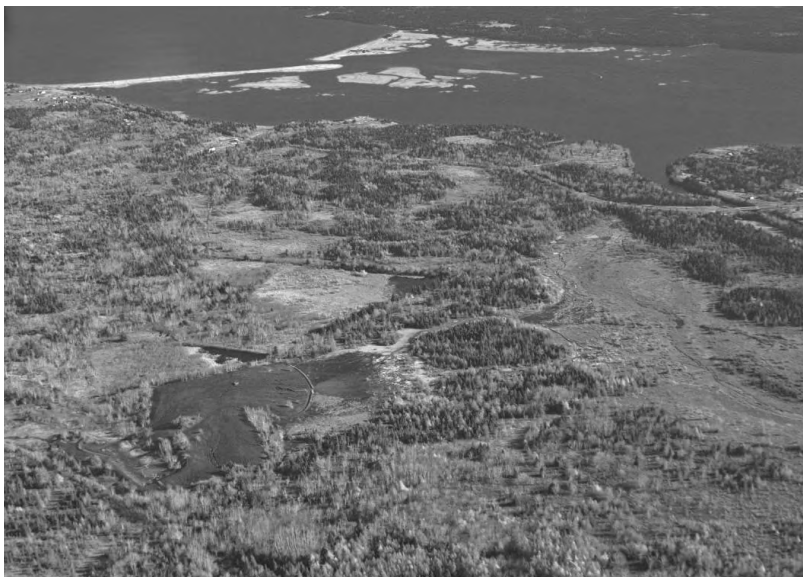
*Figure 1 Aerial view of the waste rock pile at Gowrie Wash Plant prior to remediation*

The Gowrie Wash Plant was constructed by the Dominion Coal Company in 1893 and was used for washing of coal from the Gowrie Colliery, located nearby. During its operation, coal was transported to the wash plant by rail, where it was washed and bagged for sale on the domestic residential market. The resulting wash water and coal fines were carried via flume and ditch to the southeast into Morien Bay. Operations were abandoned in 1897 leaving behind over 170,000 cubic metres of waste rock in a pile that has slowly eroded and weathered over the years, silting drainage courses and producing numerous seeps of acid rock drainage. Coal fines accumulations are also evident around the edge of a large natural wetland area located downstream of the waste rock pile. The waste rock pile before remediation is shown on Figure 1.

The preferred remedial option just described was then constructed. Materials were imported from local sites and placed within the footprint at Gowrie in 2008 and 2009. The final shaping and capping were completed in early 2010. The post-construction monitoring phase has now begun. A comparison of figures 1 and 3 shows the dramatic improvement in appearance of the site has been achieved.

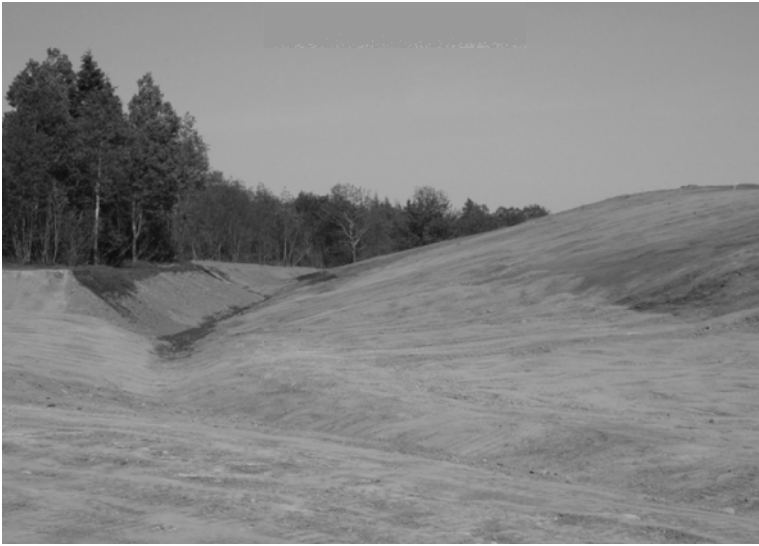
*Figure 2* View of the re-profiled pile prior to placement of the engineered cap

The preferred option for the engineered cap consisting of the following layers, in ascending order: a rough graded top of waste surface, a 150 mm sand bedding layer, a 1.5mm HDPE liner, a geocomposite geonet drainage layer, a 600mm compacted layer of glacial till with the upper part having soil amendments to be covered with hydraulic seeding. The cap is shown during construction on Figure 2.

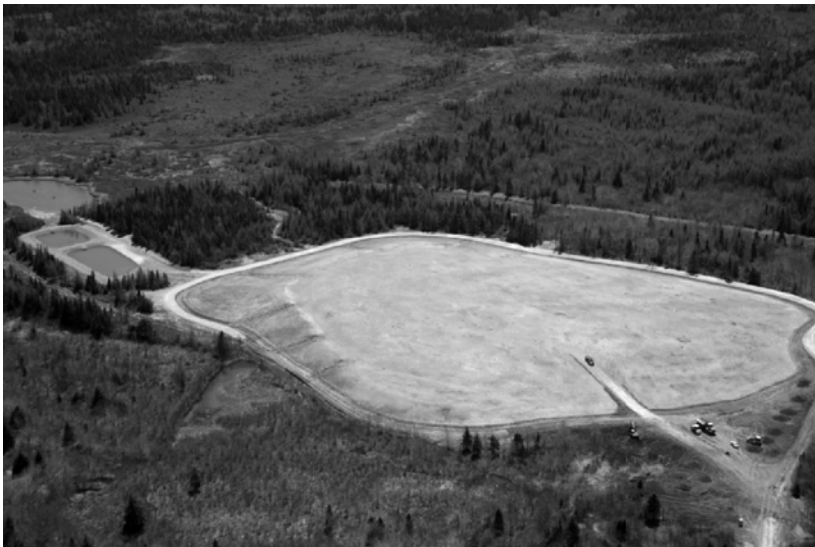
*Figure 3* Aerial view of the reclaimed waste rock pile, May 2010

The cap construction was commenced in late 2008 with the import of approximately 170,000m<sup>3</sup> of similar waste rock and coal fines materials from several local sites within 20km radius. Former rail track beds were used where practicable for haulage to minimize truck traffic through nearby communities. The final consolidated, reshaped and capped pile reached substantial completion in spring 2010, see Figure 3.
