Surface water management and encapsulation of mine waste to reduce water pollution from Frongoch Mine, Mid Wales

Paul Edwards, Tom Williams, Peter Stanley

Abstract

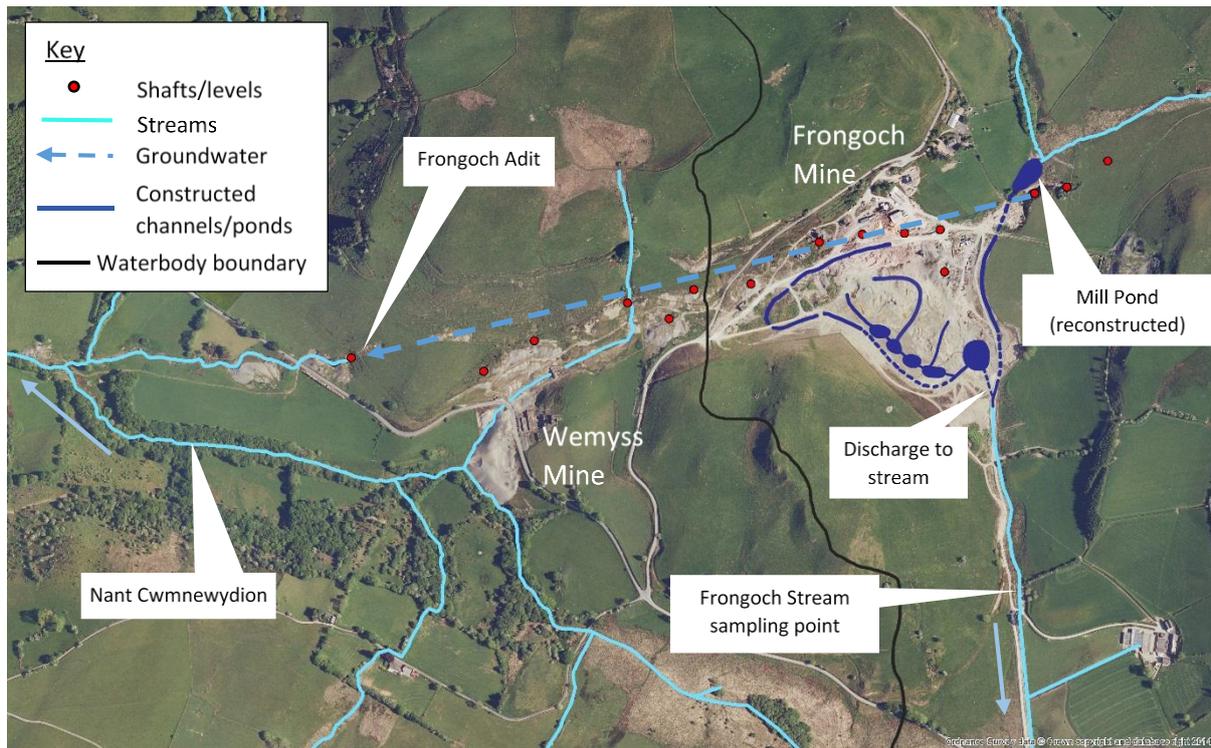
Figure 1 Aerial photo of Frongoch and Wemyss mines in 2009 showing surface and groundwater pathways, including channels and ponds constructed from 2011 to 2015.

Mineral ownership at Frongoch belonged to the Earls of Lisburne and mineral rights changed to the west of the watershed, where the same lode was mined at Wemyss Mine (Fig.1). A lease of 1759 is recorded, though Frongoch remained a small mine until 1790, when new management invested. The mine operated initially as Bron-y-Goch and Llwynwnwch mines, but the most successful period was 1834 to 1874, when the two leases were consolidated (Bick 1996).

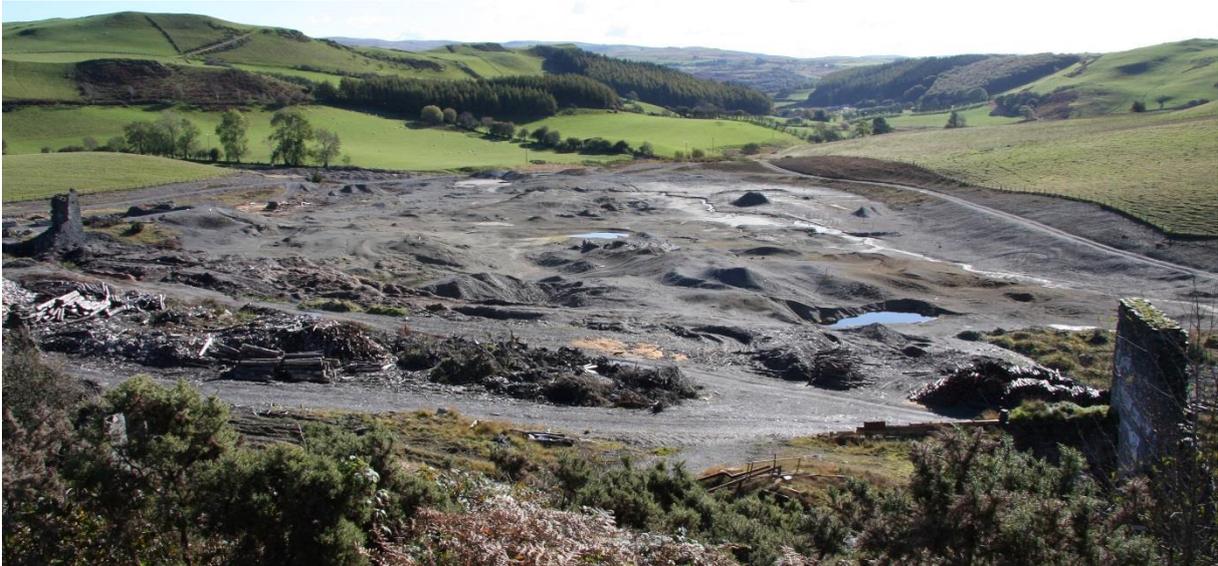
Figure 2 Photo of Frongoch Mine looking from north west to south east in October 2010.

In total over 23,000m² of the site was afforded a lower permeability cap during the Phase 2 works, and validation testing provided confidence that this was compacted sufficiently to attain the permeability requirement of 1x10⁻⁸m/s. Topographical surveys confirmed an average clay thickness of 396mm, with over 450mm in some areas (up to 50% greater than required), which adds to the overall performance of the cap. The effect of the remediation on the landscape can be seen in Figures 2 and 3.

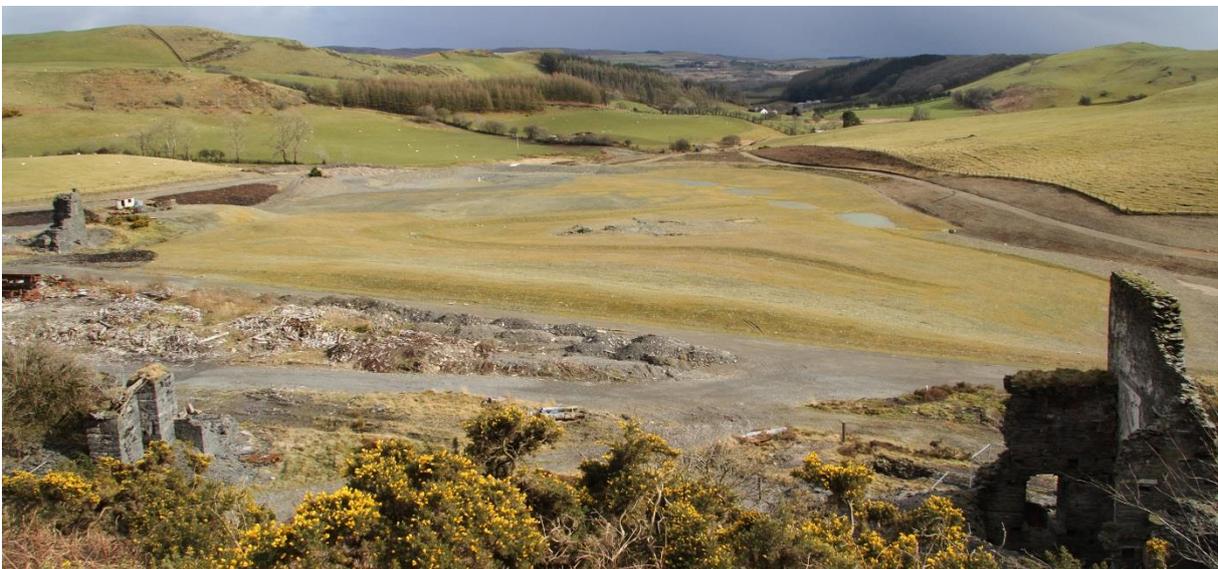
Figure 3 Photo of Frongoch Mine looking from north west to south east in April 2016.
