Holistic Approach to Reed Bed Management on UK Coal Mine Water Treatment Schemes

Arabella M. L. Moorhouse-Parry, Stephen A. Smithson and Christopher J. Satterley

The Coal Authority, 200 Lichfield Lane, Mansfield, Nottinghamshire, UK, NG18 4RG

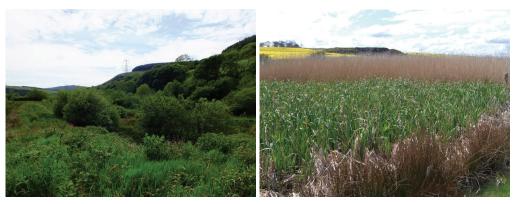
Figure 1 Overgrown reed bed with trees and scrub at Whitworth A&B, South Wales (left), vs. mixed plant (Typha sp. and Phragmites sp.) maintained reed bed at Allerdean Mill, Northumberland (right)

A common misconception in the early days of reed bed management was that these natural systems could be operated with a "minimum amount of attention and money" if they were "properly designed and constructed" (Hedin et al., 1994). This statement has been taken somewhat literally at many sites in the past, with often little, to sometimes even no maintenance taking place. Operational experience in the UK has shown that this lack of intervention inevitably results in a reduction in treatment efficiency of a reed bed. Ochre and organic debris accumulation increases over time, reducing the freeboard of water. This can result in water over topping the reed bed bunds, which can cause localised flooding with part treated mine water if not promptly rectified. Furthermore, the accumulation of detritus in the reed bed combined with a reduction in water depth, allows natural plant succession to take place, with invasive trees (e.g. alder and birch) and shrubs (e.g. gorse and hawthorn) often colonising reed beds and, over time, out competing the reeds (fig.

1). These larger terrestrial plants not only have the potential to damage the infrastructure of the reed bed itself if left unchecked, with the roots breaching liners (clay or plastic), but also cause preferential flow pathways to develop, reducing treatment performance further.

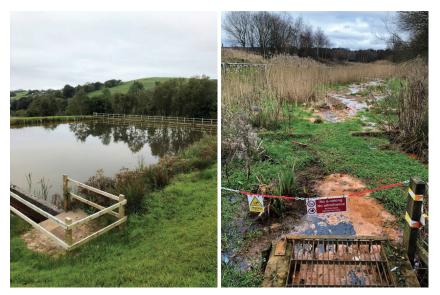
Figure 2 Old Meadows, Lancashire, where the reeds failed to recover following a reed cut (left), and Chell Heath, Stoke-on-Trent, where grasses and thistles have out competed the reeds (right)

When the Truxor was first deployed at Coal Authority sites, the blades were set at the lowest level, water levels were increased, where possible, so that the machine would float, and the reeds were cut at the water level. This procedure had the disadvantage that when the reed beds were full of detritus, the rhizomes were at risk of being pulled out of the substrate. Furthermore, any surviving reed stems were often drowned as the water level was too high. Both of these outcomes resulted in the reeds failing to recover, with either a few plants surviving around the edges of the reed bed, or the reed beds becoming devoid of plants altogether, examples include the reed beds at Sheephouse Wood and Old Meadows, Lancashire (fig. 2).

In addition to controlling water levels during routine maintenance activity, another key consideration for managing water levels is to minimise invasive plant species (e.g. grasses) from colonising reed beds. If water levels are kept too shallow, common grasses can get a foothold in a reed bed and in some circumstances, out compete the reeds e.g. Chell Heath, Staffordshire (fig. 2). Freshly planted reed beds are most at risk of this, however, if reed cuts are too brutal, the plants can be weakened, allowing other plant species to establish. Water depths in Coal Authority reed beds are generally maintained at a minimum depth of 300 mm to help mitigate this risk.

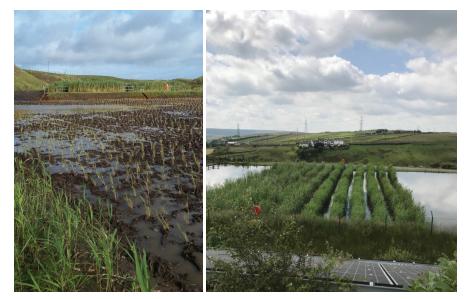
Figure 3 Individual planting of young plants at Pool Farm, Scotland (left), which failed to establish vs. acclimatised reeds replanted in rows at Deerplay, Lancashire (right)

Reeds used to be planted individually and evenly spaced $(3-4 \text{ plants per } m^2)$ across the reed bed (fig. 3), however, this offered limited protection to plants from the

prevailing weather conditions, and exposed them to greater risk of predation from birds (as happened at Summersales, Lancashire and Kimblesworth, County Durham). This methodology has been replaced by planting reeds together in rows (fig. 3), with the tops of the plants kept above the minimum water outlet level of the reed bed. Planting the reeds close together affords the plants greater protection from the weather, and reduces the risk of the tender plants being eaten by geese in the winter months, before they become fully established. Where predation from birds is a known risk, young reeds are planted into hessian mats and grown to ≈ 50 cm in height before being taken to site. This minimises the risk of the rhizomes being pulled directly from the growing media by the grazing birds.
