Stream restoration solutions for challenging environments

Mary Beth Berkes

GAI Consultants, Inc, 385 E Waterfront Drive, Homestead, PA, USA, m.berkes@gaiconsultants.com

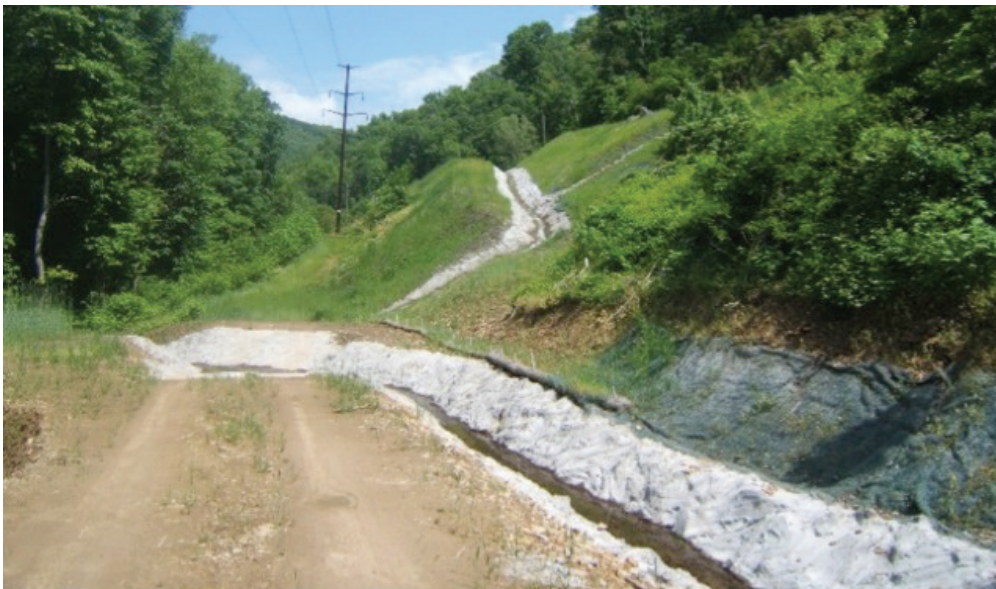
Figure 1 Riprap used for Conveyance on Reclaimed Land in West Virginia

Surface water management on reclaimed land often requires conveyance of flows down hillsides with slopes exceeding 20%. Trapezoidal channels at a constant slope with a manufactured lining have been used to manage conveyance on reclaimed lands. An example of riprap drainage for stormwater conveyance in West Virginia is shown in Fig. 1.

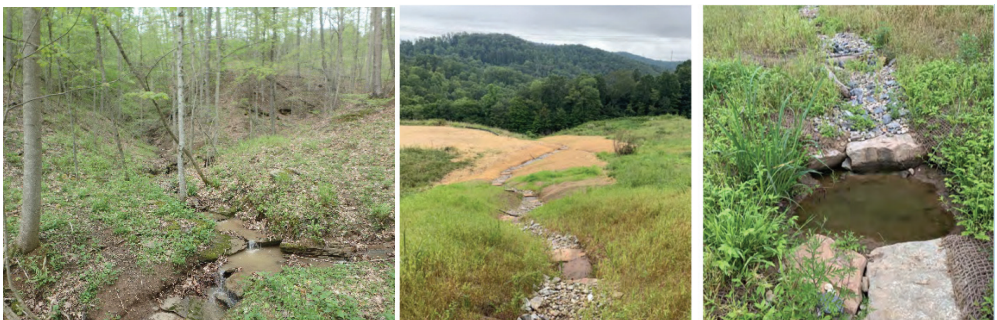
Figure 2 Reference Reach (Left) and Constructed Step Pools (Right) for Headwater Streams

The reference reaches utilized for this case study are located on comparable landscapes to the design reaches, have watershed sizes ranging from 0.008 to 0.009 km² (2.1 to 2.3 ac), and exhibit slopes of 16% and 22%, respectively. Longitudinal profile data, or data plotted along the stream bed showing slopes and locations of riffles, steps, and pools for each reference reach, was collected using a transit (laser) level. The reference reach with the 16% slope was found to have pools spaced at 3 to 7.5 times the bankfull width (or channel forming flow width), and the reference reach with the 22% slope was found to have pools spaced at 1.2 to 4.2 times the bankfull width. Thus, for the project reach step pools were designed for placement at 2 to 7.5 times the bankfull width for consistency with the reference reach ratios. In a similar manner, the reference reach data was utilized to establish step heights, or the amount of drop down to each pool. For the reference reaches, step heights ranged from 0.10 to 0.60 m (0.33 ft to 2.0 ft), or 0.7 to 4.3 times

the mean bankfull depth. Thus, step heights for the project stream were designed to have heights of 0.5 to 4.0 times the mean bankfull depth. A reference reach and the constructed step pools are shown in Fig. 2.

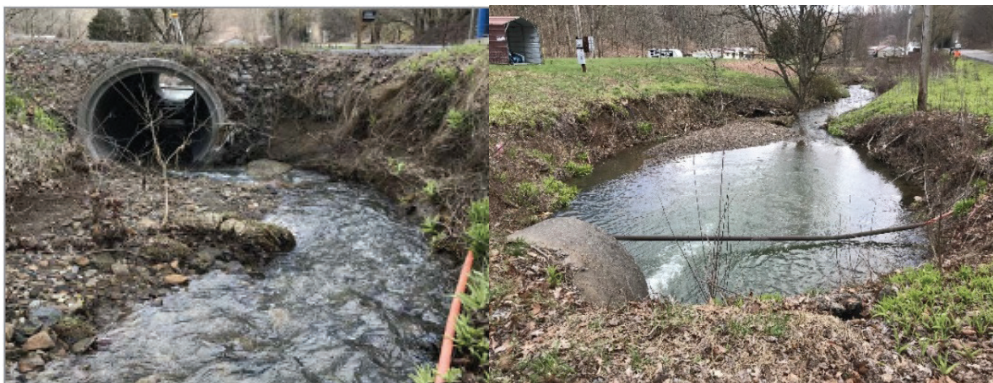
Figure 3 Obstructed Conditions at an Undersized Culvert Inlet (Left) and Outlet (Right)

culvert combined with accelerated sediment transport resulted in aggradation and bank erosion upstream of the culvert and an unnatural scour hole downstream of the culvert (Fig. 3). These conditions were a barrier to fish passage due to the drop in elevation at the culvert outlet and a hazard to the community as the roadway and driveway overtopped during storm events.

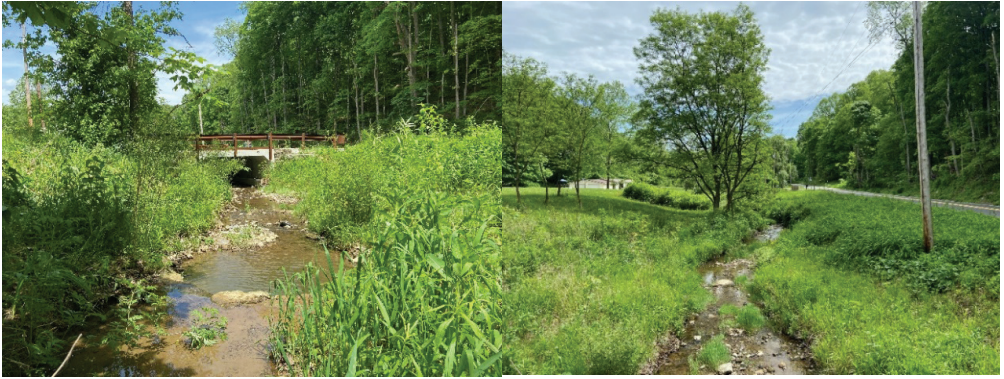
Figure 4 Restored Conditions at Stream Inlet (Left) and Outlet (Right) During Year 3 Monitoring

The implemented stream restoration included replacement of the existing circular culvert with an open bottom box culvert. A dissipater pool, which is a circular shaped energy dissipater filled with riprap and gradual transitional slopes at the downstream end, was installed at the culvert outlet. The dissipater pool was designed to have dimensions comparable to similar pool structures within the restoration reach. The dissipater pool was constructed by placing boulders in a circle around the perimeter of the pool, which results in a pool that creates a natural environment for energy dissipation at the outlet as opposed to a traditional riprap apron. The streambed elevation at the culvert outlet has remained constant through four years of monitoring, thus the dissipater pool has been an effective form of grade control. However, the open bottom culvert did not include fish baffles or grade control at the upstream entrance and degradation of the stream bed, in the form of sediment transport downstream, has occurred at the culvert inlet. This trend is evidenced by the stream bed elevation at the inlet decreasing by up to 0.30 m (1 ft) over four years of monitoring.

While the stream is still stable, use of fish baffles within the culvert or placement of boulders across the streambed at the culvert inlet, similar to what was successful for grade control at the outlet, are recommended for projects where site conditions show substantial sediment movement.

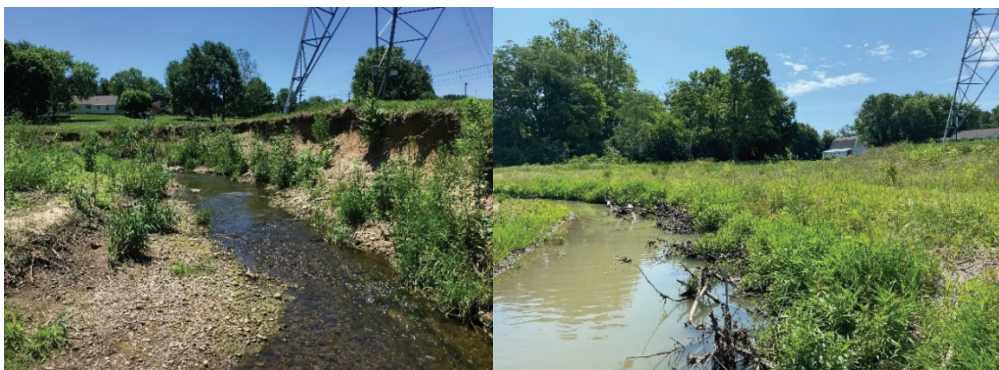
Figure 5 Bank Height Comparison for Unstable (Left) and Restored Stream (Right)

Probability (AEP) or 100-year base flood without increasing water surface elevations. The stream was re-aligned to eliminate the sharp bends and steep curves to allow for stable meanders. Under the unstable condition, the stream bank height on the outside of several bends was 2 to 3 times the bankfull height. These tall, steep banks were especially prone to erosion (Fig. 5), and under the proposed relocation, the ratio of bank height to bankfull height was reduced to 1 to 1.4. This reduction of bank height ratio allowed for benching and construction of a floodplain closer in elevation to the active stream channel. A series of terraces were used to connect the floodplain to the surrounding topography at the original ground level. Fig. 5 shows a bank height comparison under both unstable and post-construction conditions.
