# Sandy Creek restoration – the tale of two acid mine drainage treatment systems

Benjamin Ross Fancher

West Virginia Department of Environmental Protection – Division of Land Restoration – Office of Special Reclamation, Philippi, WV, USA, benjamin.fancher@wv.gov

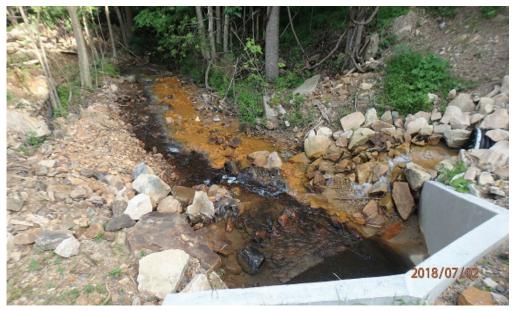
Figure 2 Iron and aluminum precipitating out in streambed causing staining (image: Ben Fancher)

Between late 2017 and spring 2020, extensive construction took place at F&M Coal mining permits to retrofit AMD treatment. At S-57-84, Buildings A and B each address distinct locations within the permit area. Building A handles mine water from underground mine portal and S-1073-86 (Fig. 2), while Building B addresses AMD from the bottom of the pit location on S-57-84 and cracks in rock outcroppings above Left Fork Sandy Creek. Both buildings utilize lime slurry for AMD treatment, adjusted based on pH monitoring. After two years, trials switched to sodium hydroxide for more adaptable treatment based on variable

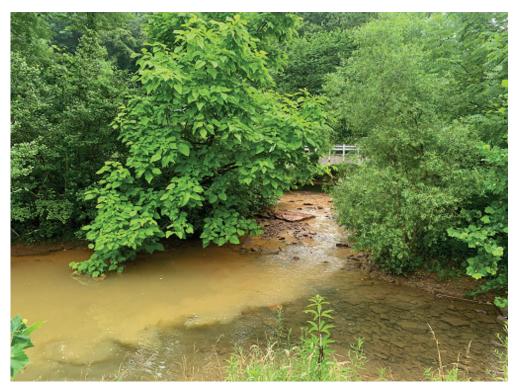
Figure 6 Confluence of Left and Right Fork Little Sandy Creek in Fellowsville, WV (image: Ben Fancher)
