The use of geomorphology as the basis of mining closure: a case study of Waste Rock Facility rehabilitation at the Santa Bárbara mine (Perú)

Alfredo Gallardo¹, Juan del Río², John Melgarejo³

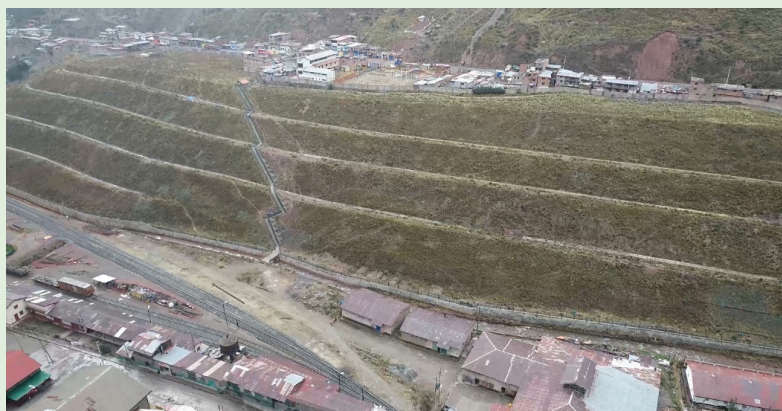
Photography 1: View of typical closure of mining environmental liabilities

Over the past two decades of activities related to the closure of mining environmental liabilities, the industry has largely operated within the framework of these guidelines and the predefined parameters for the shape and structure of components, such as waste rock facilities (WRFs). Most of these facilities have been remediated according to the following criteria:

- Total or partial removal of rock material.
- Profiling and physical stability of slopes
 - Covering with natural waterproofing material (clays, gravels and topsoil).
 - Waterproofing with geosynthetics and topsoil.

Many of these projects remain under restricted access and continuous surveillance, as none have successfully achieved stable closure conditions that harmonize with the natural environment. Common issues include soil erosion, limited vegetative growth, failures in concrete channels, and the presence of acid rock drainage, among others. These challenges force mining companies to incur permanent maintenance costs for infrastructure and water treatment, undermining the long-term sustainability of the closures process.

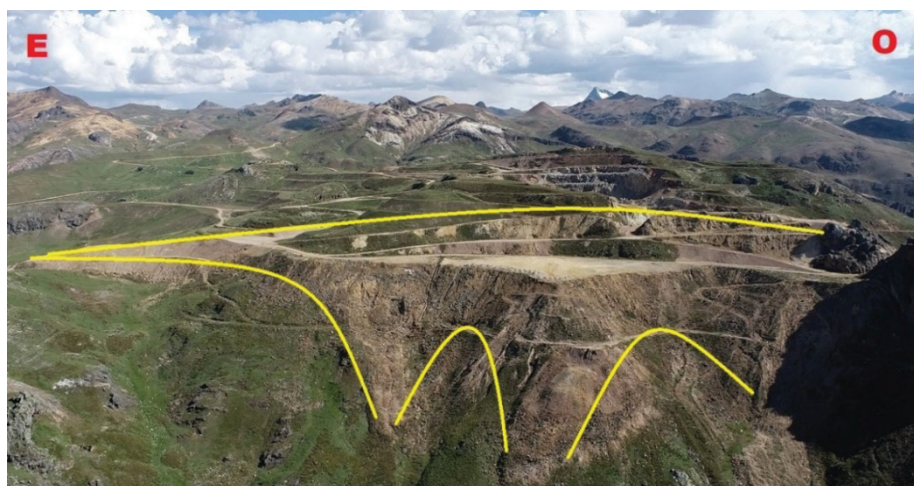
Photography 2: Front view of the WRFs

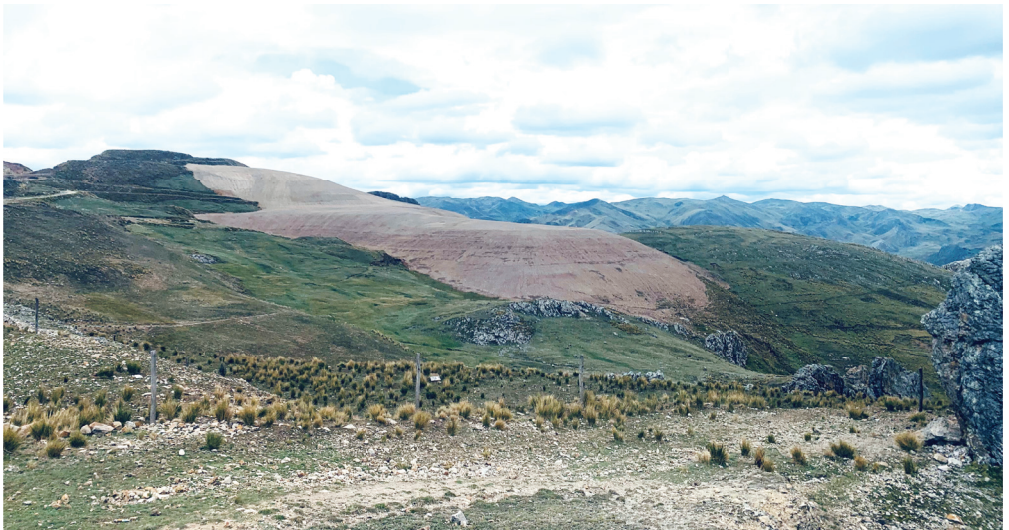
Photography 3: View of the WRF (DSB-02B and DSB-14)
