## SUMMARY REPORT ON THE GEOLOGICAL AND HYDROGEOLOGICAL ASPECTS OF THE LUSAKA WATER SUPPLY AND THE IMPACTS OF POLLUTION

D.C.W. NKUWA, Aachen University of Technology, Lochnerstr. 4-20, W-5100 Aachen, Germany.

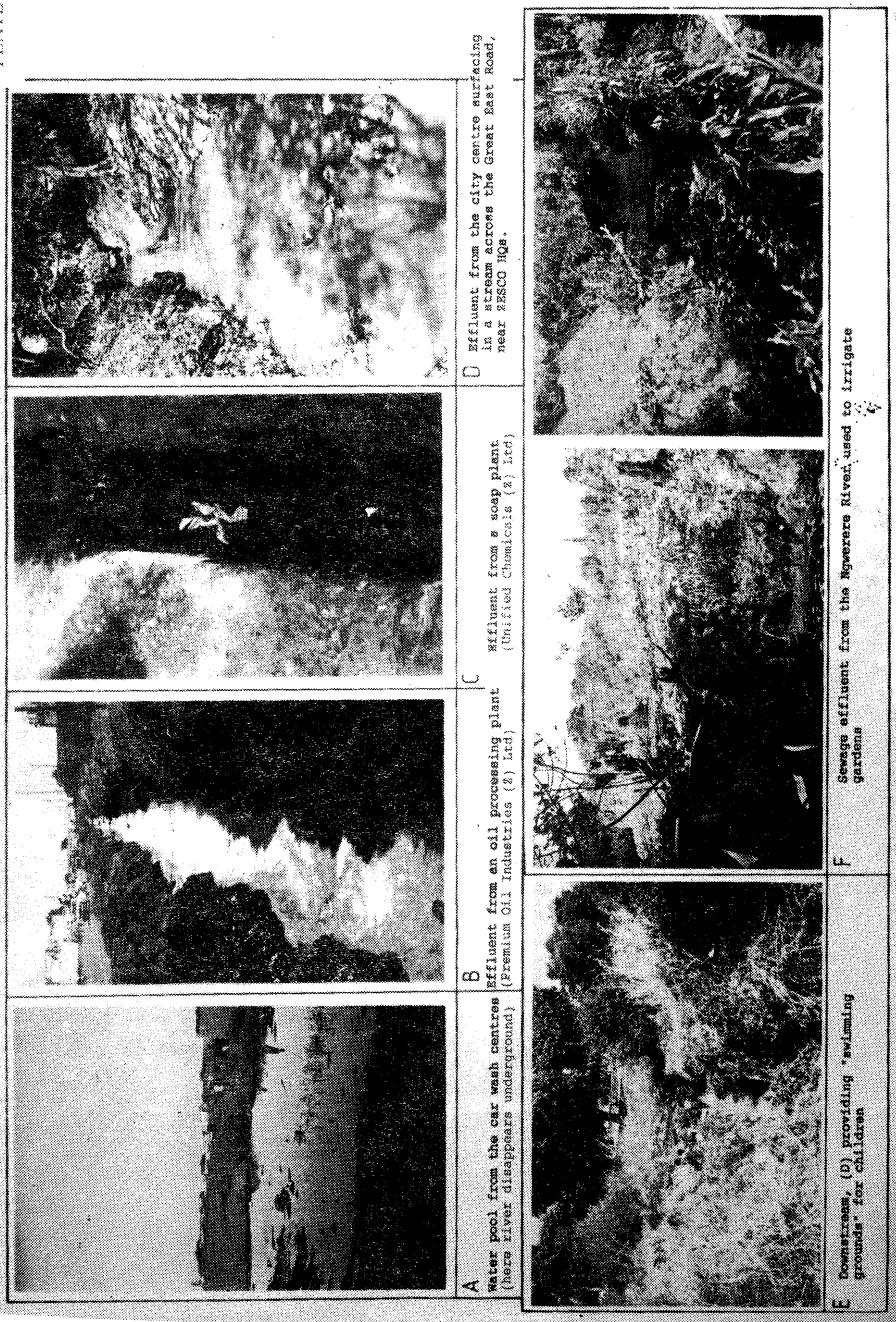
PLATE 2

3. the car wash centres along Kafue road generate 'quantities' of waste waters everyday (Plate 1D) which finally drain into the subsurface (Plate 2A), to find their way into the aquifer(s),

D: Waste waters from car wash centres along Kafue Road
