# Forecast of emergency situations owing to excessive water inflows into tailings ponds

#### O. Sammarco, M. Ovi and M. Costabile

Bureau of Mines, Dept of Earth and Environment, Tuscan Region, Via Goldoni 6, 58100 Grosseto, Italy

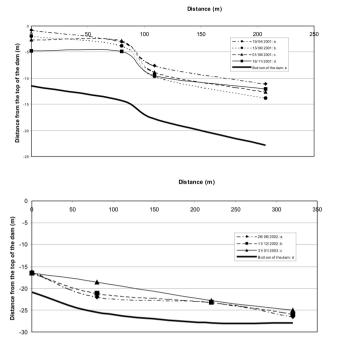
Some isochrones of the piezometric levels in the most downstream dam of the Gavorrano mine pond and in the one of the Fenice Capanne mine pond are drawn in figure 5 and in figure 6, respectively. The bottom of both dams is also drawn in these figures. The difference between the two situations shows up: in the first case, 72% of the dam is under the ground water, while in the latter just 11% of the dam is under the ground water. In other words: the dam failure risk is very higher in the first case (Sammarco 2003b). This different risk rate is also related to the tailings, as the piezometric situations in the dams indicate, in these cases, the ones in the tailings, which are just upstream the dams themselves.

Figure 6. Fenice Capanne mine. Trends of isochronous piezometric levels in the dam of the tailings pond (a, b and c) and bottom of the dam (e).
