Overcoming the Pitfalls of abandoned mine workings in the Sydney Coalfield

Dave FORRESTER, Bruce NOBLE

AECOM, 164 Charlotte Street, Sydney, NS B1P 1C3

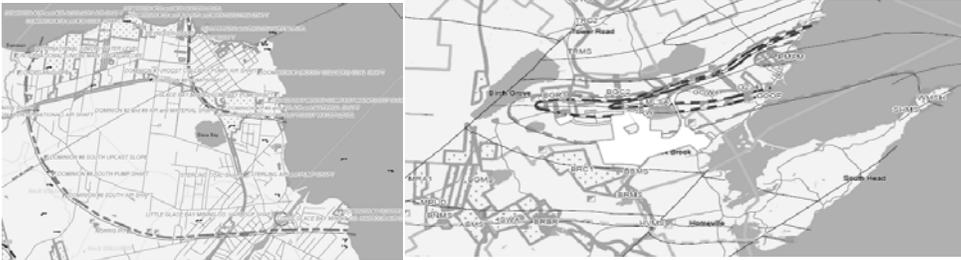
Figure 1 Seam outcrops in the Glace Bay & Port Morien areas of the Sydney Coalfield

Sinkhole subsidence hazards are dependent firstly on the location of the shallow mines which in turn are located close to the outcrop of the seam with the ground surface. The outcrop maps for the Glace Bay and Port Morien areas of the Sydney Coalfield are shown in Figure 1.
