W O R K S H O P
**ENGINEERING
IN
KARST**

**Portorož, Slovenia
September 7 - 9, 1996**

Torr Quarry ~ Foster Yeoman

SLOPE STABILITY STUDY

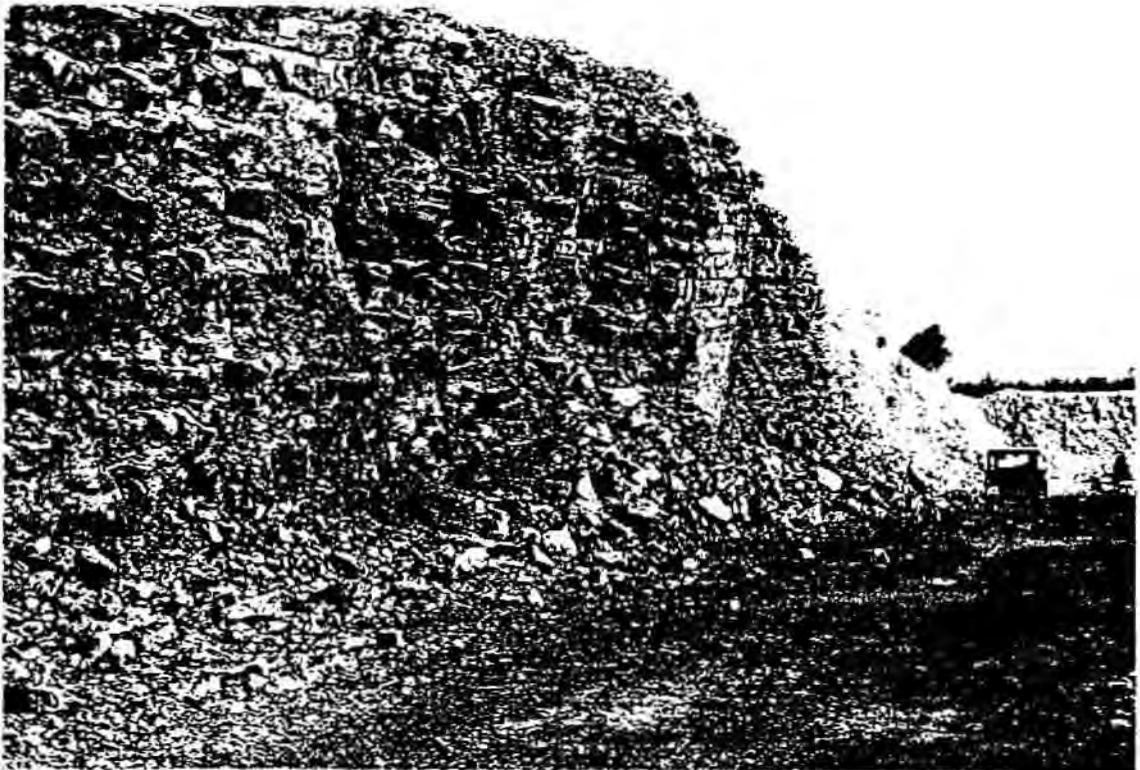
Photograph No 8
Bench B, N zone/W wall. Toppling failure

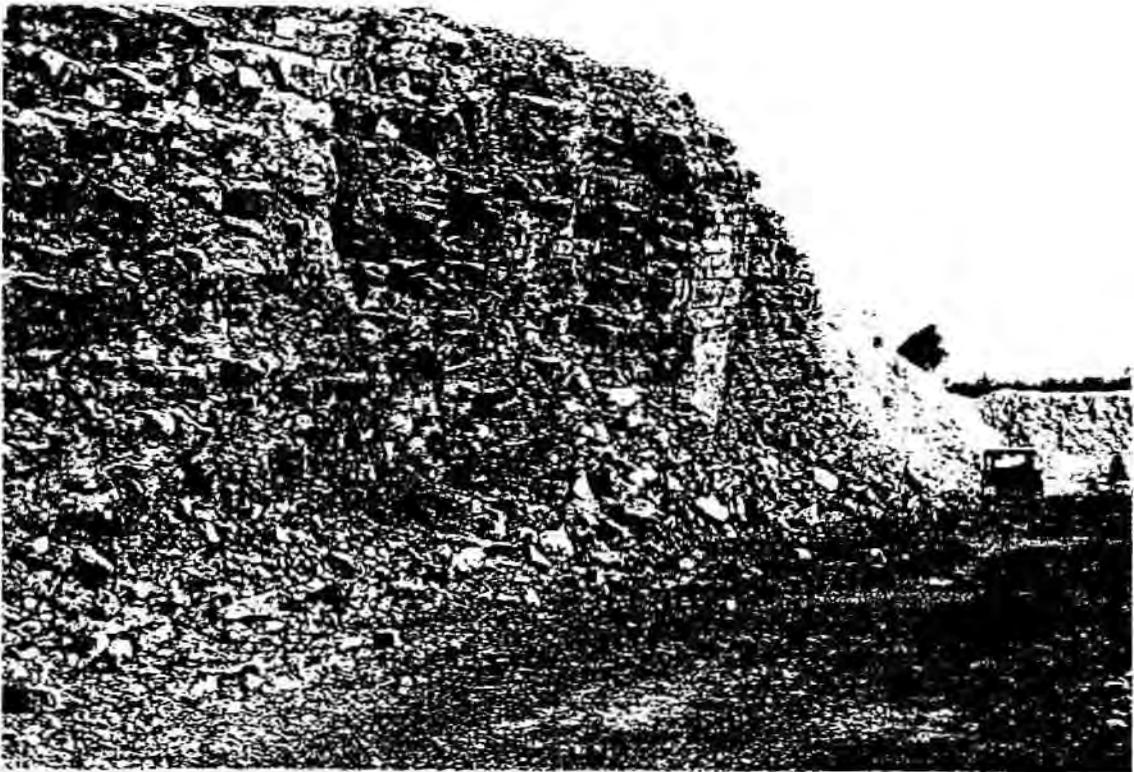
Photograph No 8
Bench B, N zone/W wall. Toppling failure

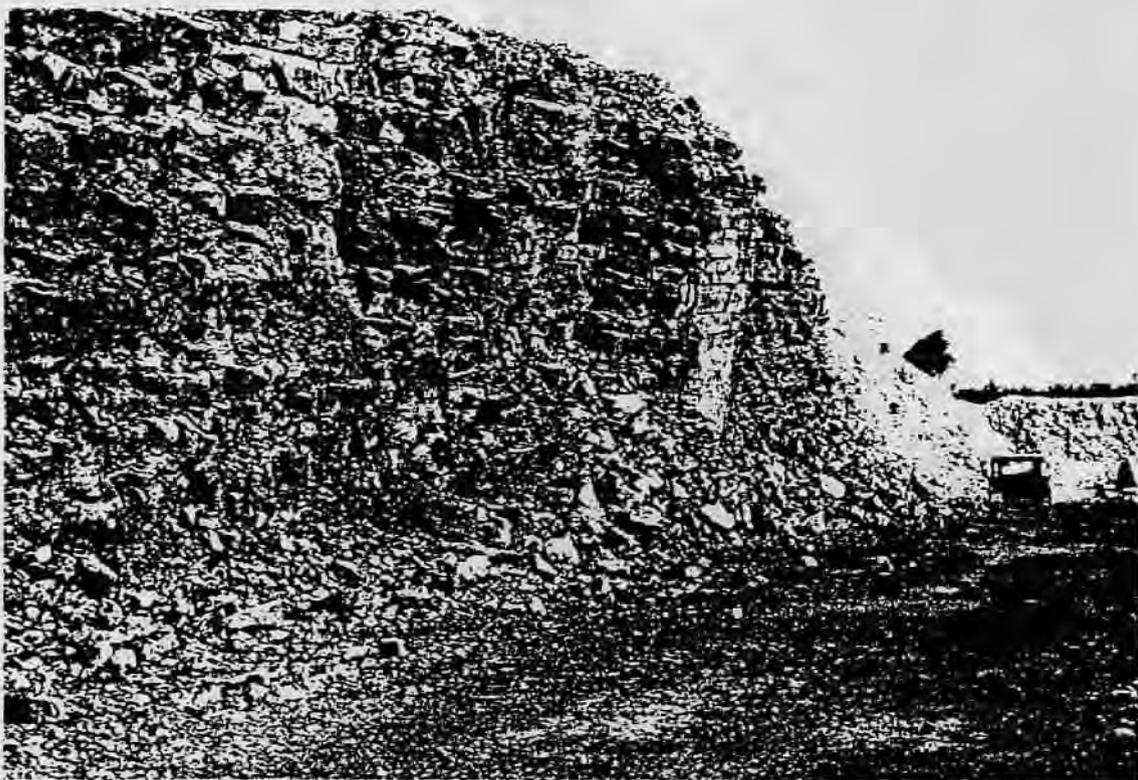
Photograph No 8
Bench B, N zone AM wall, top line failure
reproduced from best available copy

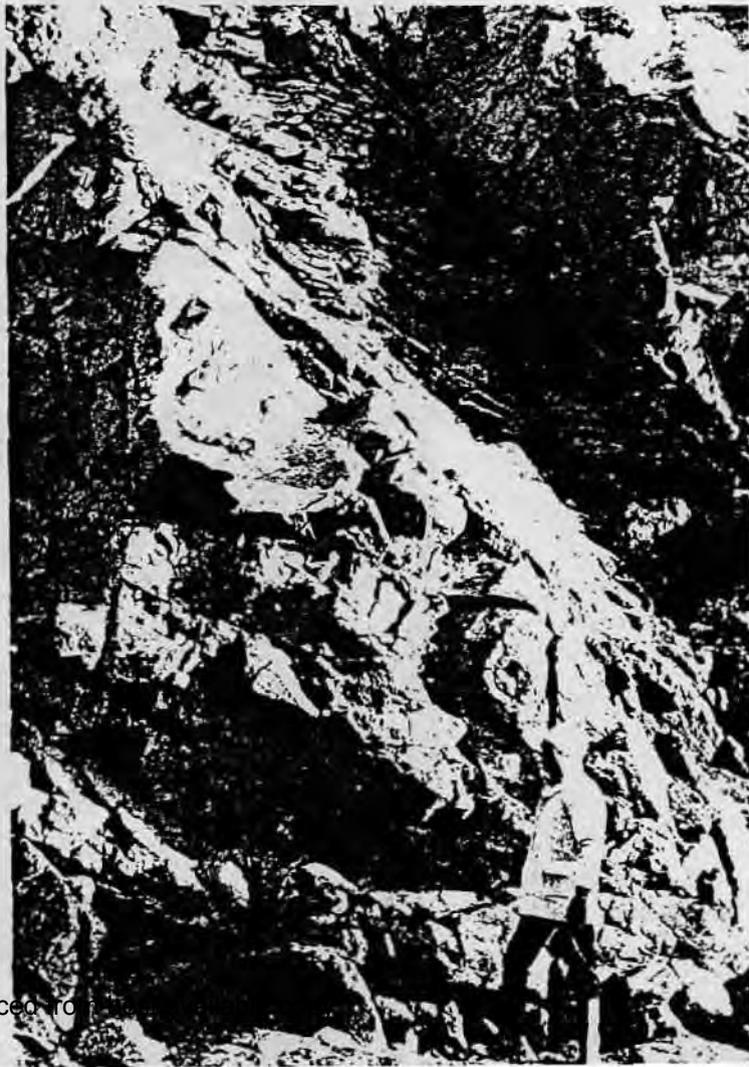
Photograph No 12
Bench B, N zone/E wall. Drag
features in fault zone

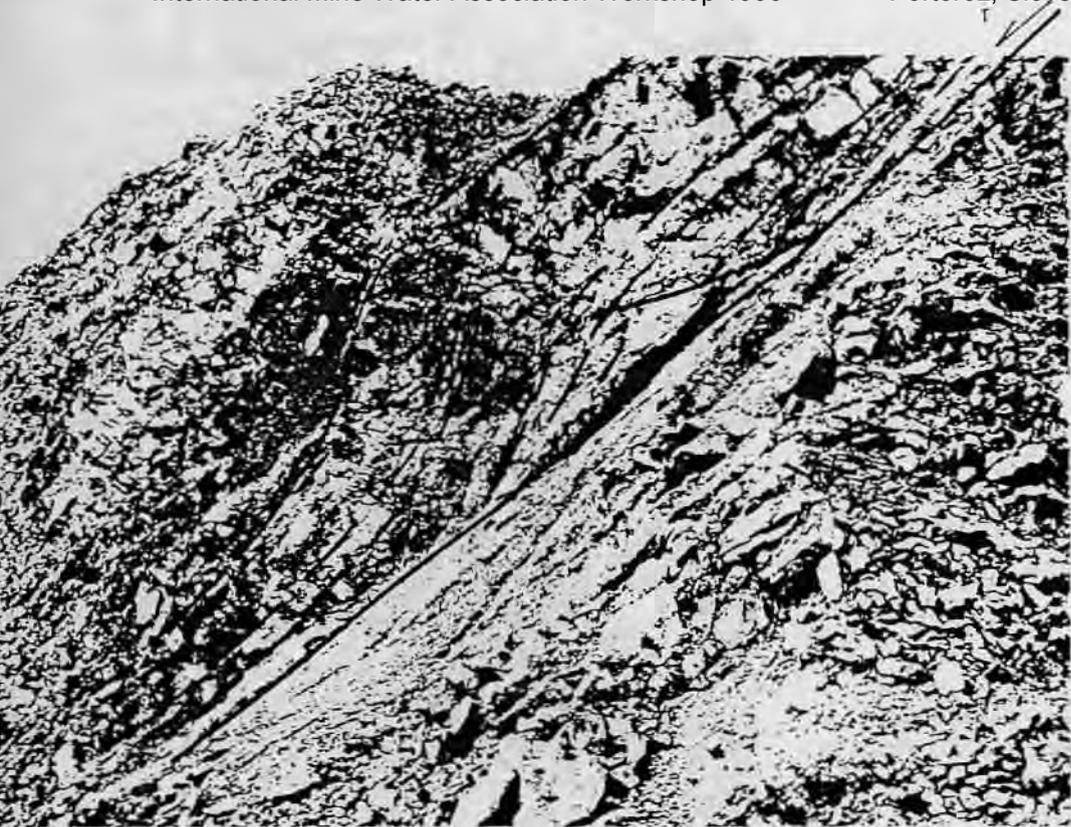
Photograph
No 27
Backthrust
related
folding above
thrust plane

Thrust
ramp

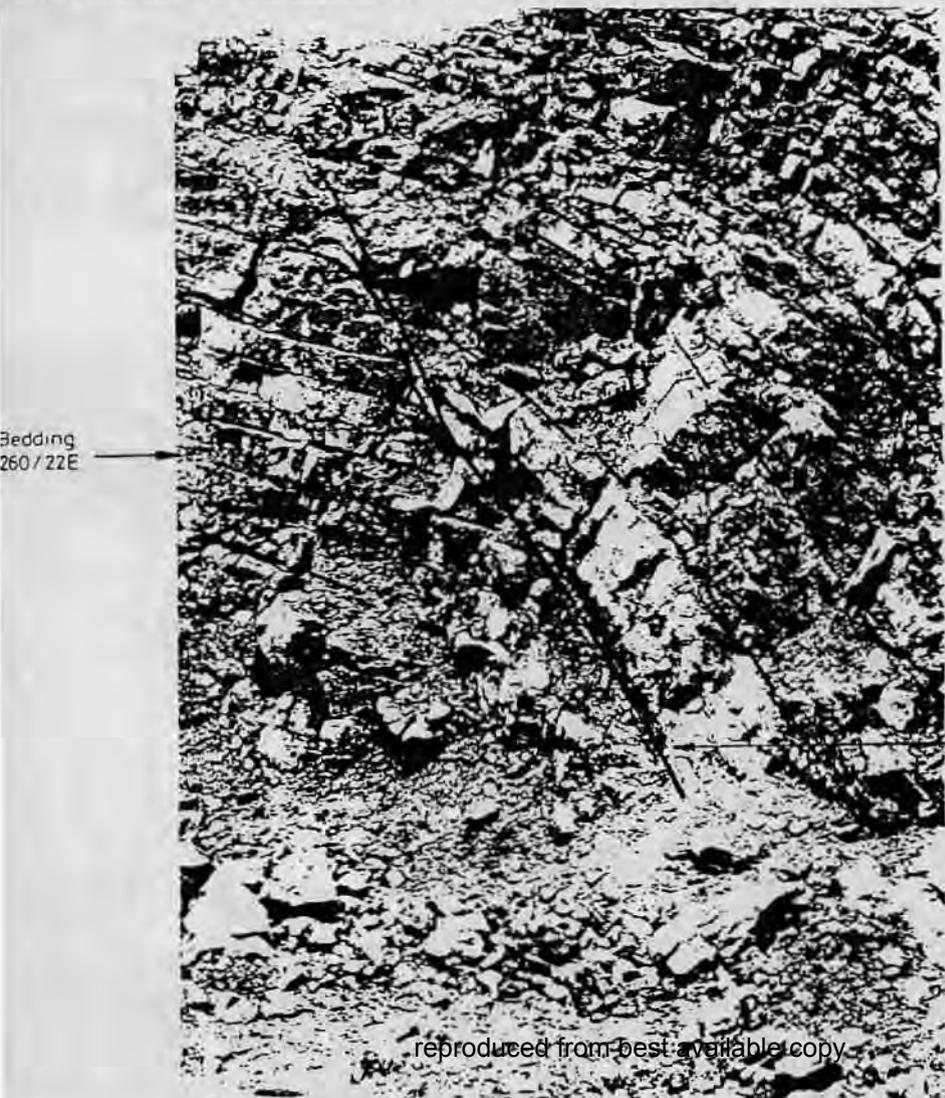
Photograph No 28
Bench B, N zone W wall

Bedding
024/45E

Oblique thrust
ramp

Bedding
260/22E

Fault 010/55E

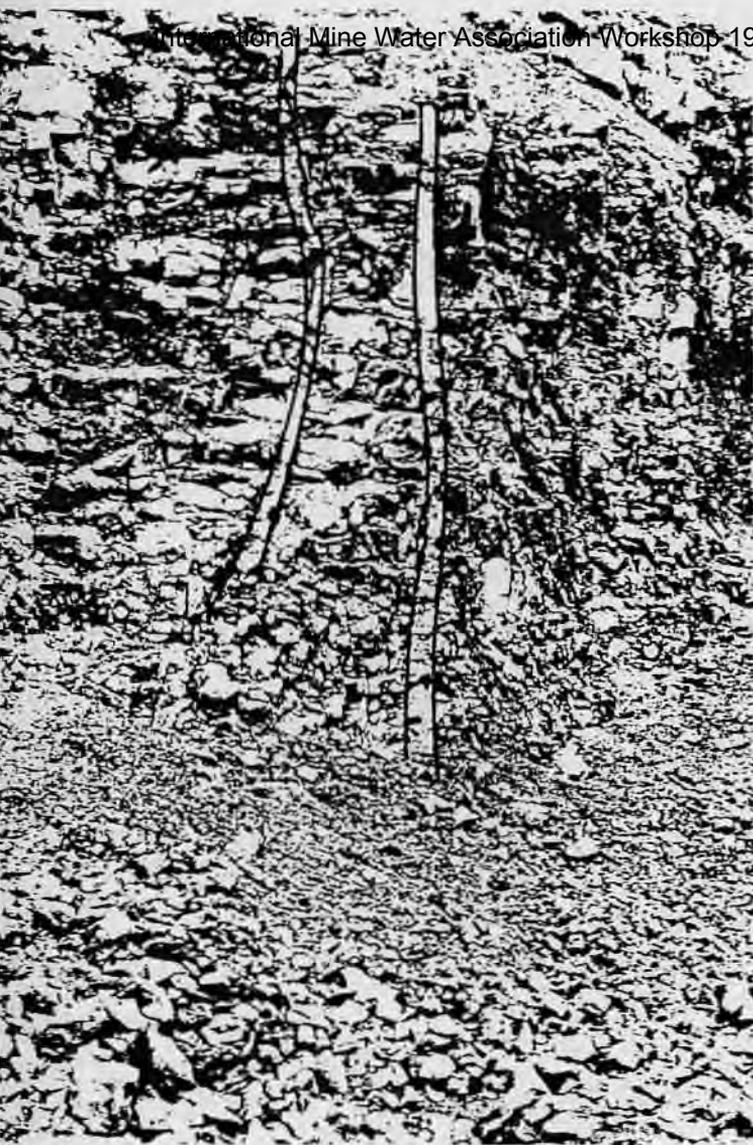
Veins trending
N-S

Photograph No 31
Example of dilational veins.
Calcite infilling.

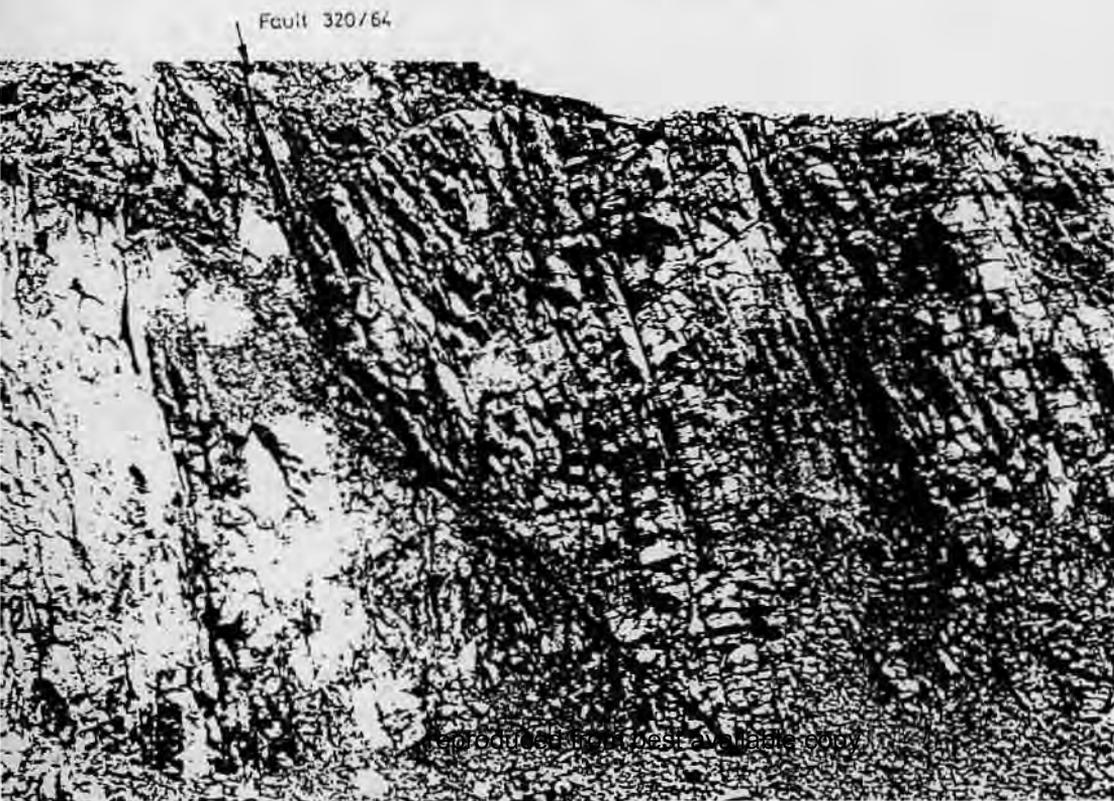
Fault 320/64

Dilational
Joints

Photograph
No 32
Shear
fractures at
high angle
to bedding
