## EXTENDED ABSTRACT

**Closure of an open pit and landfill for excavated earth**

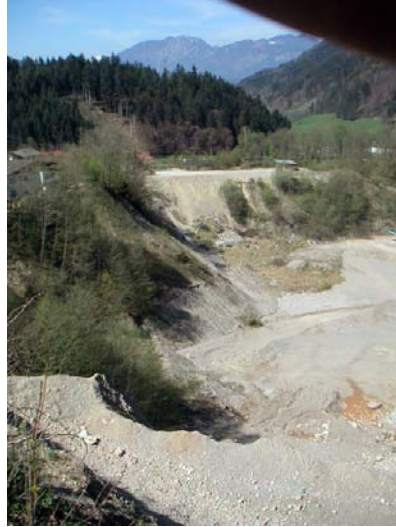
*Figure 2 Scrap view of the open-pit mine before refilling*

Quaternary loose sediments are used in the Eastern Alps often as industrial rocks. In Itter in Tyrol/Austria from 1967 to 2006 400,000 m<sup>3</sup> gravel was recovered and used in the construction industry (Figure 1 and 2). Some embankments were not stable any more. After the exhaustion of the economically winnable gravel reserves the closure of the open pit was to be intended.

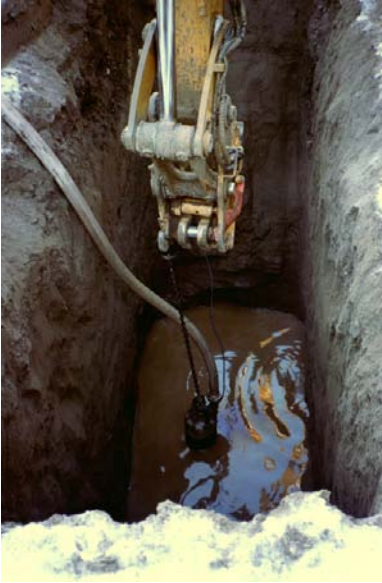
*Figure 3 Investigation of the subsoil by trenching* *Figure 4 Sampling of the groundwater to the perpetuation of evidence*

A geological ground survey with the water outlets in the opencast mine was carried out. A conservation project of water management was authorized to prepare the licensing procedure. Test pits, pumping tests and water analysis were carried out and the water bearing bed was explored (Figure 3). A hydrologic triangle was put on. Water samples and hydrogeochemical analysis (conductivity, water hardness, sulphate, pH value, water level) improved that there is no pollution of

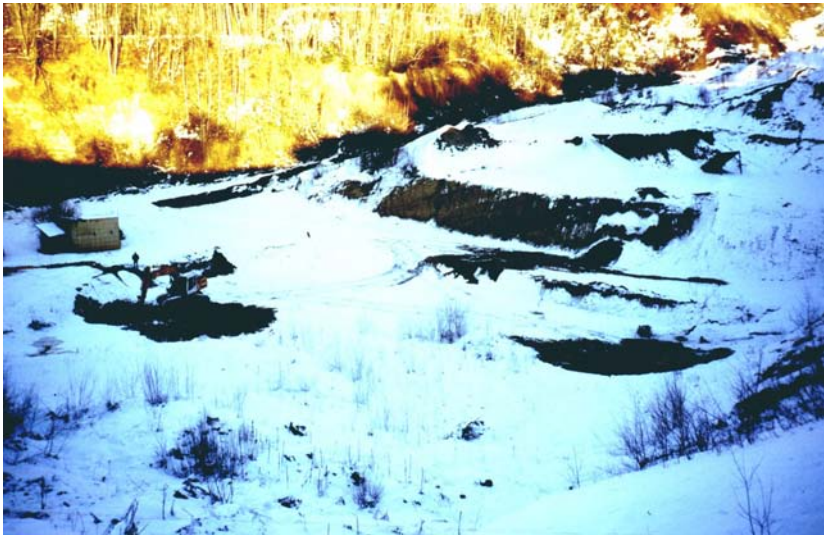
*Figure 5 Whole view of trenching (hydrologic triangle)*

the surface and the groundwater and no hazard for potable water (Figure 4). There is no interrelationship between surface and / or groundwater and potable water (Figure 5).
